**GEOTECHNICAL & GEO-
ENVIRONMENTAL REPORT
PROPOSED DEVELOPMENT
SITE OFF FLORAL MILE,
HARE HATCH, READING**

**Prepared for:
GTO Engineering**

Job No: 11839

There is a proposal to develop the site off Floral Mile, Bath Road, Twyford.

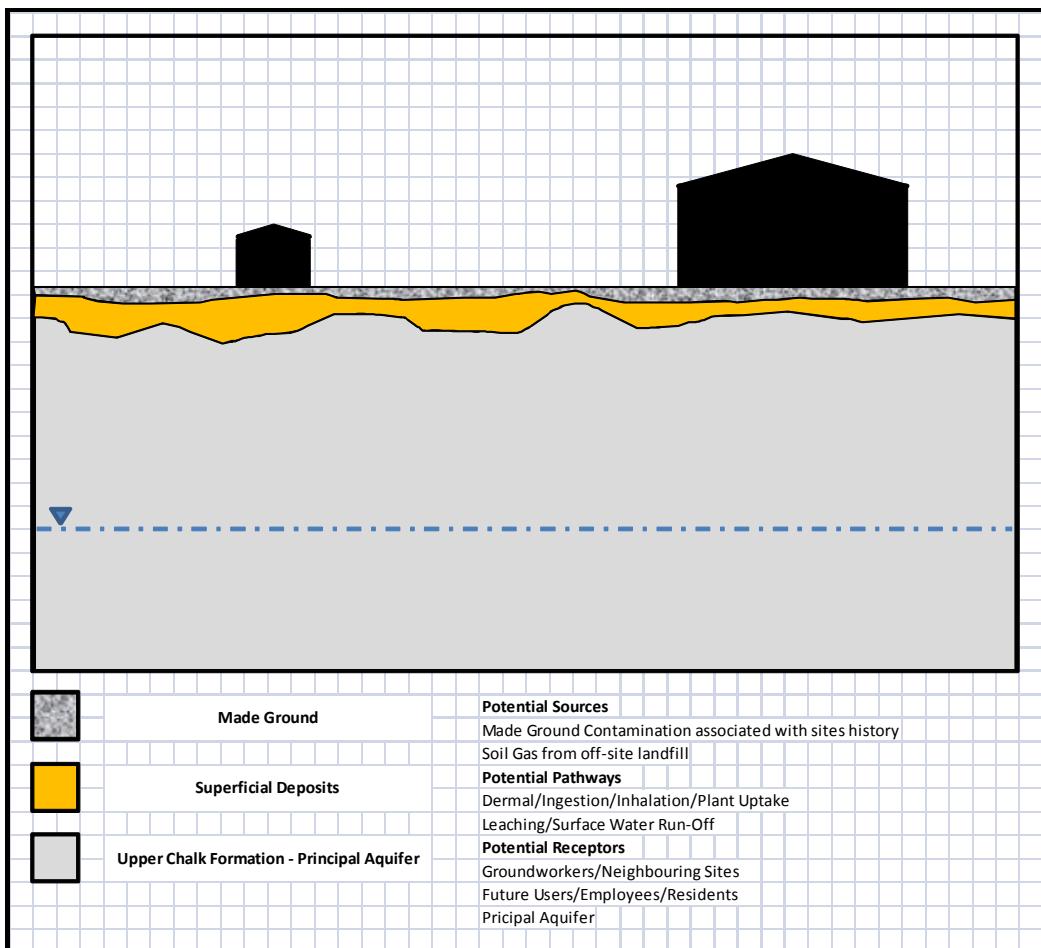
The results of the preliminary risk assessment are summarised in the preliminary Site Conceptual Model presented below;

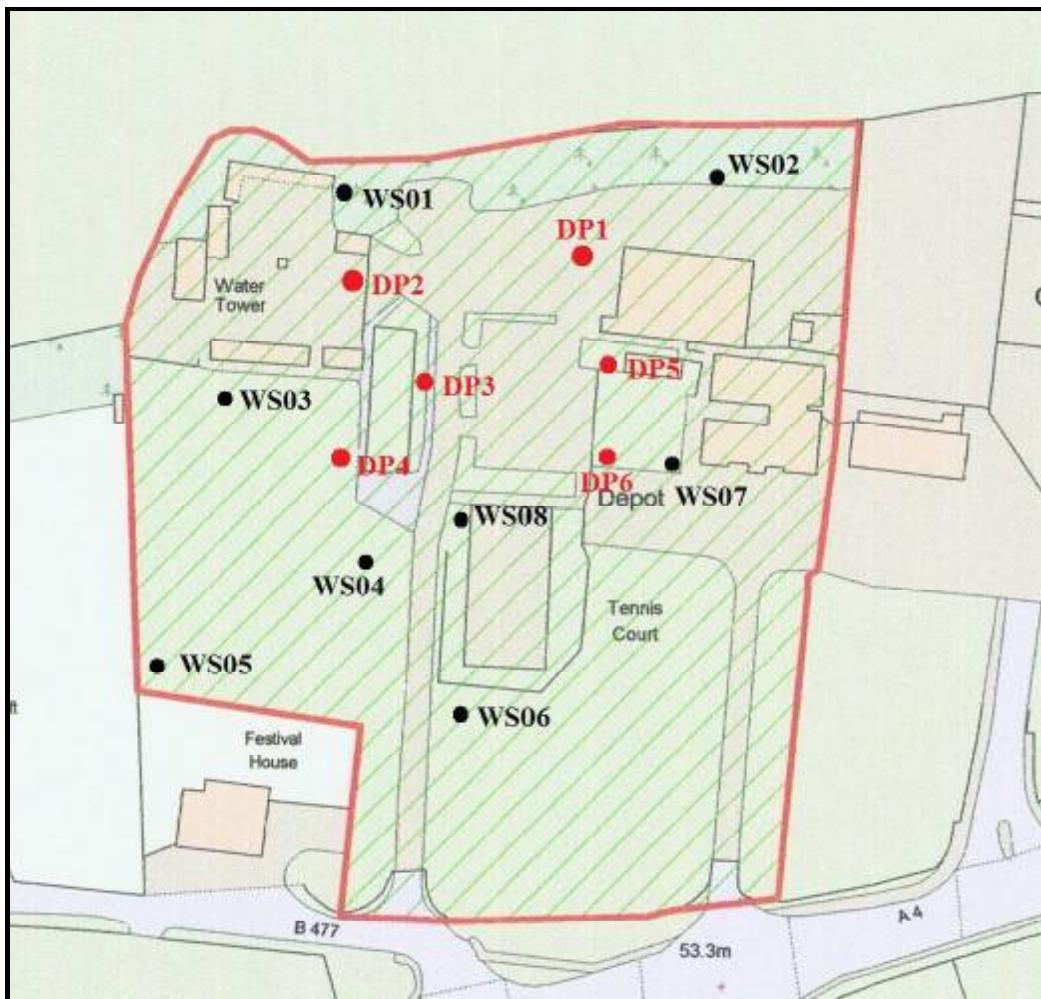
Figure 02. Site Layout and Borehole Locations

The borehole logs are presented in **Annex C**. The additional probing is detailed in Annex H. The positions of the Boreholes (WS) and Probes (DP) are shown on **Figure 02**.

- Figure 01 Site Location
- Figure 02 Site Layout and Borehole Locations

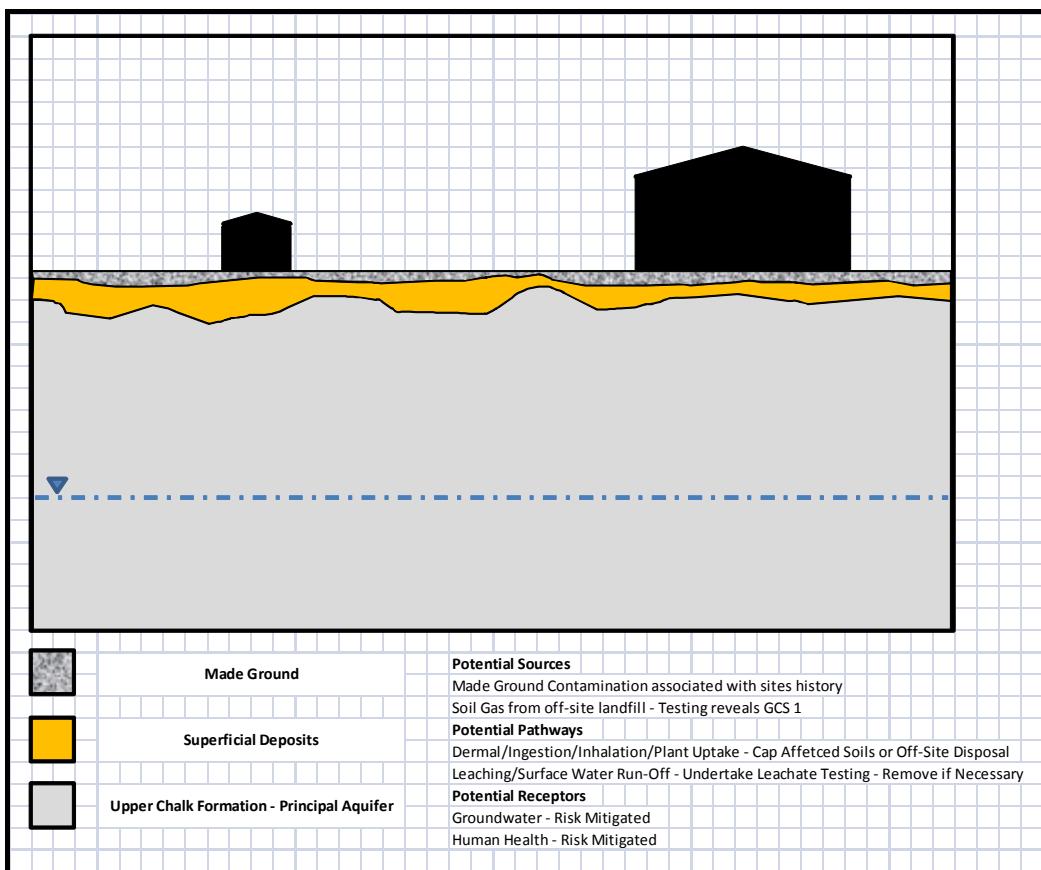
A site conceptual model is presented below. The model is schematic and not to scale.
