# Surface Water Drainage and SuDS Strategy Report

EX22/O50/O6

105 Colemans Moor Road  
Woodley  
Reading  
RG5 4DA

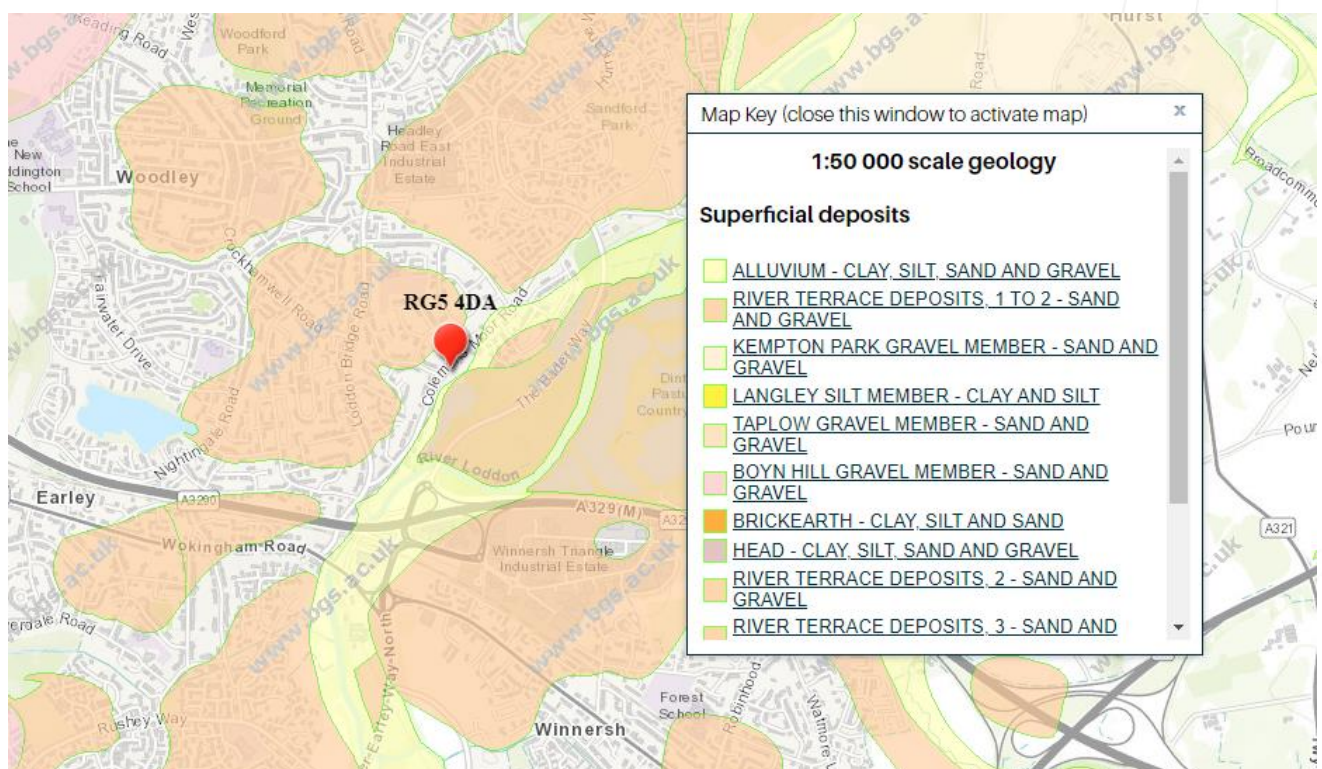
Figure 1: Superficial Geology Plan

- 2.0.3 The River Loddon is located approximately 500m to the south of the site.
- 2.0.4 Information taken from the British Geological Survey (BGS) shows the underlying geology as superficial deposits classified as Alluvium – Clay, silt, sand and gravel. Bedrock geology is classified as London Clay Formation – Clay, silt and sand as shown in [Figure 1](#) and [Figure 2](#) below. Local borehole information shown in [Figure 3](#) shows made ground above clay which was encountered at a depth of 2.2m.

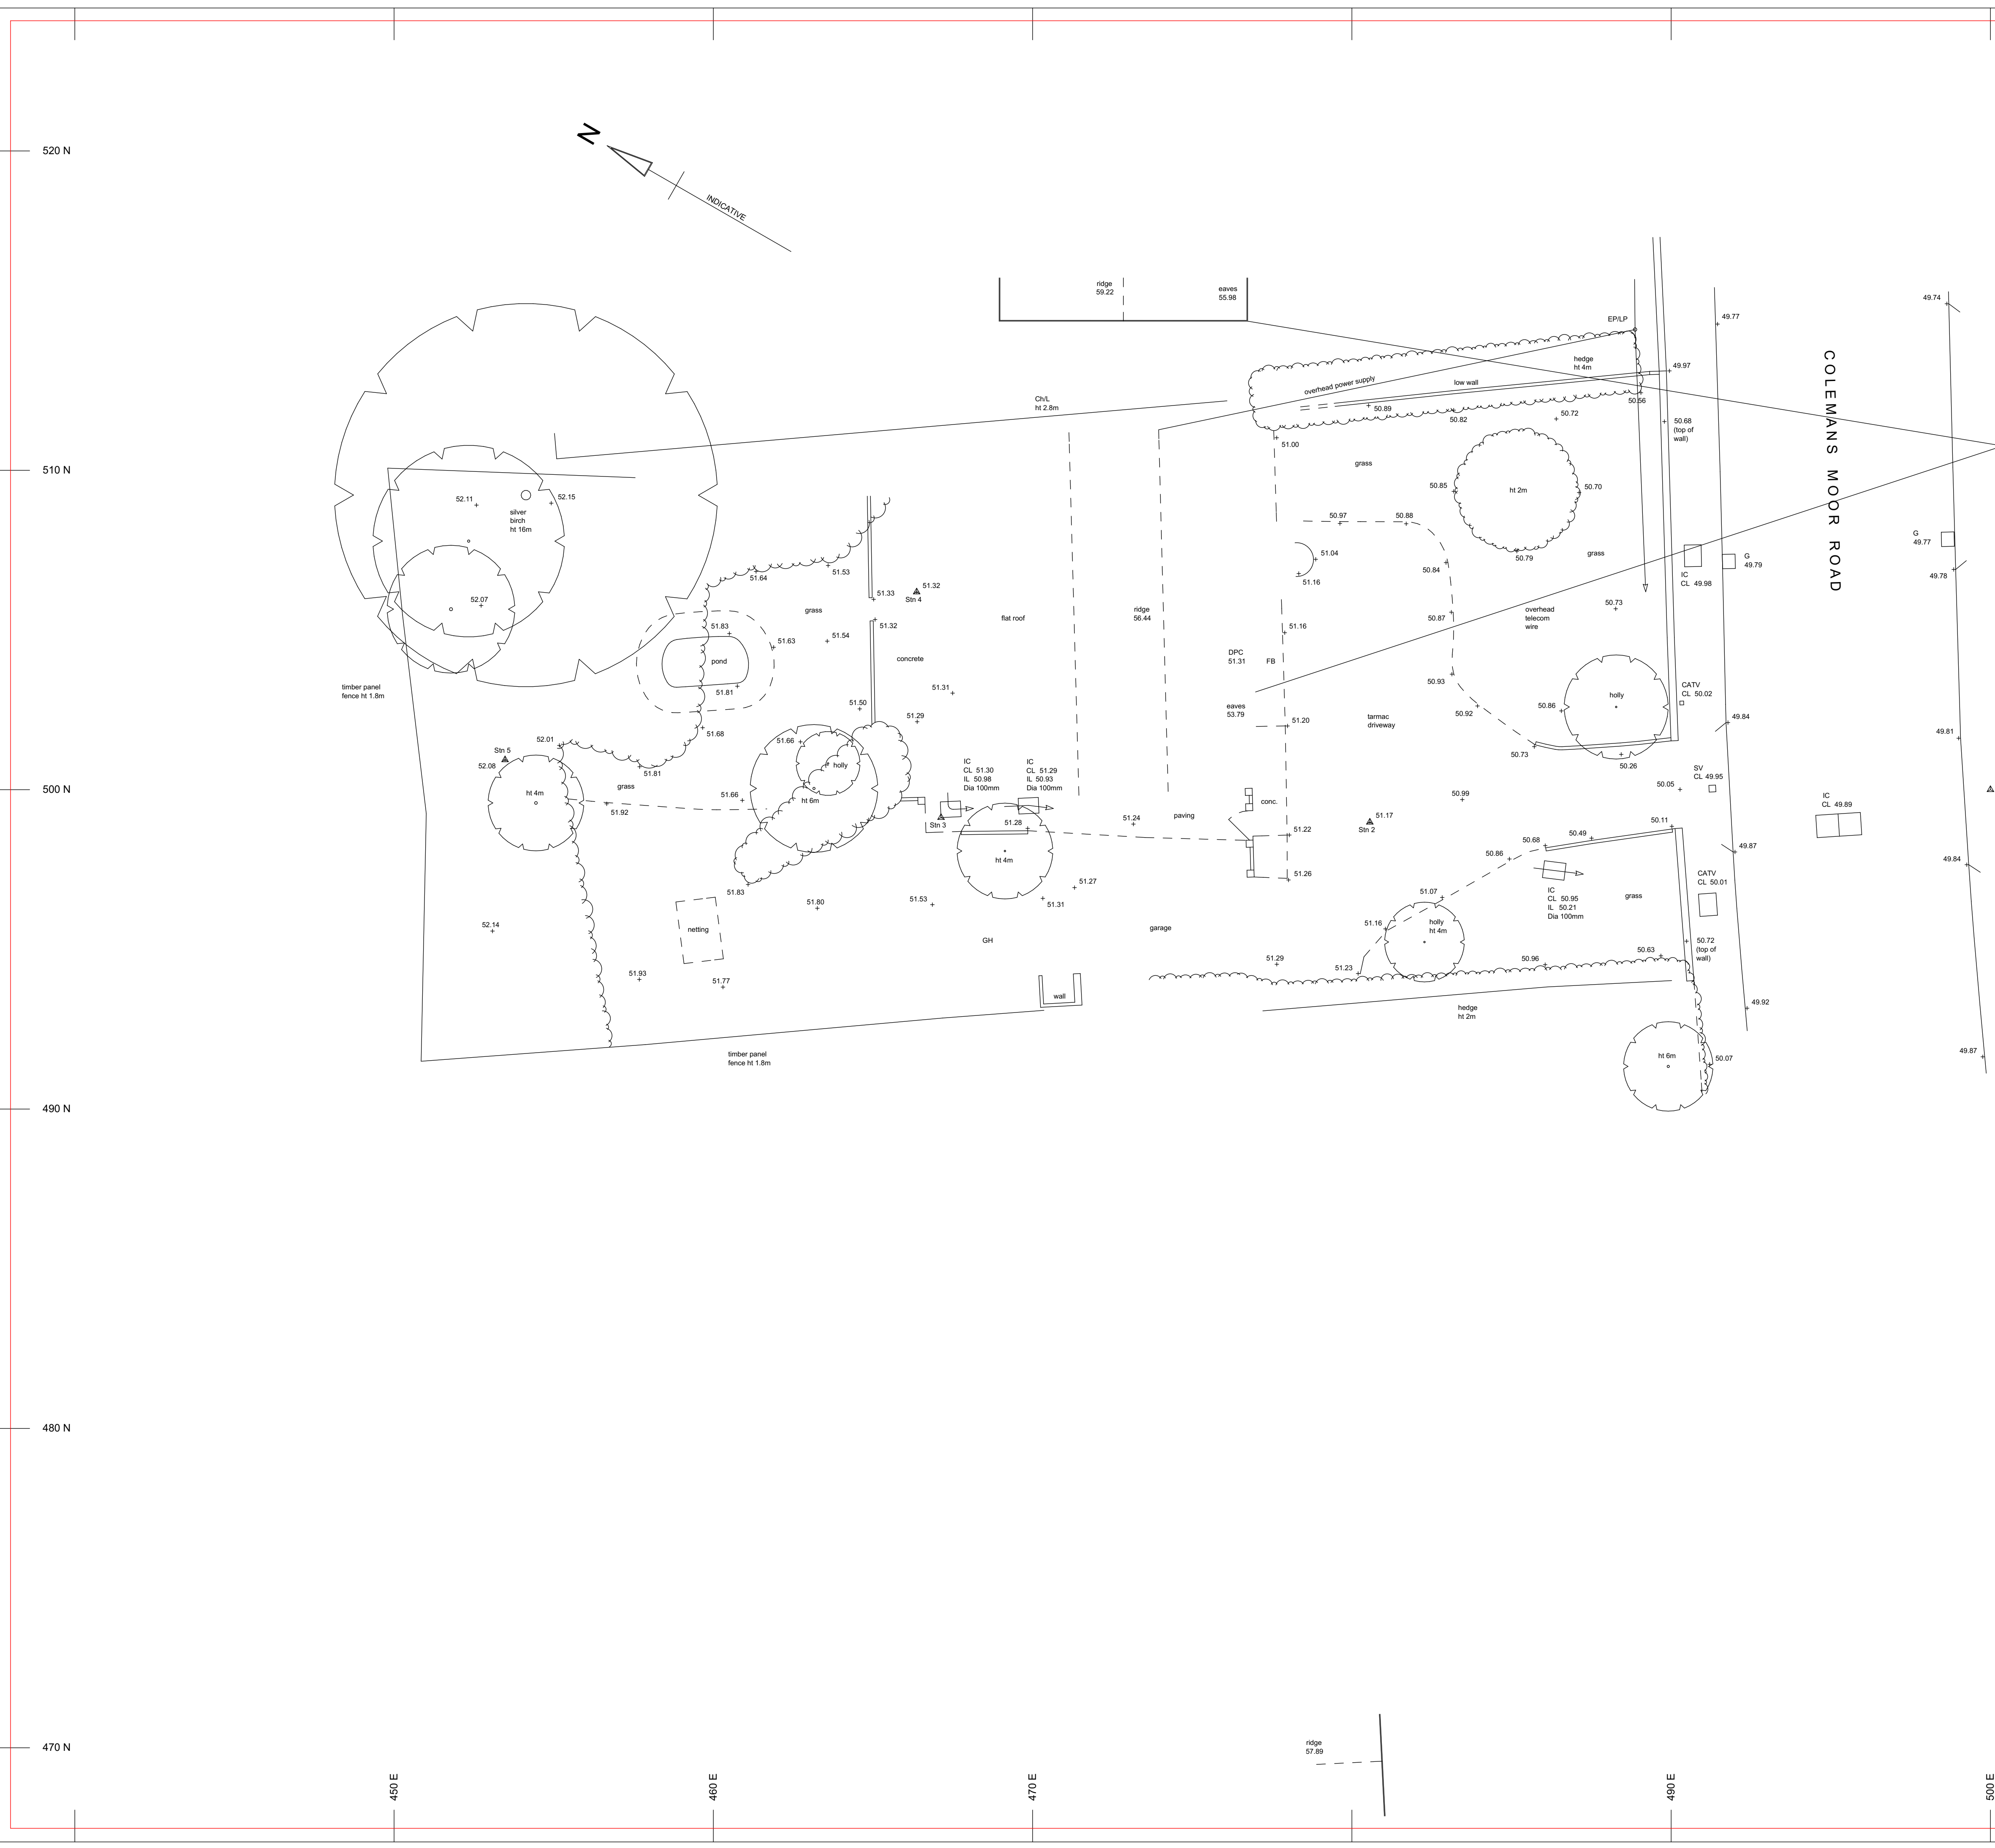
### Appendix A – Topographical Survey

1. Levels in metres relative to Arbitrary Datum situated on STN 1, value 50.00m.

- 2.0.1 The site is located off Colemans Moor Road, Reading and is an existing dwelling. A topographical survey of the site has been carried out and can be found in [Appendix A](#).

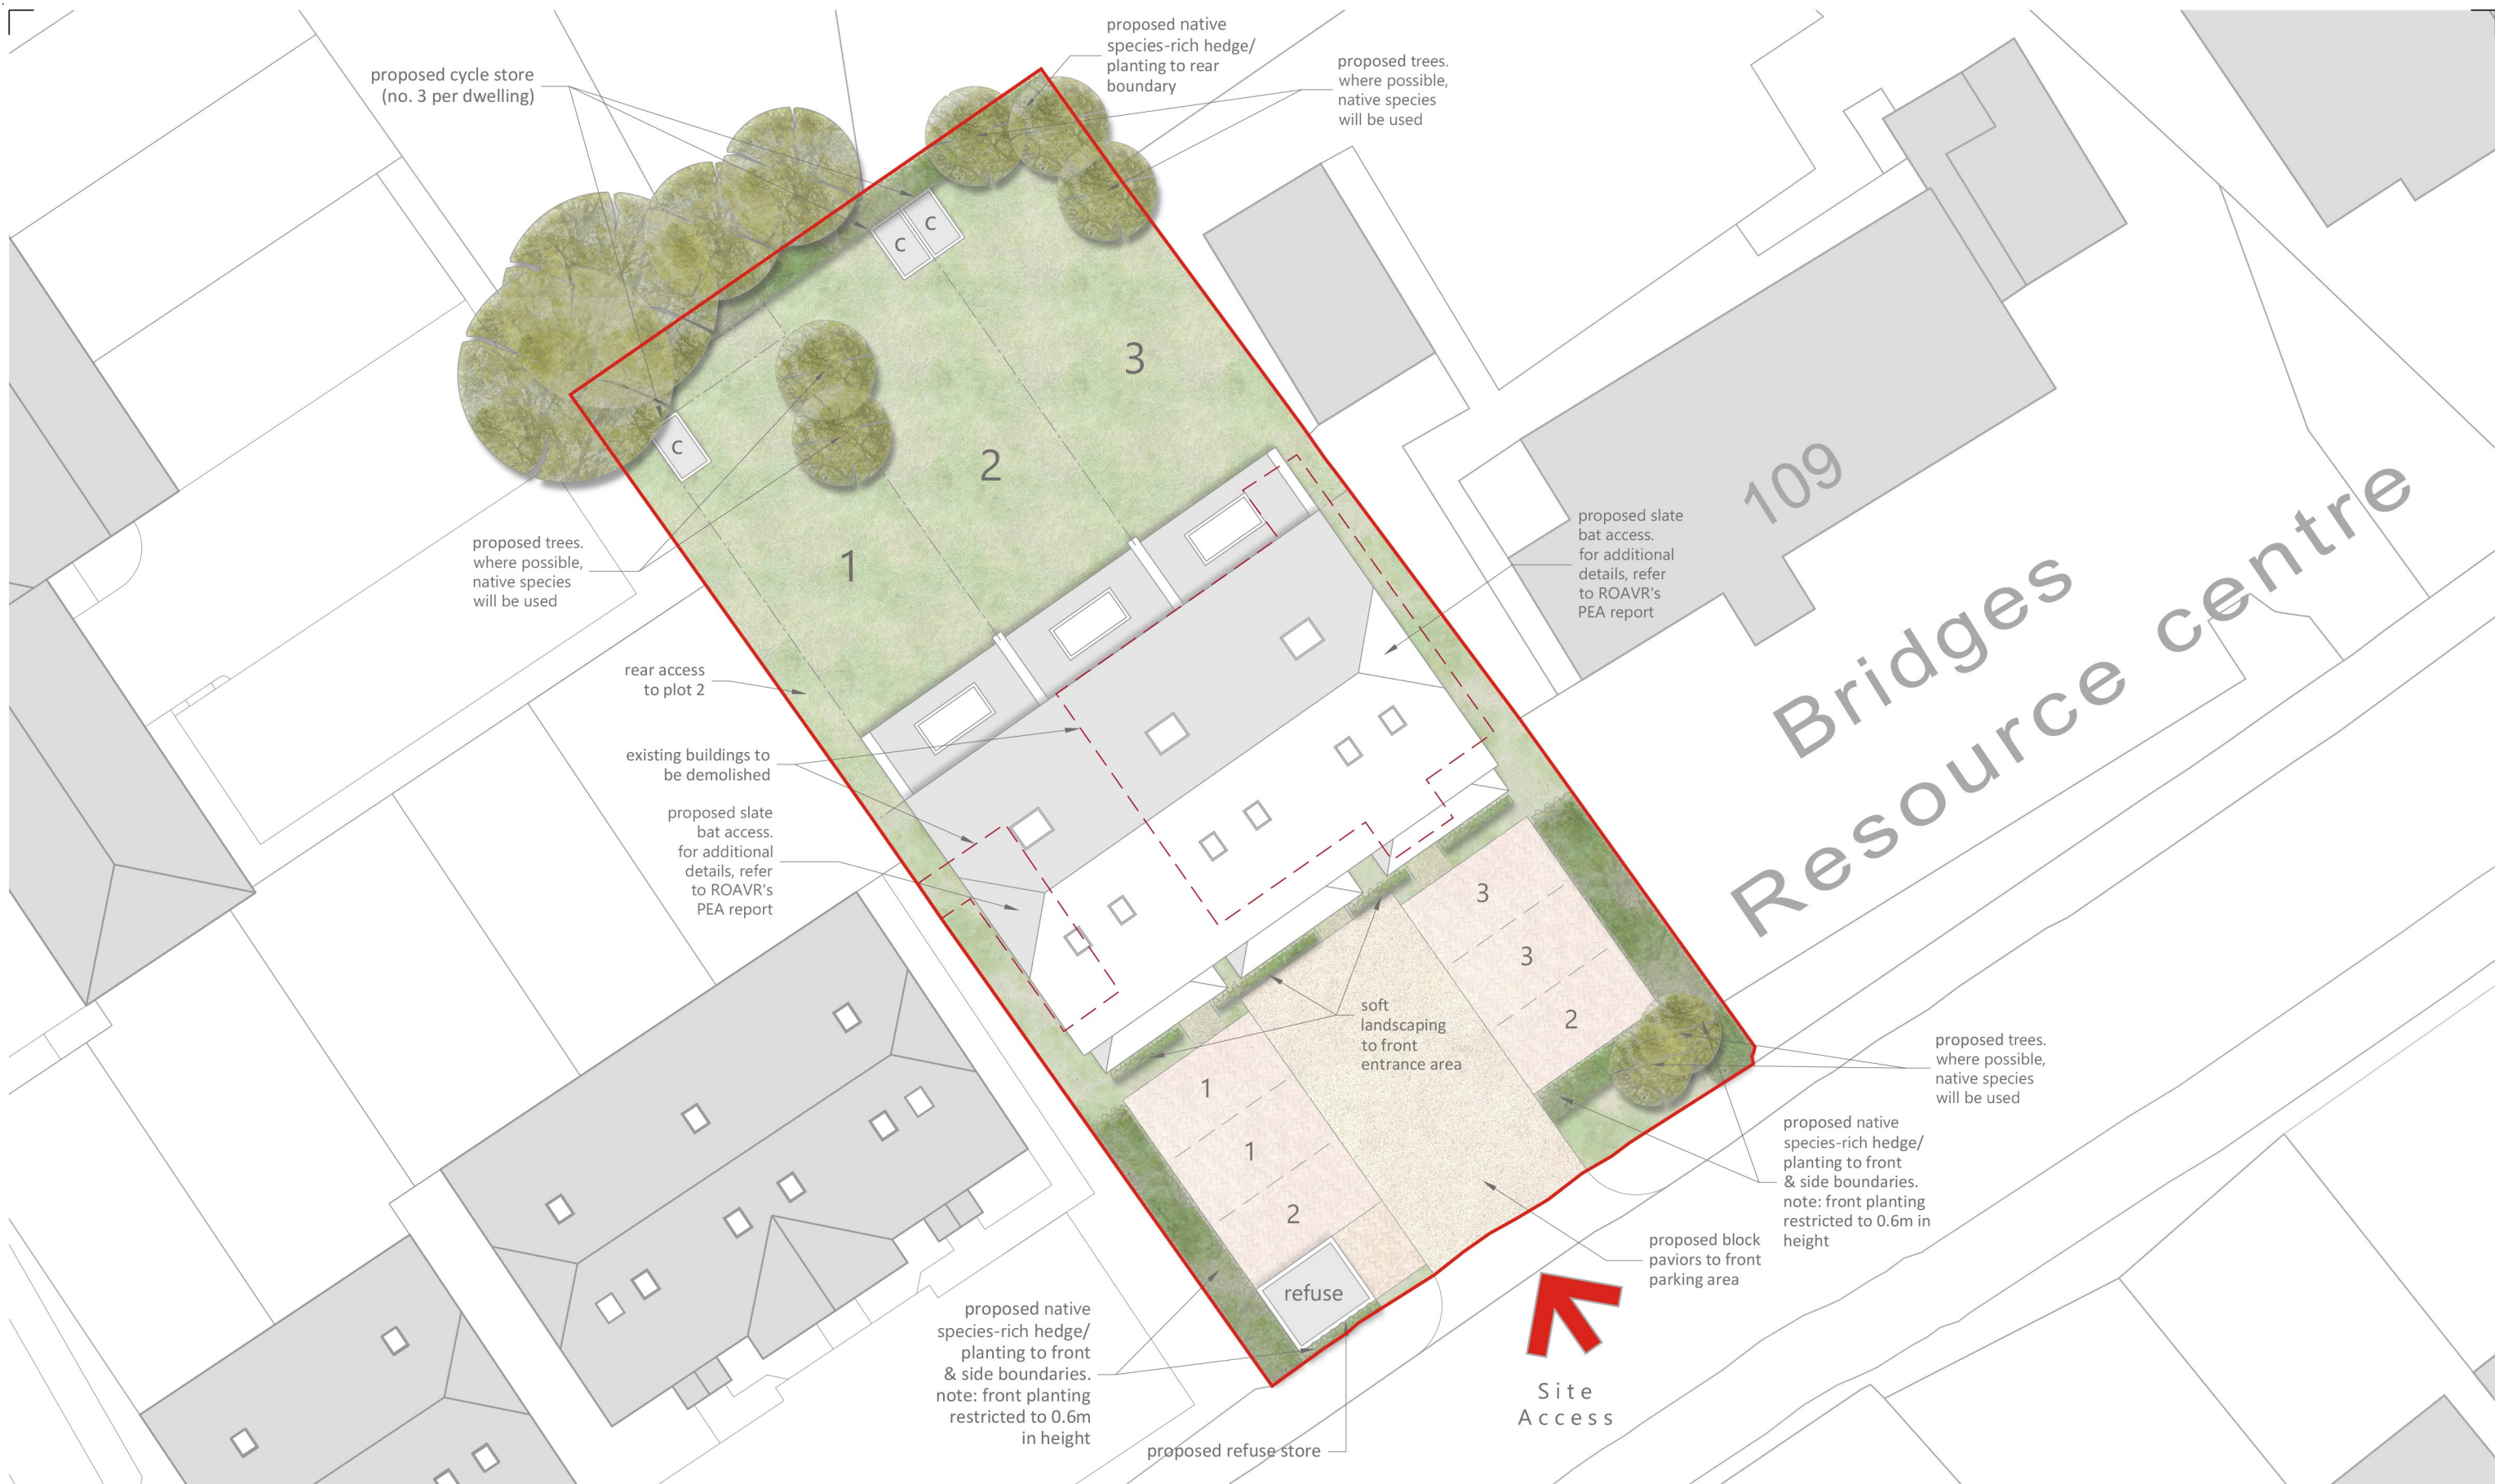
## Appendix C – Proposed Site Layout

| CLIENT | PROJECT | TITLE | DRAWING NUMBER | REV |
|---|---|---|---|---|
| Colemans Moor Heights Ltd. | 105 Coleman's Moor Road, Woodley | Proposed Site Plan | 2159_005 | B |

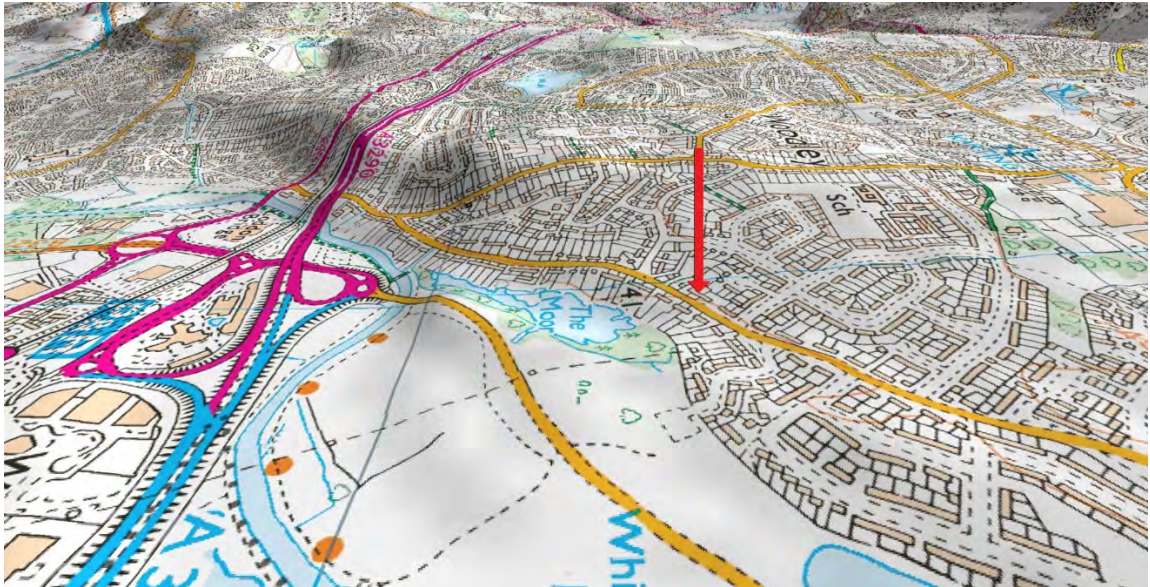
### 3.1 Topography

*The topography shown above is greatly exaggerated to allow it to be visualised.*

The site lies at the edge of a large plateau occupied by the suburb of Woodley. Ground levels at the south eastern edge of the plateau where the site is located, slope gently down to the south east and the wide flood plain of the River Loddon. This fall in ground level is only apparent on site as the sloping front garden and driveway down to Colemans Moor Road.

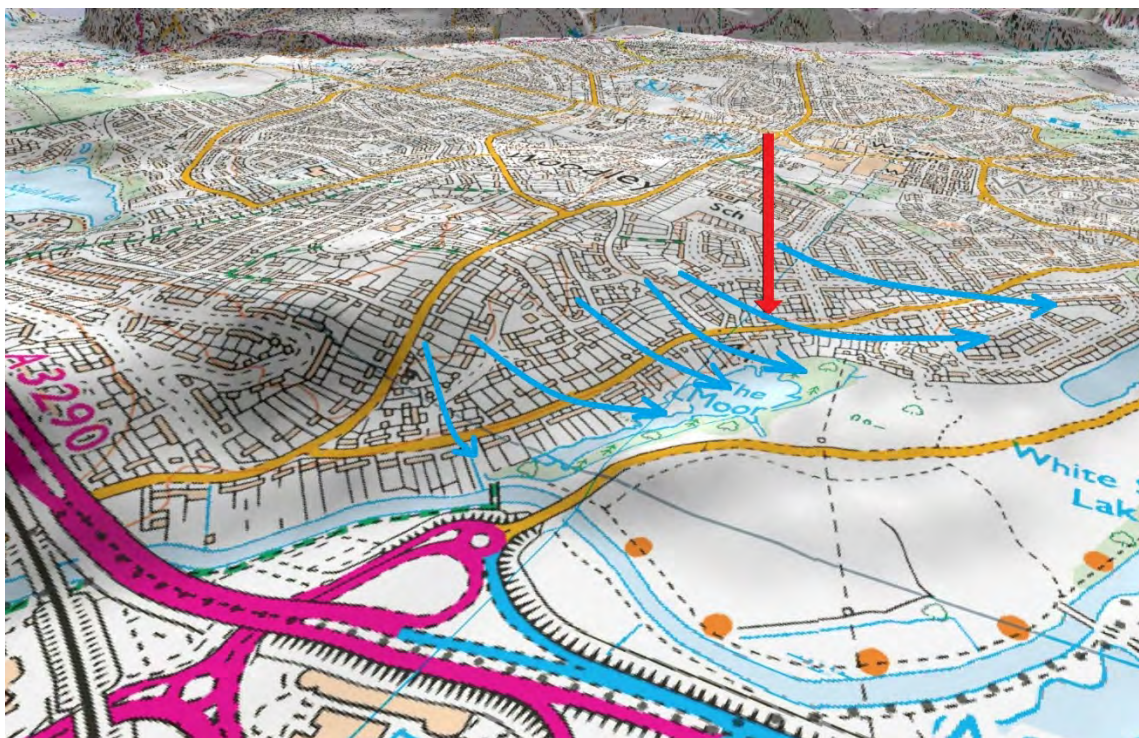
### 3.5 Migration of Contaminants

*Above, expected direction of surface and shallow groundwater flow*

Any mobile contamination in the site area, either floating (fuel or lubricants) or dissolved would be expected to move with surface waters in 1) the streams, drains and culverts and 2) within the flow of shallow groundwater, in made ground, the terrace gravels over the London Clay and downhill to the south east. This water, from drainage systems or from the aquifer, together with its potential contamination, would eventually feed into the River Loddon.

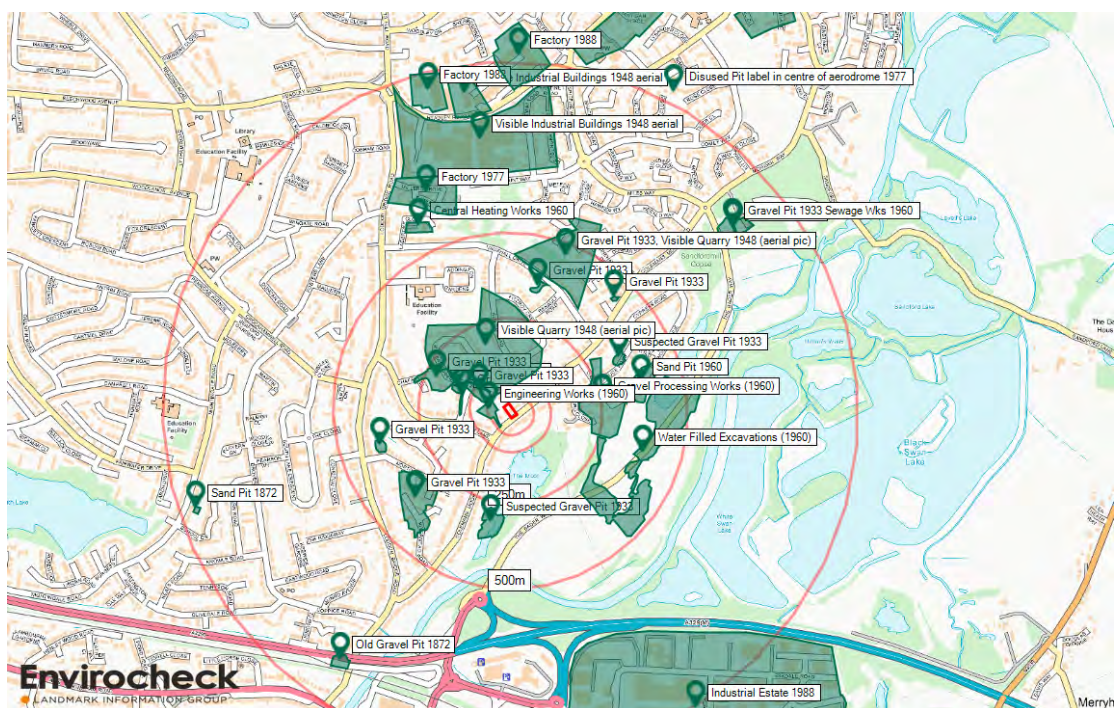
#### 4.3 Summary of Map and Aerial Picture Review

*The features found on the historic maps between 1875 and 2020 are presented above.*

The maps and aerial pictures have not identified any contamination activities on the site area but have shown that the closest potential source of contamination was an engineering works just 20m-50m to the north west of the site. The maps have also shown that significant amounts of gravel extraction have taken place in the area and there is potential for these old quarries to have been infilled with waste.

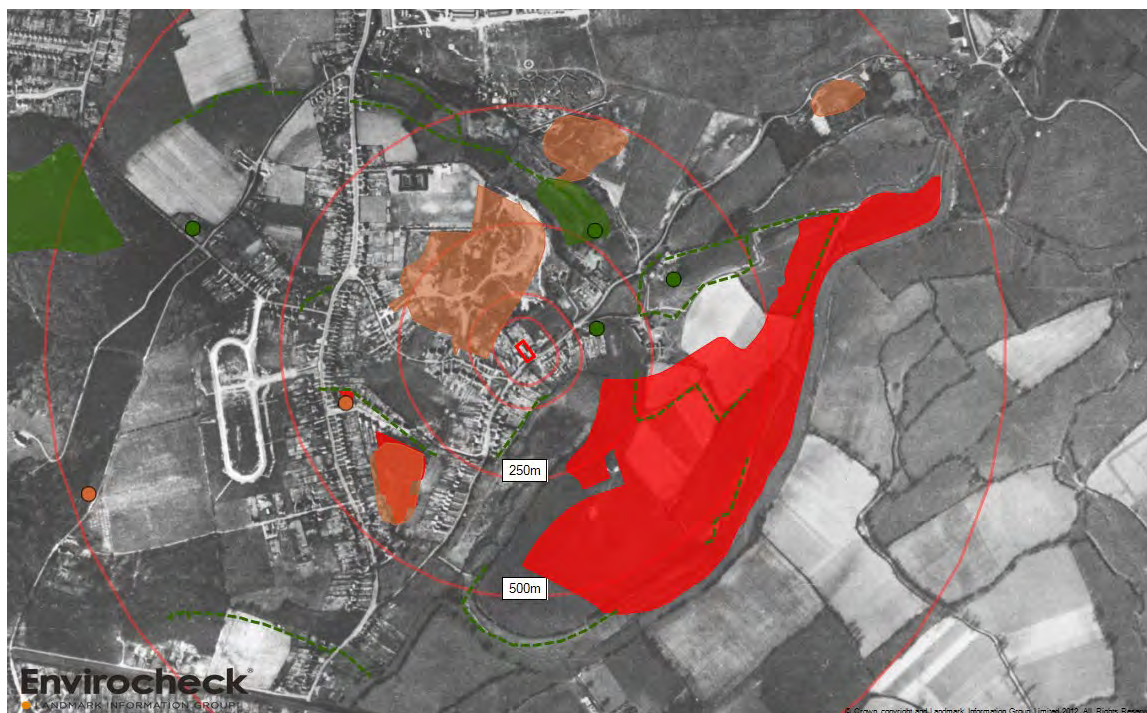
*Above, the areas of landfills (red) and areas of potentially infilled land (green and brown) are presented on the 1948 aerial picture.*

The environmental database search, supported by the historical mapping, has shown that the site lies within 250m of a number of gravel pits which appear in the 1930's and then in the 1960's. Landfill records show that some were infilled with waste materials.

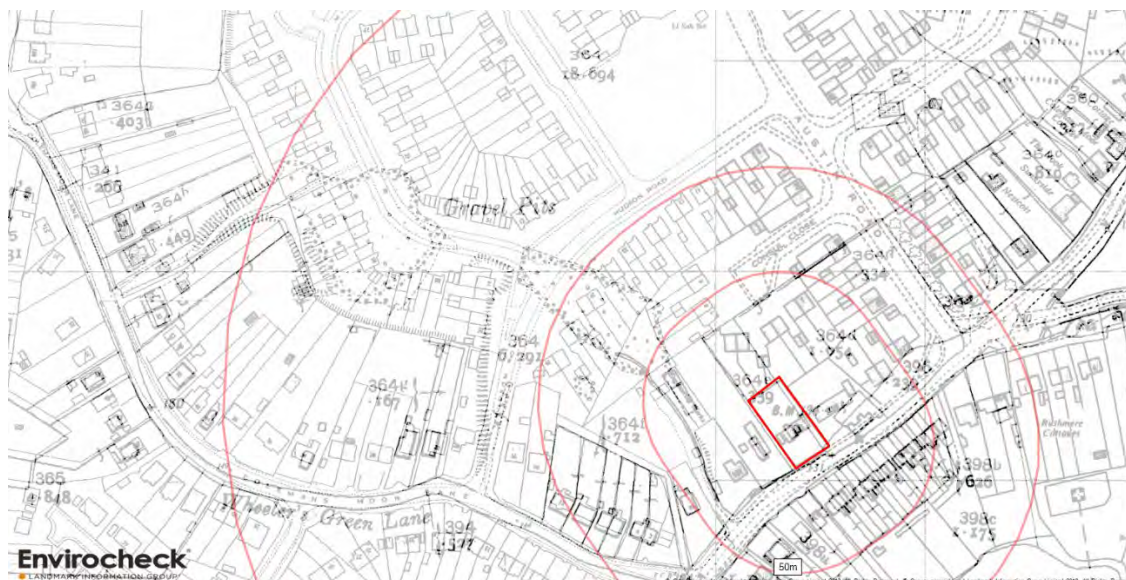
*Above, an overlay of the 1933 map and the 1968 map*

The closest gravel pit was just 50m - 80m to the north west of the site and was named Wheeler's Green Gravel Pit. This pit partly underlay the engineering works 20m-50m to the north west however, as discussed later in this report, gas monitoring was undertaken at the engineering works and did not reveal any elevated gas concentrations requiring any significant further consideration or mitigation.

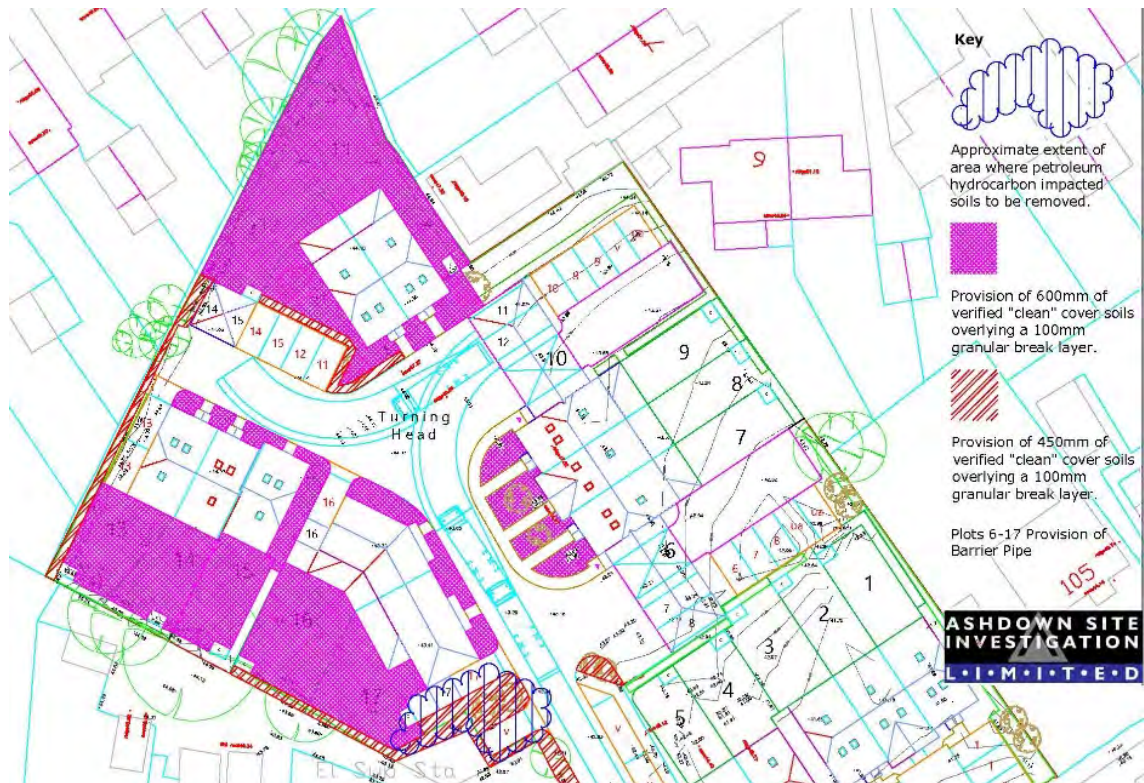
### 6.3 Ashdown Remedial Recommendations

*Above, extracts of the Ashdown Investigations Report for review.*

The remedial recommendations for this site involved the removal and replacement of contaminated soil in garden areas to a depth of 600mm and replacement with a break layer or anti capillarity barrier which is covered by subsoil and then topsoil. A lesser recommendation for replacement with 450mm in areas of landscaping. The recommendations included the full removal of the fuel oil and PCB oil contaminated soil around the former fuel tank location.

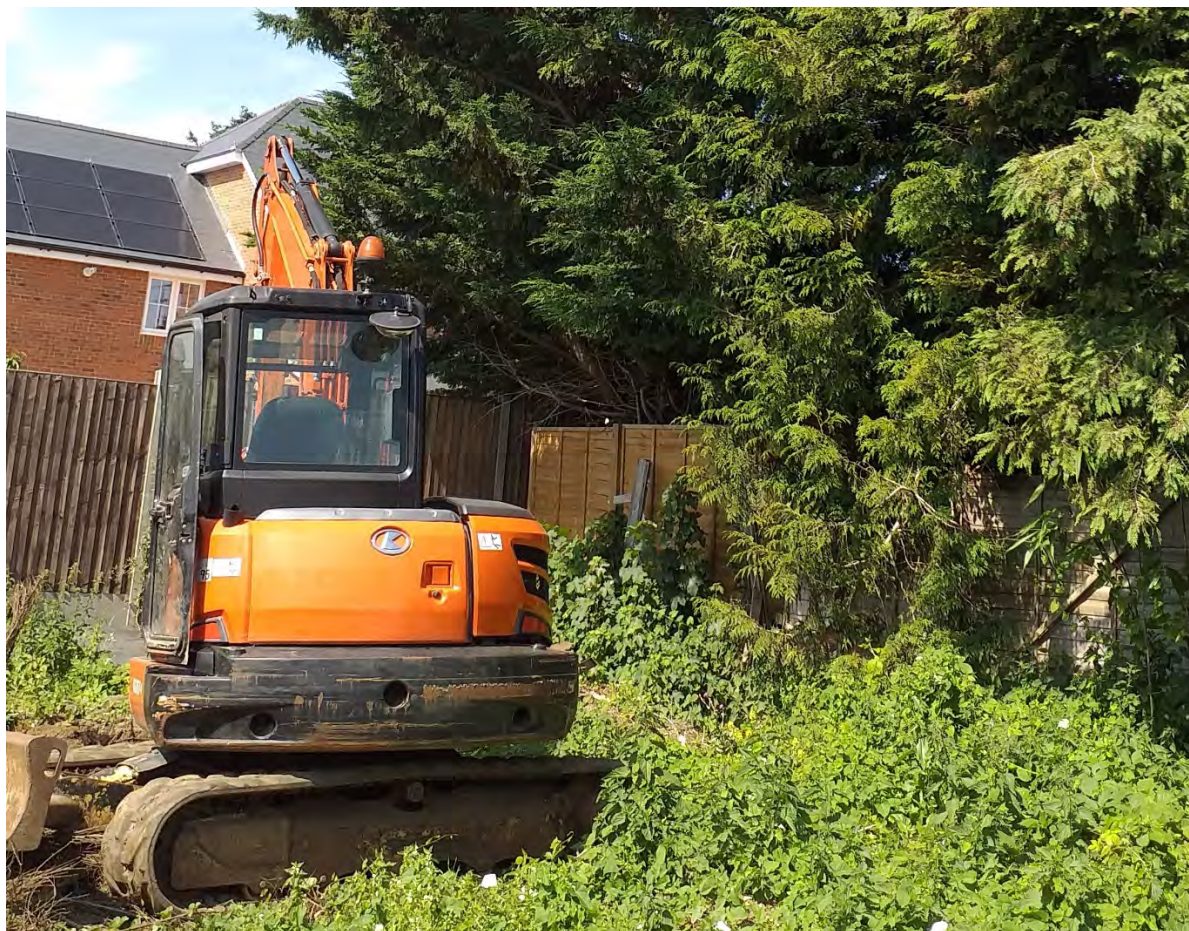
## 8.0 Initial Physical Investigations

During the site visit an excavator was used to carry out three trial pits along the south western boundary of the site, beyond which lay the old engineering works. The locations are shown on the attached site layout plan. The aim was to take a first look at the soils below the site and check for any made ground or evidence of contamination migrating from the engineering works to the north west in the shallow as well as deeper soils.

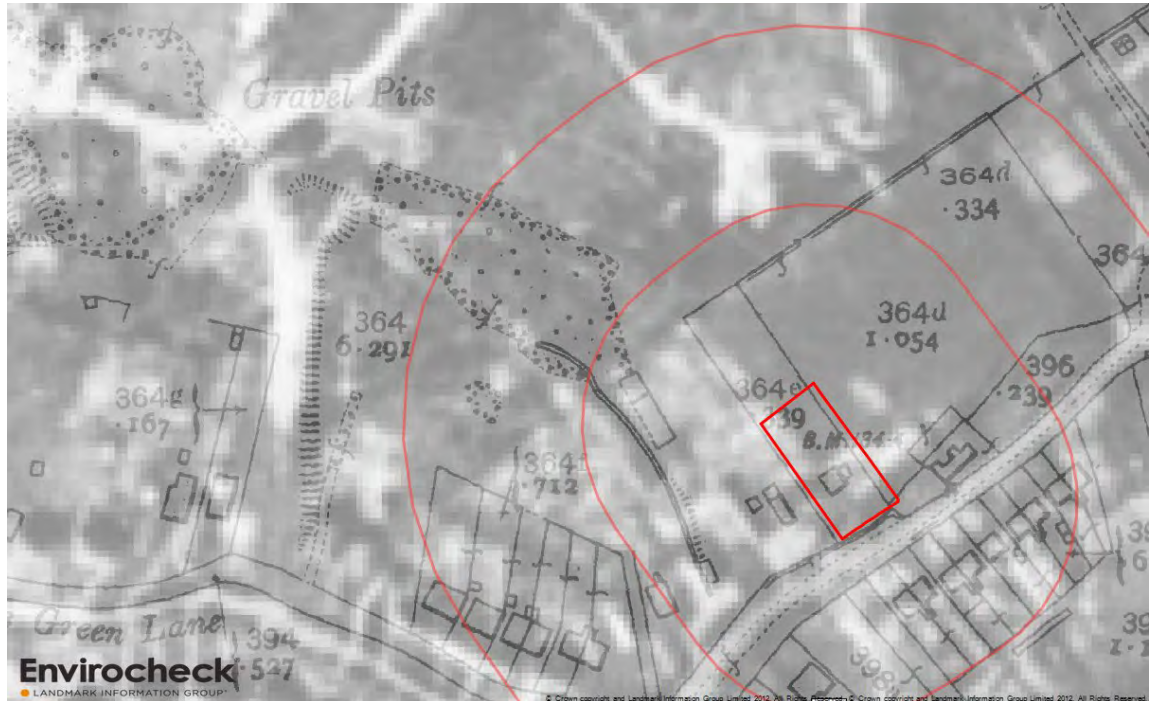
### 9.3 Wheeler's Green Gravel Pit

*Above the 1933 map overlain on the 1948 aerial picture. Please note offset (visible in the roads). Dark patchy colours inside quarry area are consistent with trees.*

This very old pit (73 years since it was seen to be overgrown in 1948 aerial picture) partly underlies the former engineering works and lies just 78m to the north west of the site.

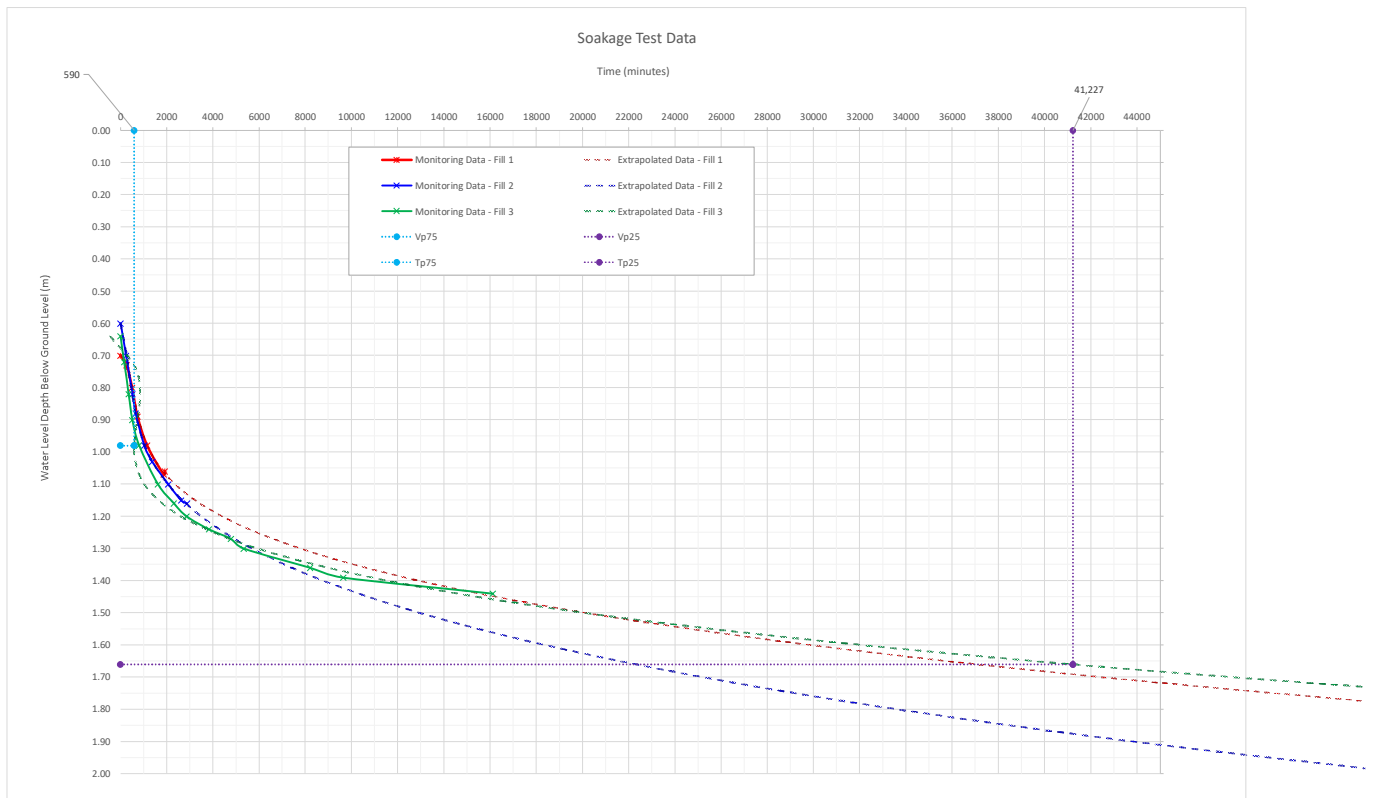
# SOAKAGE TESTS

Slowest Soil Infiltration Rate from Soakage Tests [m/s] = 2.49E-08 (0.000000024869) (Based on Soakage Test SA1 )

13. Water levels were extracted from the SA1 device and are shown on the results attached later in this document. Infiltration rates are calculated for the time it takes the water to drop from  $\frac{3}{4}$  full ( $V_p75$ ) to  $\frac{1}{4}$  full ( $V_p25$ ). Examples of soakaway design are attached to this document and are based on heavily extrapolated data and should be treated with extreme caution as the water levels were extrapolated for 17.5 days to project a water level passed the  $V_p25$  level. Although the example soakaway designs attached show that there is some capacity in a trench or crate filled soakaway none of the examples can half drain within the required 24-hour period.

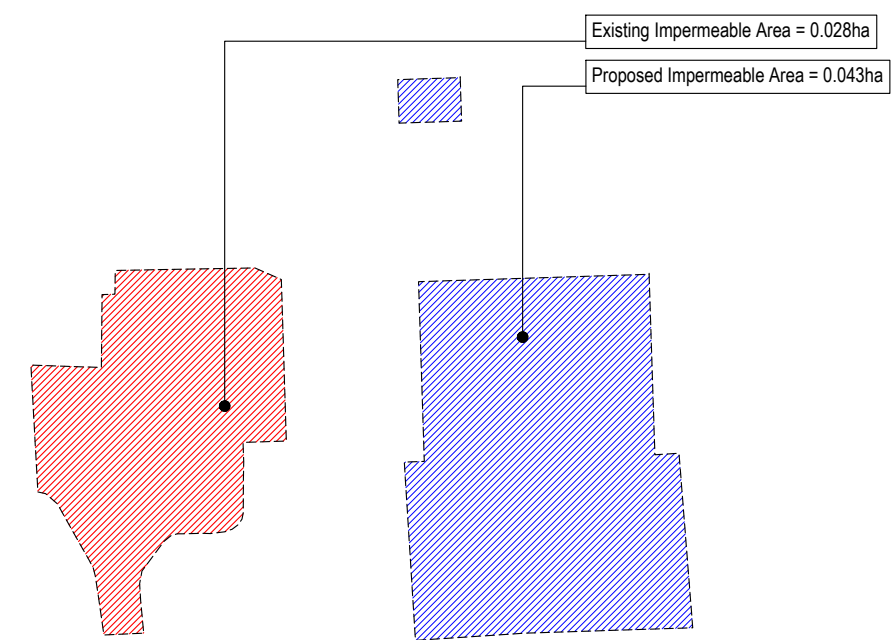
Impermeable Areas Plan

- Note:  
All existing drainage is to be checked by the contractor and verified by the engineer prior to the construction of any drainage works
- Note:  
Connection to be agreed with Thames Water prior to construction
- Note:  
All drainage points are assumed and to be confirmed by the architect

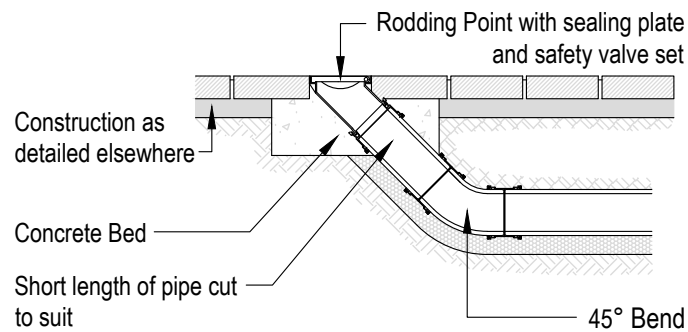
Rodding Point

Scale 1:20

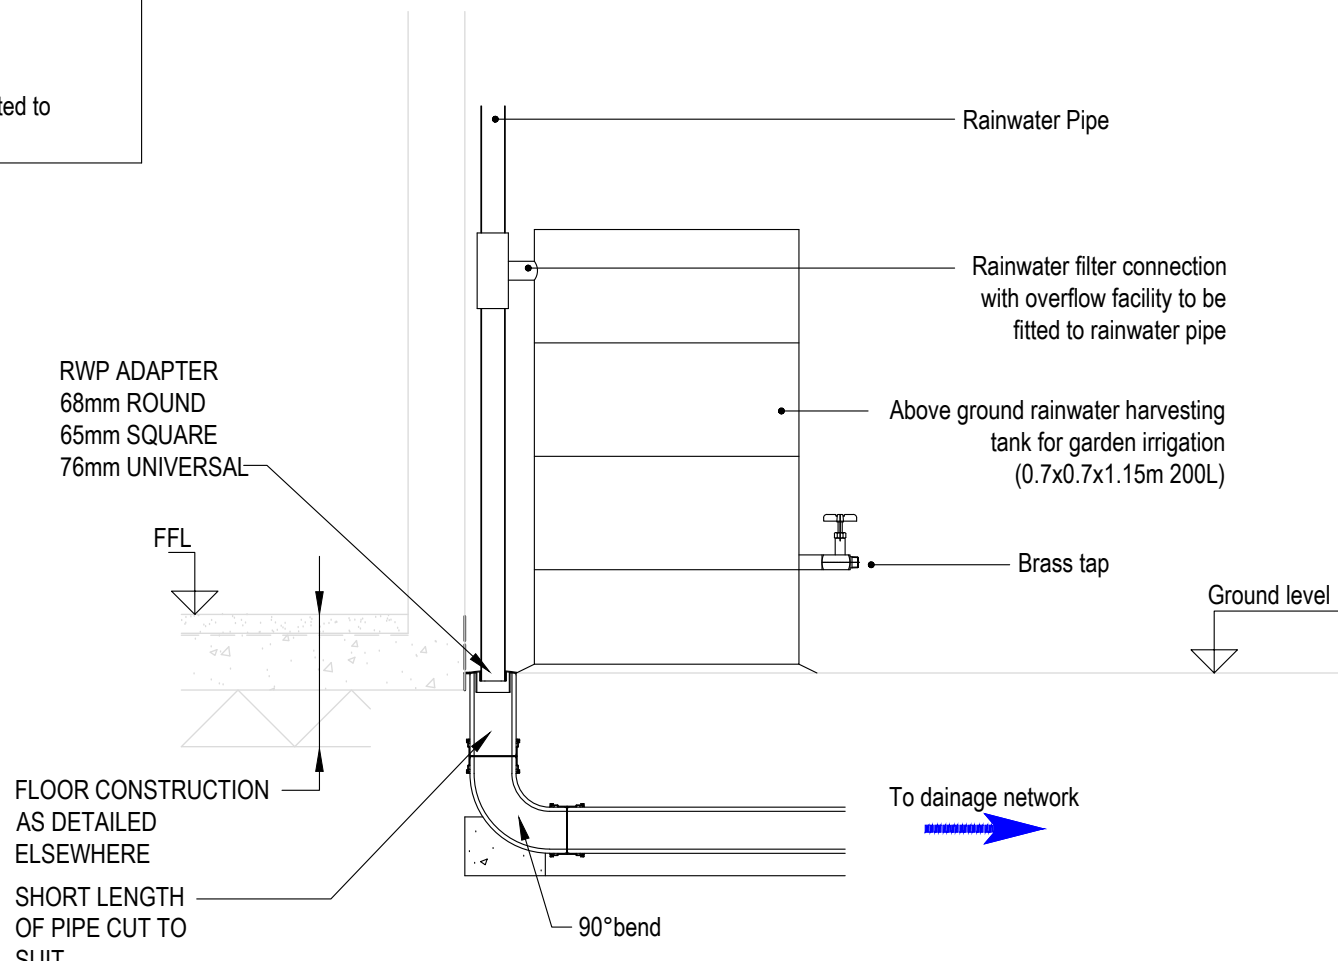
Rainwater Harvesting Detail

SCALE 1:20

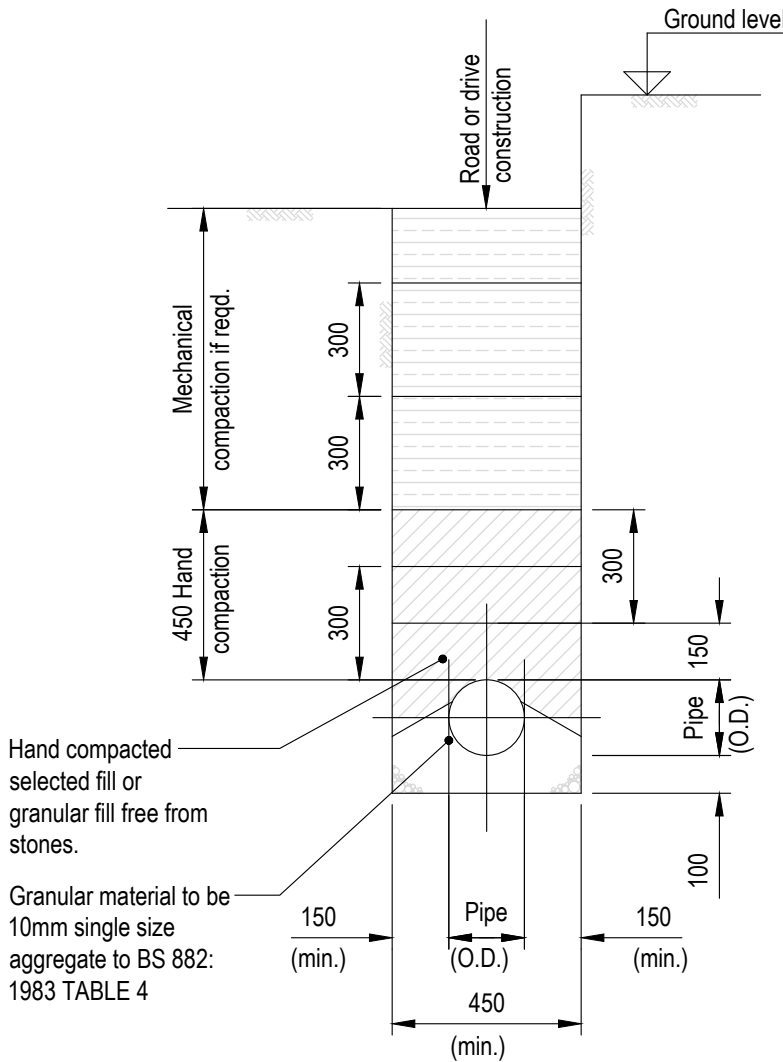
Normal Bedding

Scale 1:20

Pipe protection is required by one of the three methods shown where cover is <600mm in un-trafficked areas and <900mm elsewhere.

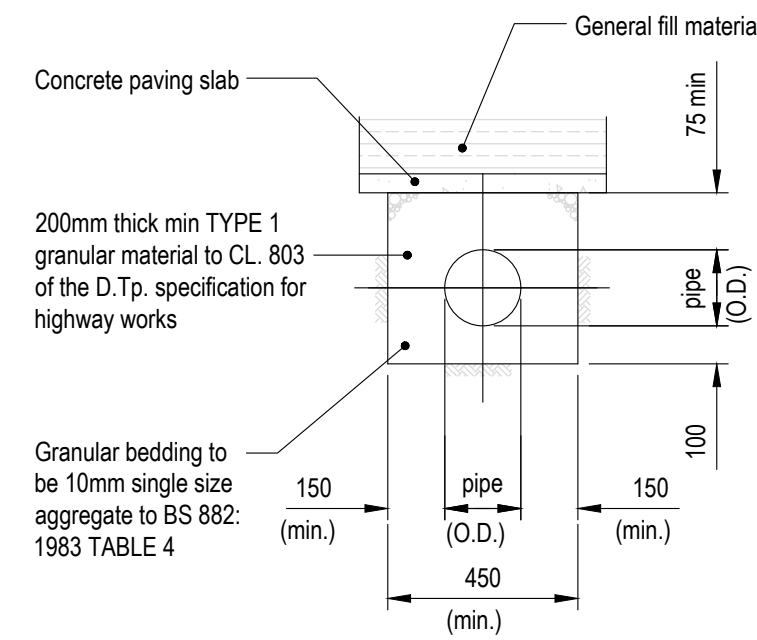
Concrete Paving Slab Bridging

Scale 1:20

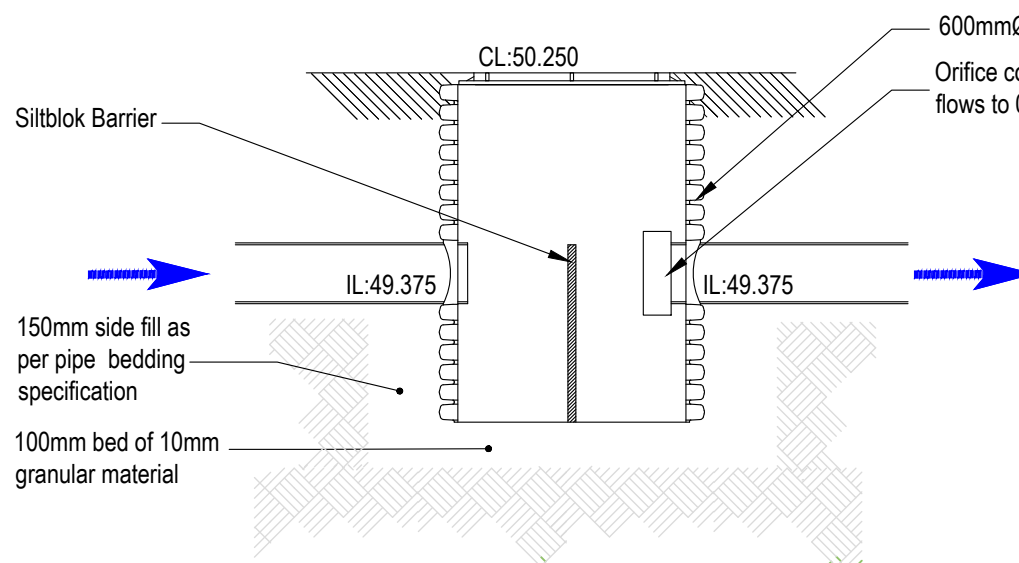
Flow Control Chamber

SCALE 1:20

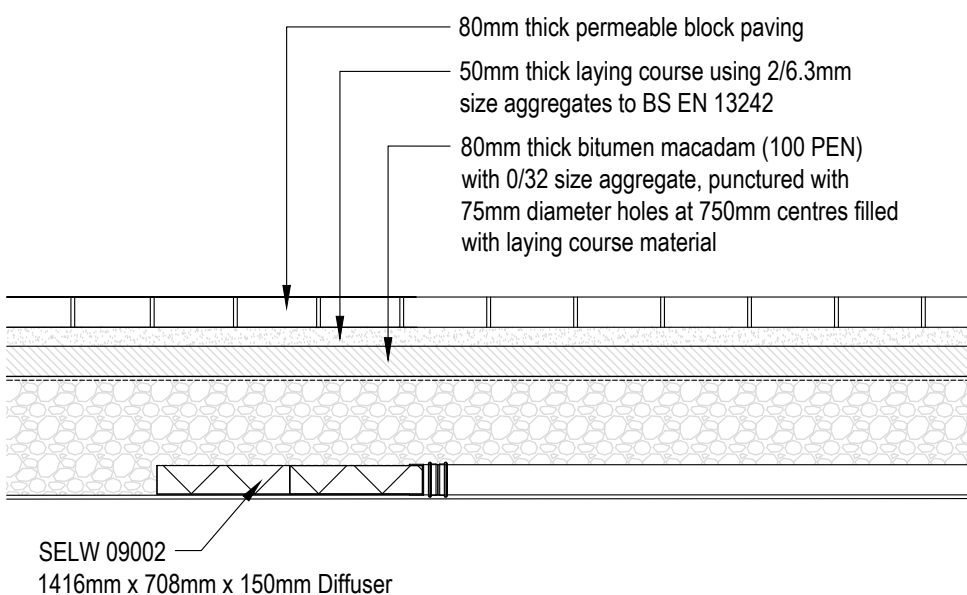
Distribution Tank Detail

Scale 1:20
