# Surface Water Drainage and SuDS Strategy Report

EX22/O50/O6

105 Colemans Moor Road  
Woodley  
Reading  
RG5 4DA

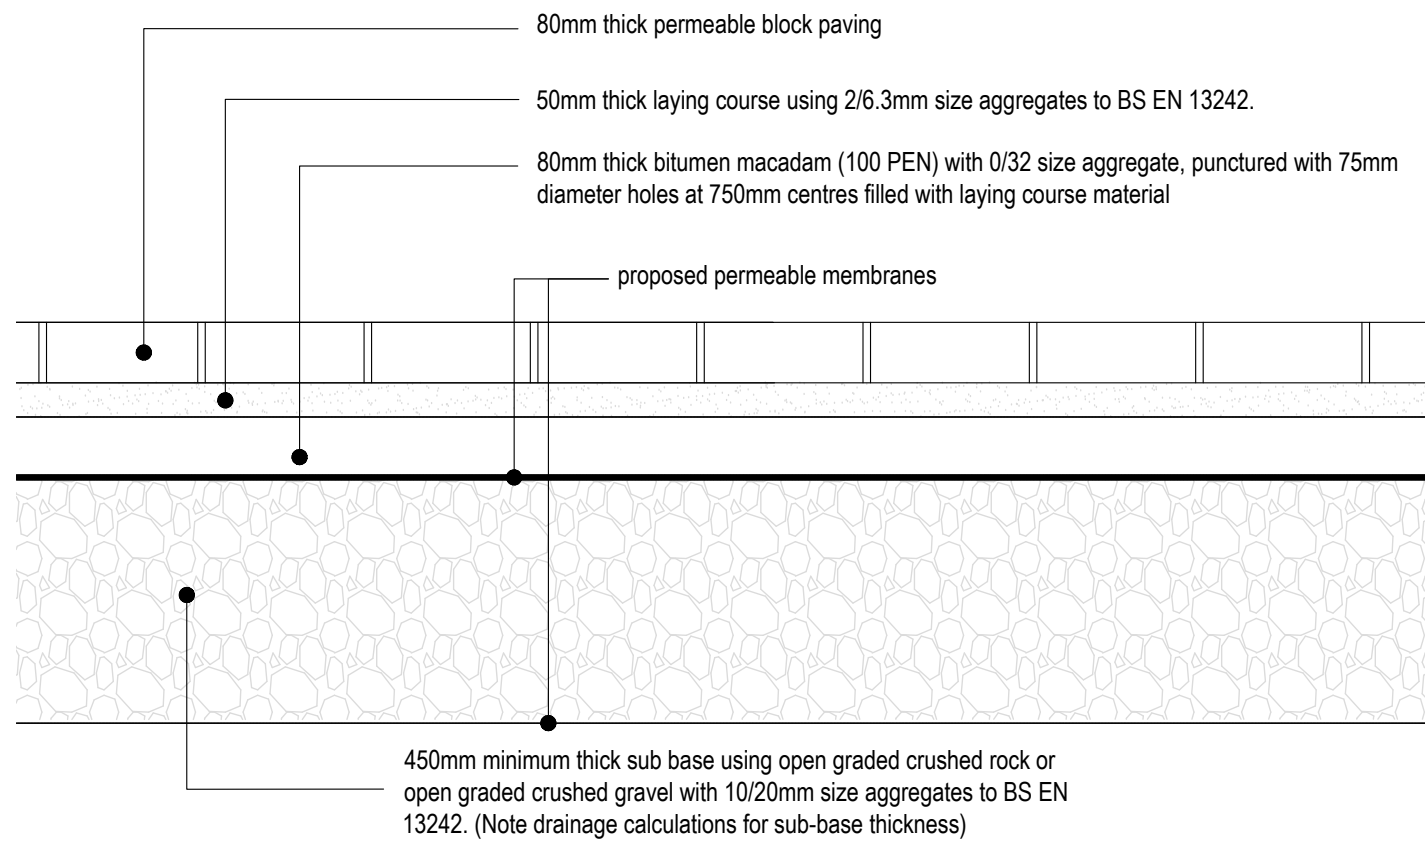
Typical Permeable Paving Construction Detail

Scale 1:10

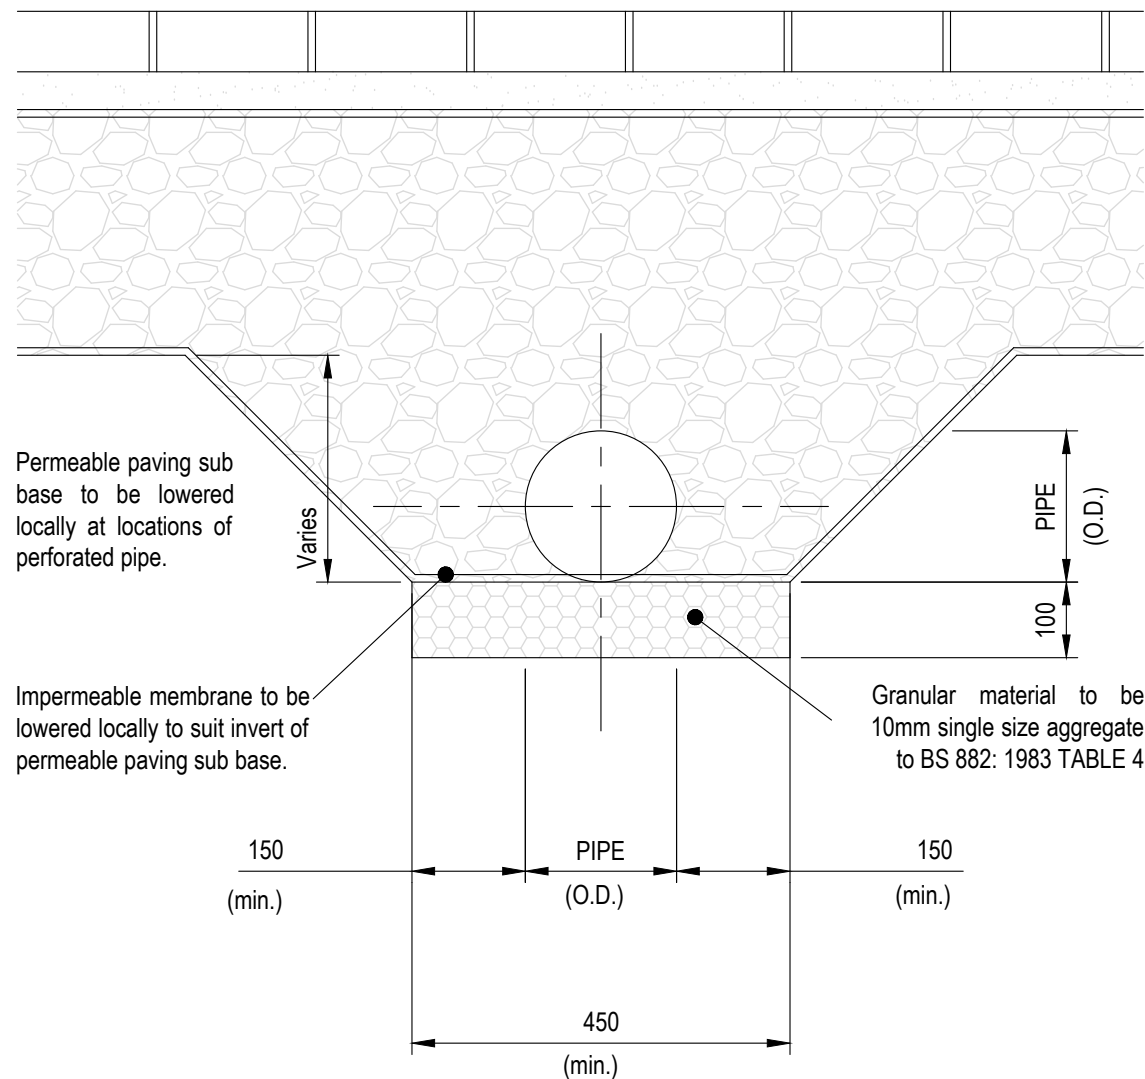
Perforated Pipe Bedding

Scale 1:10

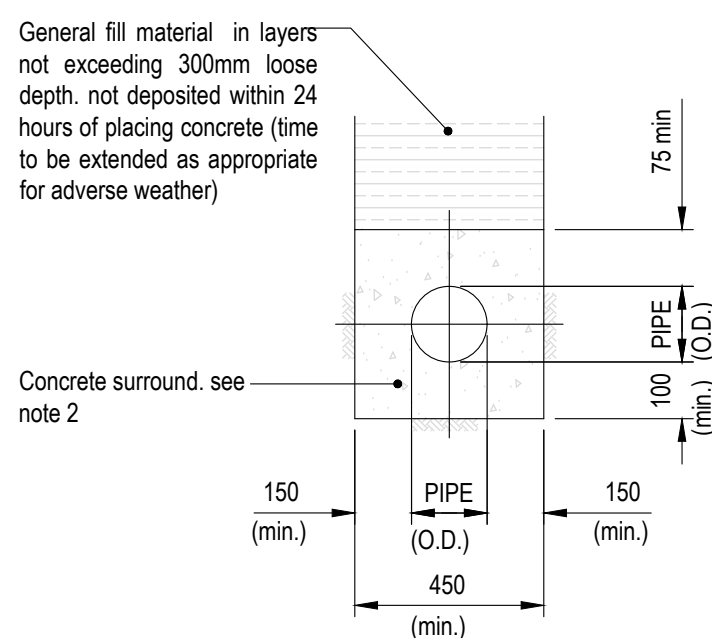
Concrete Surround

Scale 1:20
