# FLOOD MITIGATION MAINTENANCE PLAN

## ALDI STORE - GAZELLE CLOSE, WINNERSH

DATE: FEBRUARY 2026  
CRADDYS DOCUMENT REFERENCE: 12245w0007

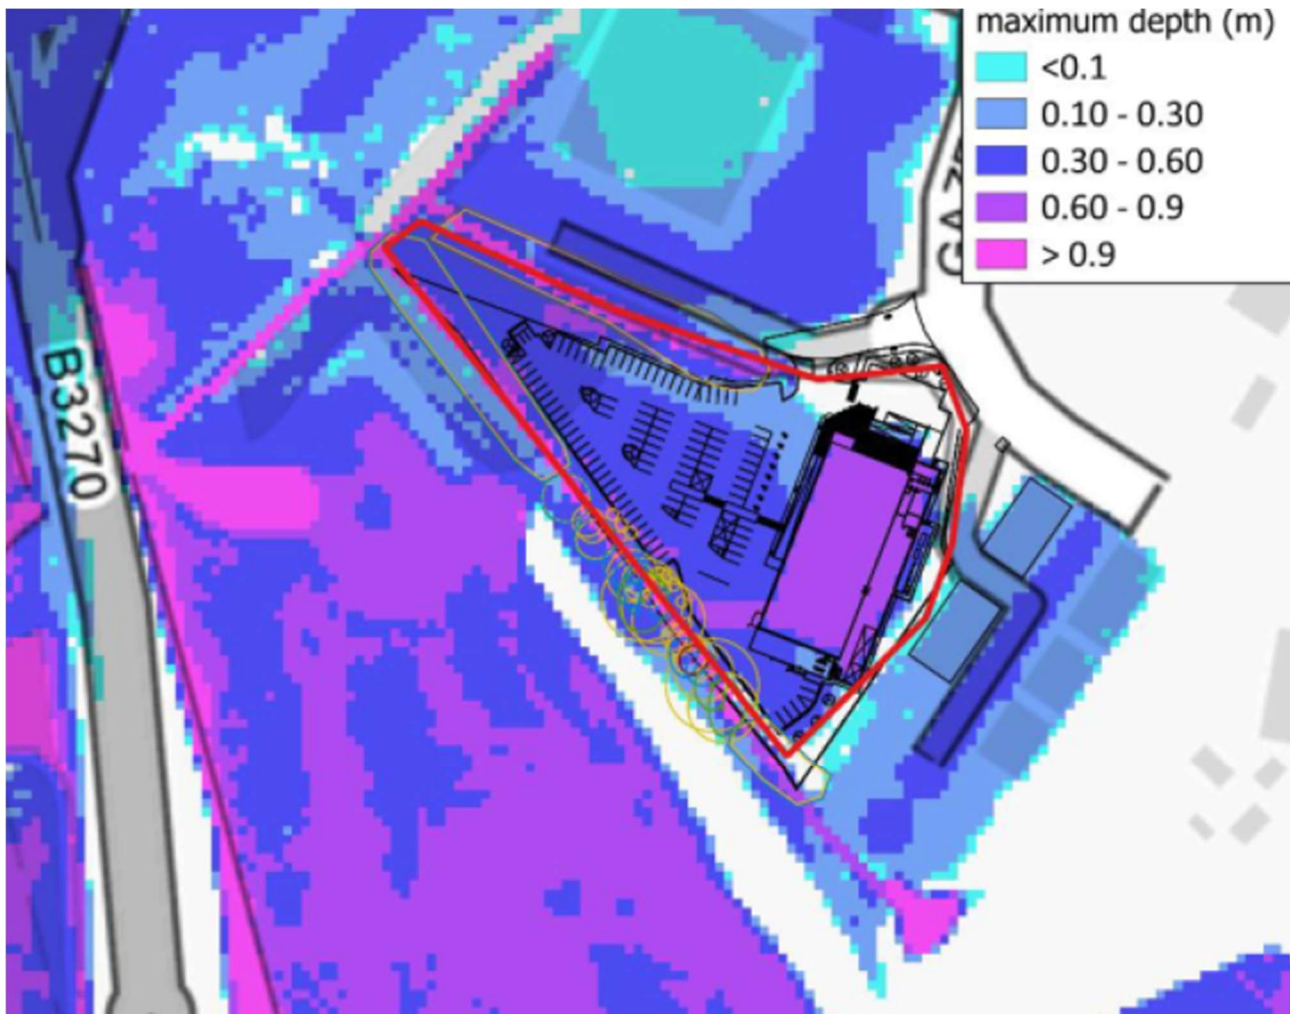
## APPENDIX A FLUVIAL FLOOD MAPPING

*Maximum depth of flooding during 1 in 100-year (1% annual chance) plus climate change event*
