**TREE PRESERVATION ORDER NUMBER: 197/1980**

**APPLICATION NUMBER: 250378**

**SITE ADDRESS: 6 SHARPTHORPE CLOSE, EARLEY, WOKINGHAM, BERKS, RG6 4DB**

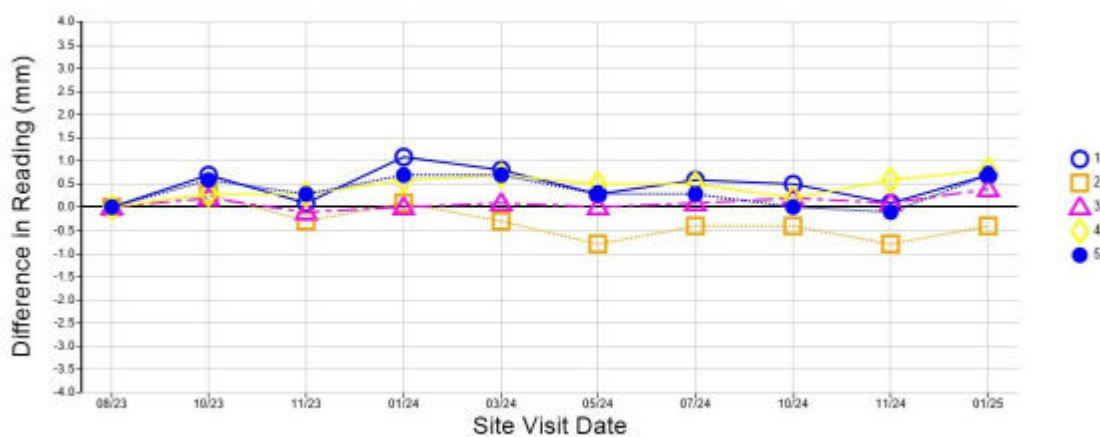
Figure 1

The above statement is only partially correct. The “Level Monitoring Difference Graphs” from the Level Monitoring Report (Figure 1 below) shows that the levels of stations 1 to 5 rose and dropped from 10/23 to 05/24.. This is not a pattern consistent with clay shrinkage subsidence where levels drop in the summer months and recovers in the winter. In addition, the amplitude of movement is so small (about 1mm) and variable that one could argue that there is no observable movement pattern.

In Figures 1 and 2, the level monitoring data is plotted at even intervals on the x-axis, but the sampling dates are not taken at equal intervals, presentation of the data does not accurately represent the trend, making it difficult to interpret the seasonal movement, if any.

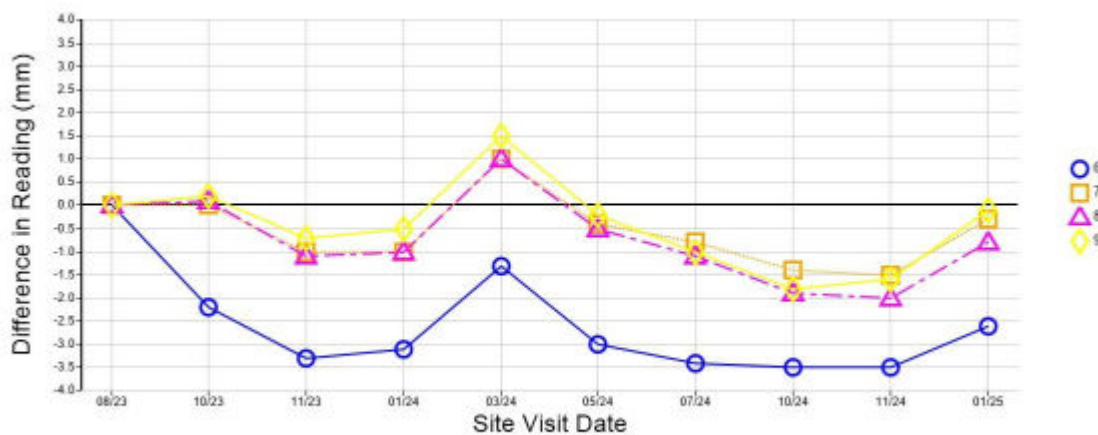
**Figure 2**

Figure 2 shows level monitoring data from stations 6 to 9. The magnitude of movement is greater but again, the pattern of movement is not consistent with level changes caused by clay shrinkage subsidence. Using station 6 for illustration, the level dropped from 08/23 to 11/23. With clay shrinkage subsidence, the ground level should begin to recover in October and November but this pattern is not observed in stations 6 to 9.

The overall amplitude of movement is also very small with the greatest movement at station 6 with a maximum of about 3.5mm.
