## DRAINAGE STRATEGY

HURST BOWLING CLUB, READING  
HURST BOWLING CLUB  
JULY 2024  
5933-HURS-ICS-XX-RP-C-07.002

5933-HURS-ICS-XX-RP-C-07.002

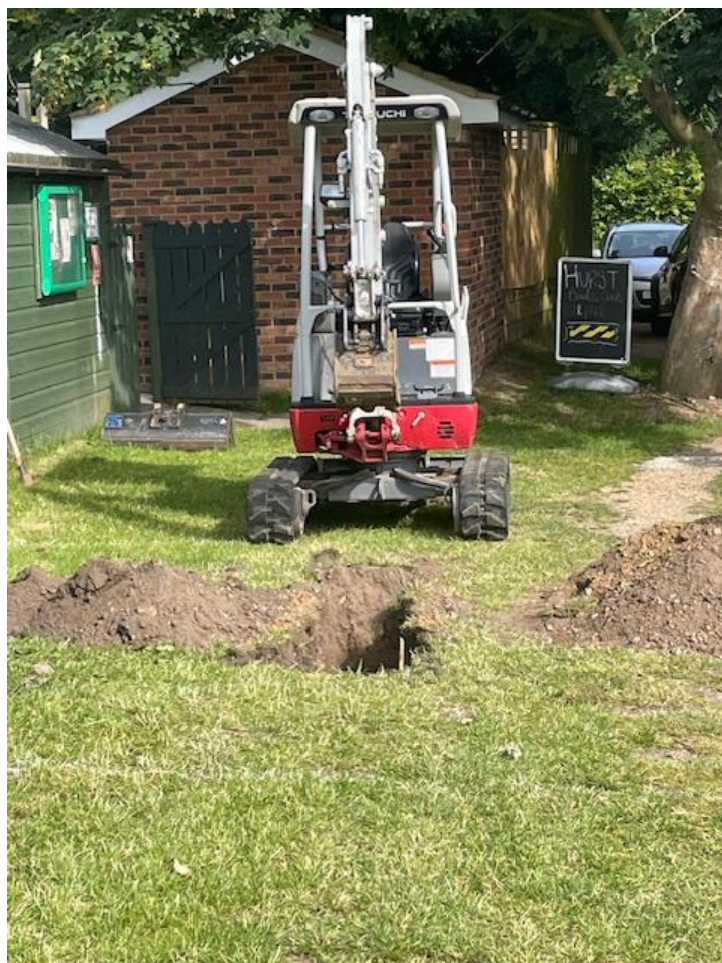
The trial pit location was in the same vicinity as the proposed soakaway, inside the property boundary of the bowling club, but outside of any tree root systems and away from any building foundations. It should be noted that no tree roots, services, or other obstructions, were encountered in the trial pit.

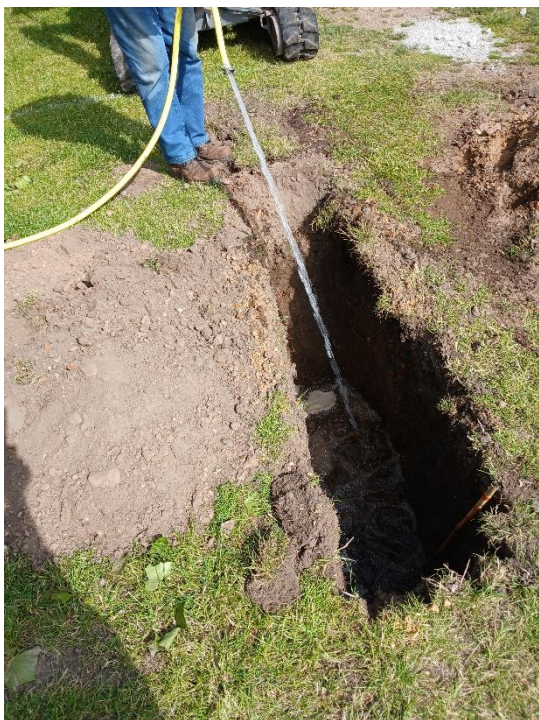
A trial pit nominally 1m long 1m deep and 300mm wide (300 litres) was dug using a mechanical excavator with a 12" (300mm) bucket, on 18<sup>th</sup> June. The soil type removed was regular top soil plus small stones for the first 300mm followed by a more sandy soil with some stones for the bottom 700mm. No clay was encountered. The walls of the trial pit were stable.

A measuring cane was inserted into the trial pit marked at 100mm intervals.

See picture left for details.

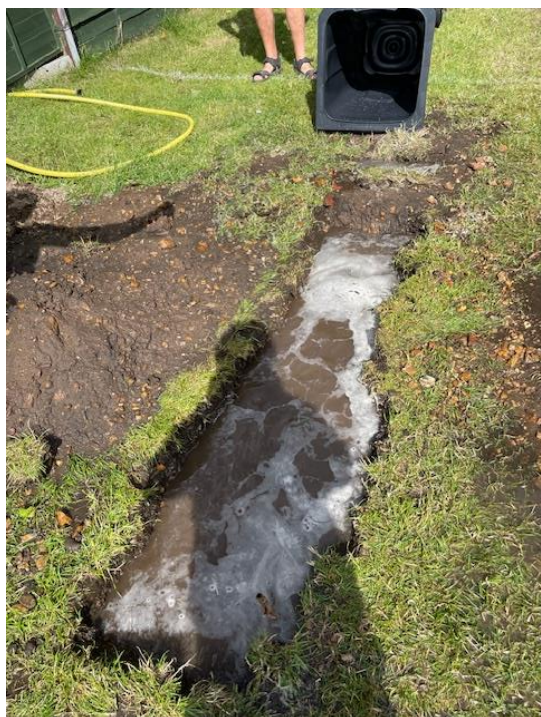
Water fill from the bowling club pumped sprinkler system was used via a 25mm internal diameter hose. The 1.5 Kw pump is fed from a water storage tank, with a 1.5m static head. The trial pit was 15m from the pump discharge. It was found that after approximately 20 minutes, with the trial pit 700mm full, the water level was not increasing, and water was draining from the pit as fast as the fill rate. At this time approximately 180 gallons (imperial assumed) of water was used, giving an input flow rate of approximately 9 galleons/40 litres per minute (recorded from volume drop in storage tank). Water input was then stopped, and the rate of drainage from this point was recorded. The pit walls remained intact. The results of this test have been recorded and are presented in the attached spreadsheet.

A picture of this test is shown left.
