PLAN - EXISTING + PROPOSED.

EXISTING + PROPOSED.

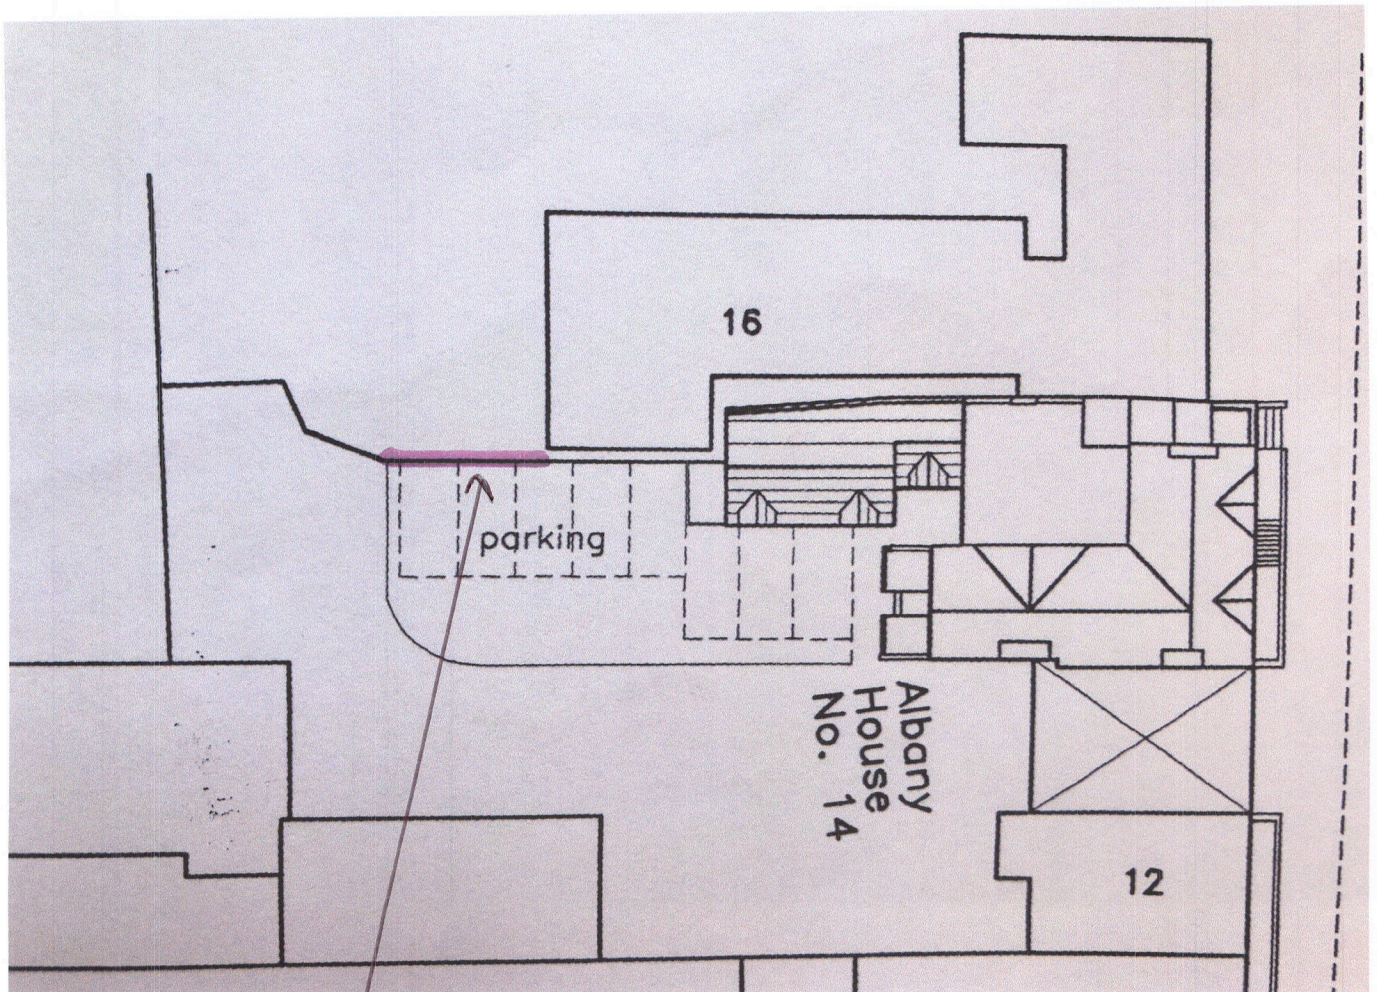
1:500

- SECTION OF WALL TO BE DEMOLISHED + REBUILT EDGED IN PINK.
- USE EXISTING BRICKS + LIME MORTAR.

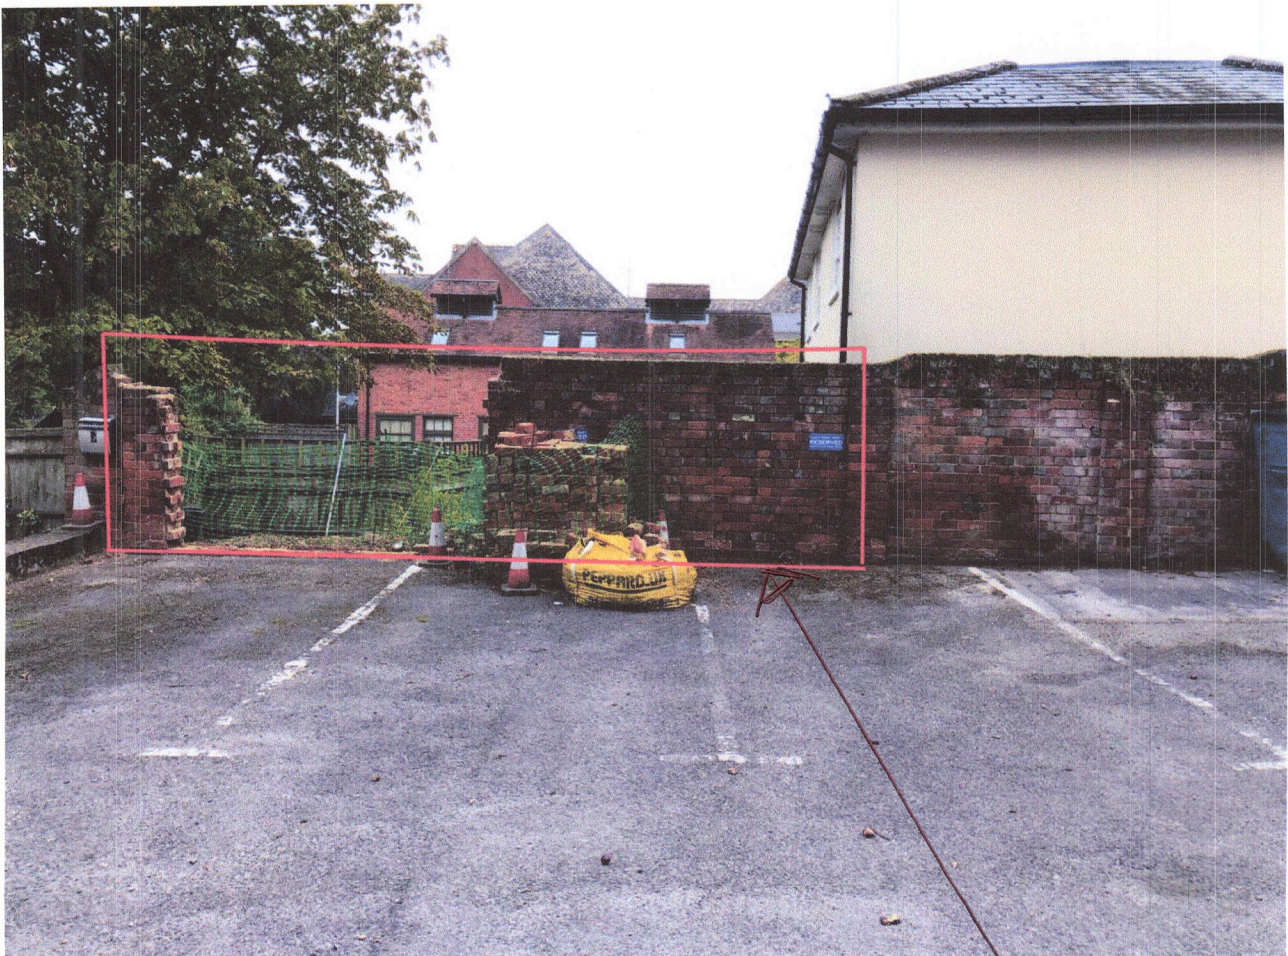
PHOTOGRAPH OF WALL AS CURRENTLY EXISTS WITH PARTIALLY  
DISMANTLED SECTION TO ALLOW REMOVAL OF TREES.

SECTION OF WALL TO BE DEMOLISHED AND REBUILT  
IS HIGHLIGHTED / SHOWN IN AREA BOXED IN RED.

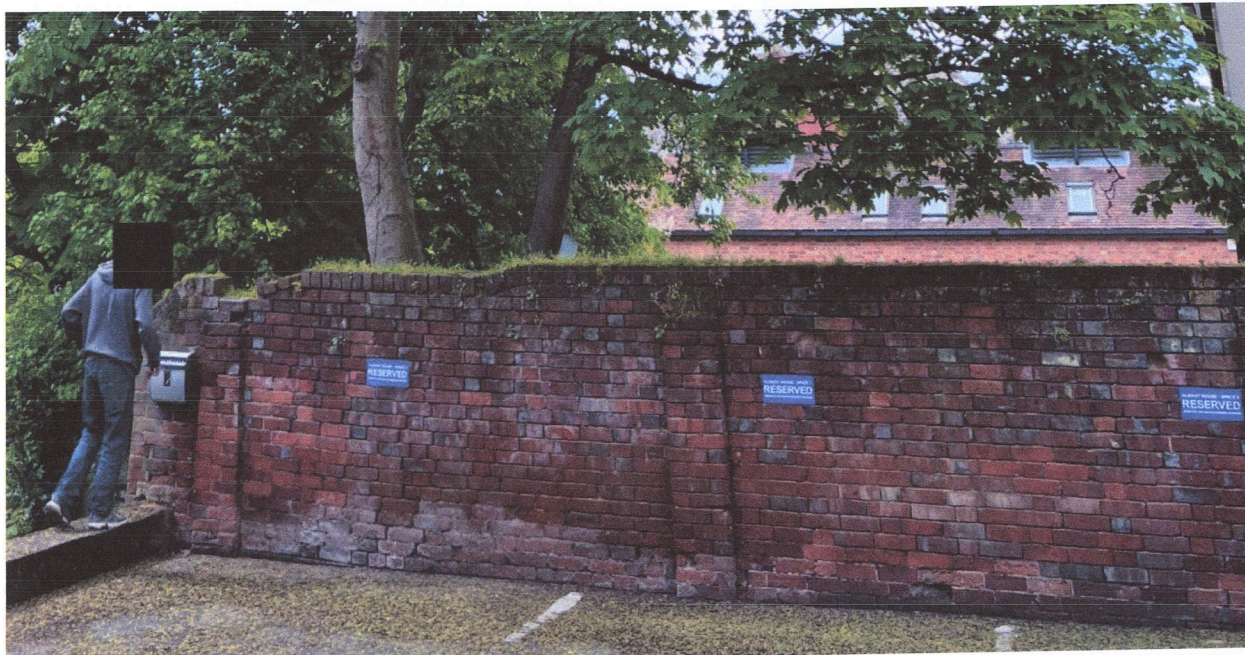
PHOTOGRAPH OF WALL PRIOR TO DISMANTLING OF A SECTION  
TO ALLOW SAFE ACCESS FOR TREE FELLING.
