# Trees and Construction

## BS5837:2012 Tree Survey, Arboricultural Impact Assessment & Method Statement

**Site:** Church Lane, Three Mile Cross, Reading, RG7 1HB

**Ref:** 261661 / A2\_AIA\_Rev.A

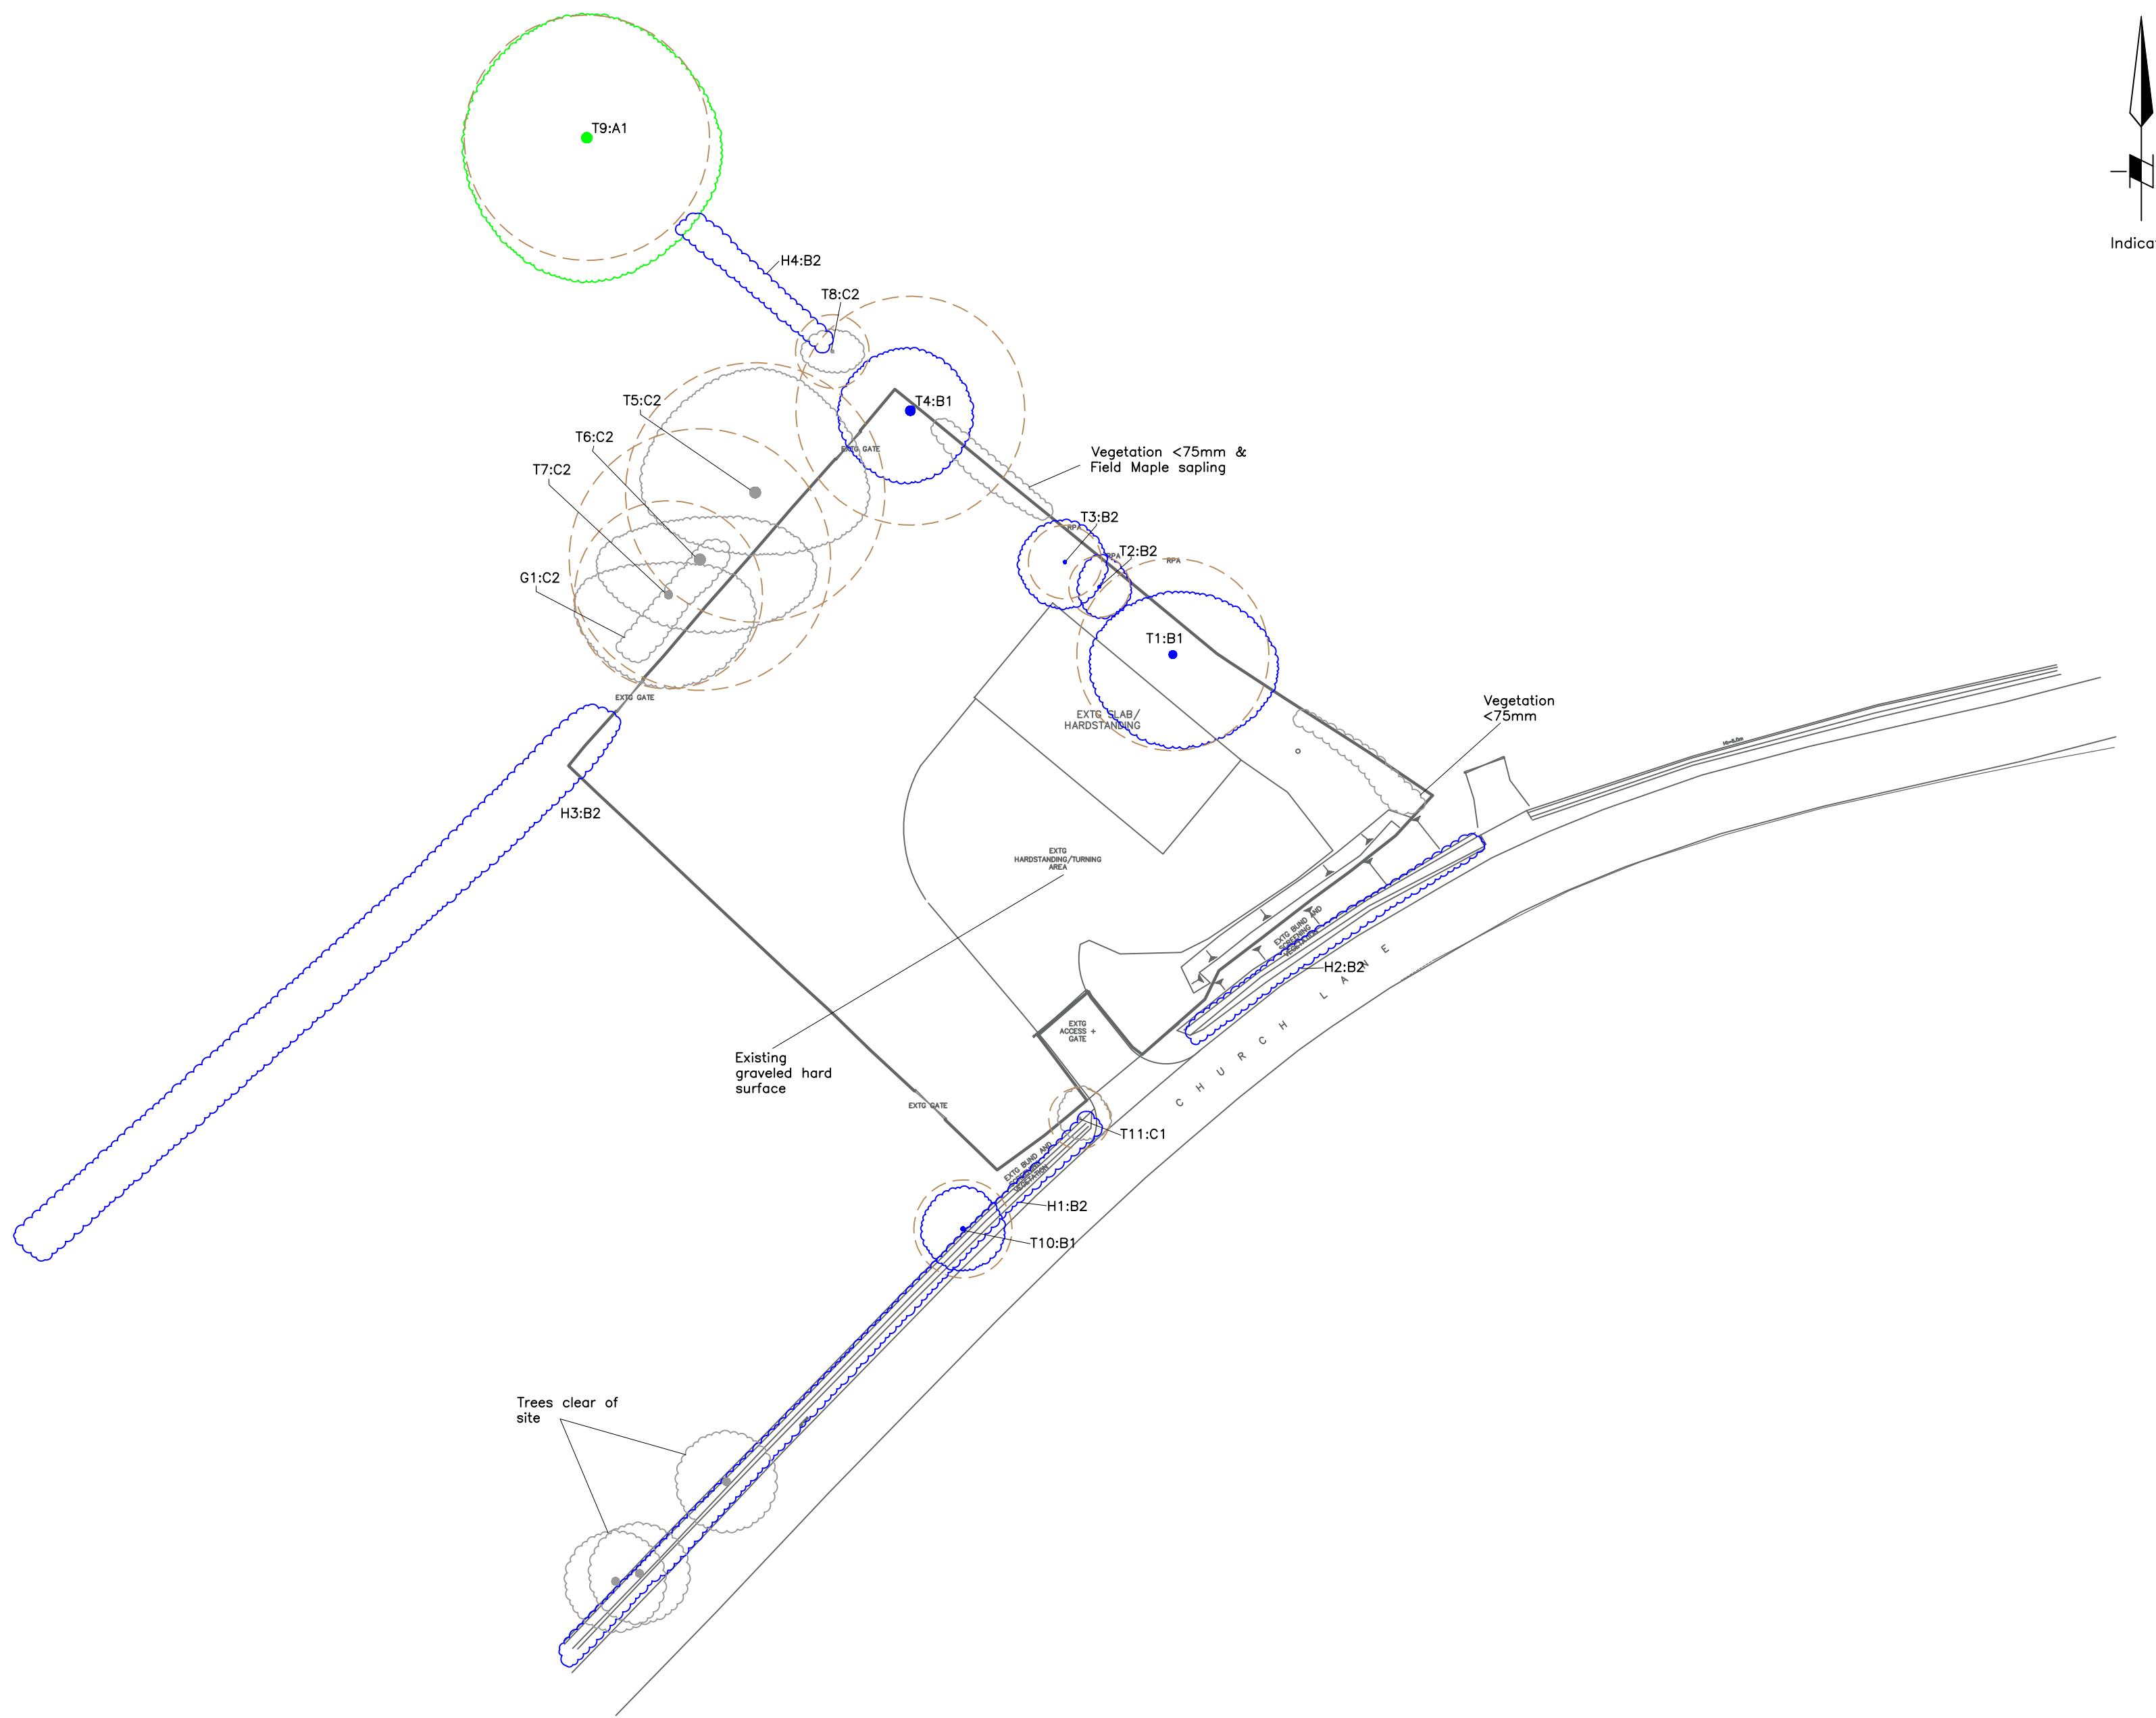
The surveyed trees are illustrated on this Constraints Plan which is prepared in accordance with British Standard BS5837: 2012 'Trees in Relation to Design, Demolition and Construction – Recommendations'

- 3.1 The following information, as with the prior contents of this report, should be read with the appended tree data table and tree constraints plan (261661/TCP/01).

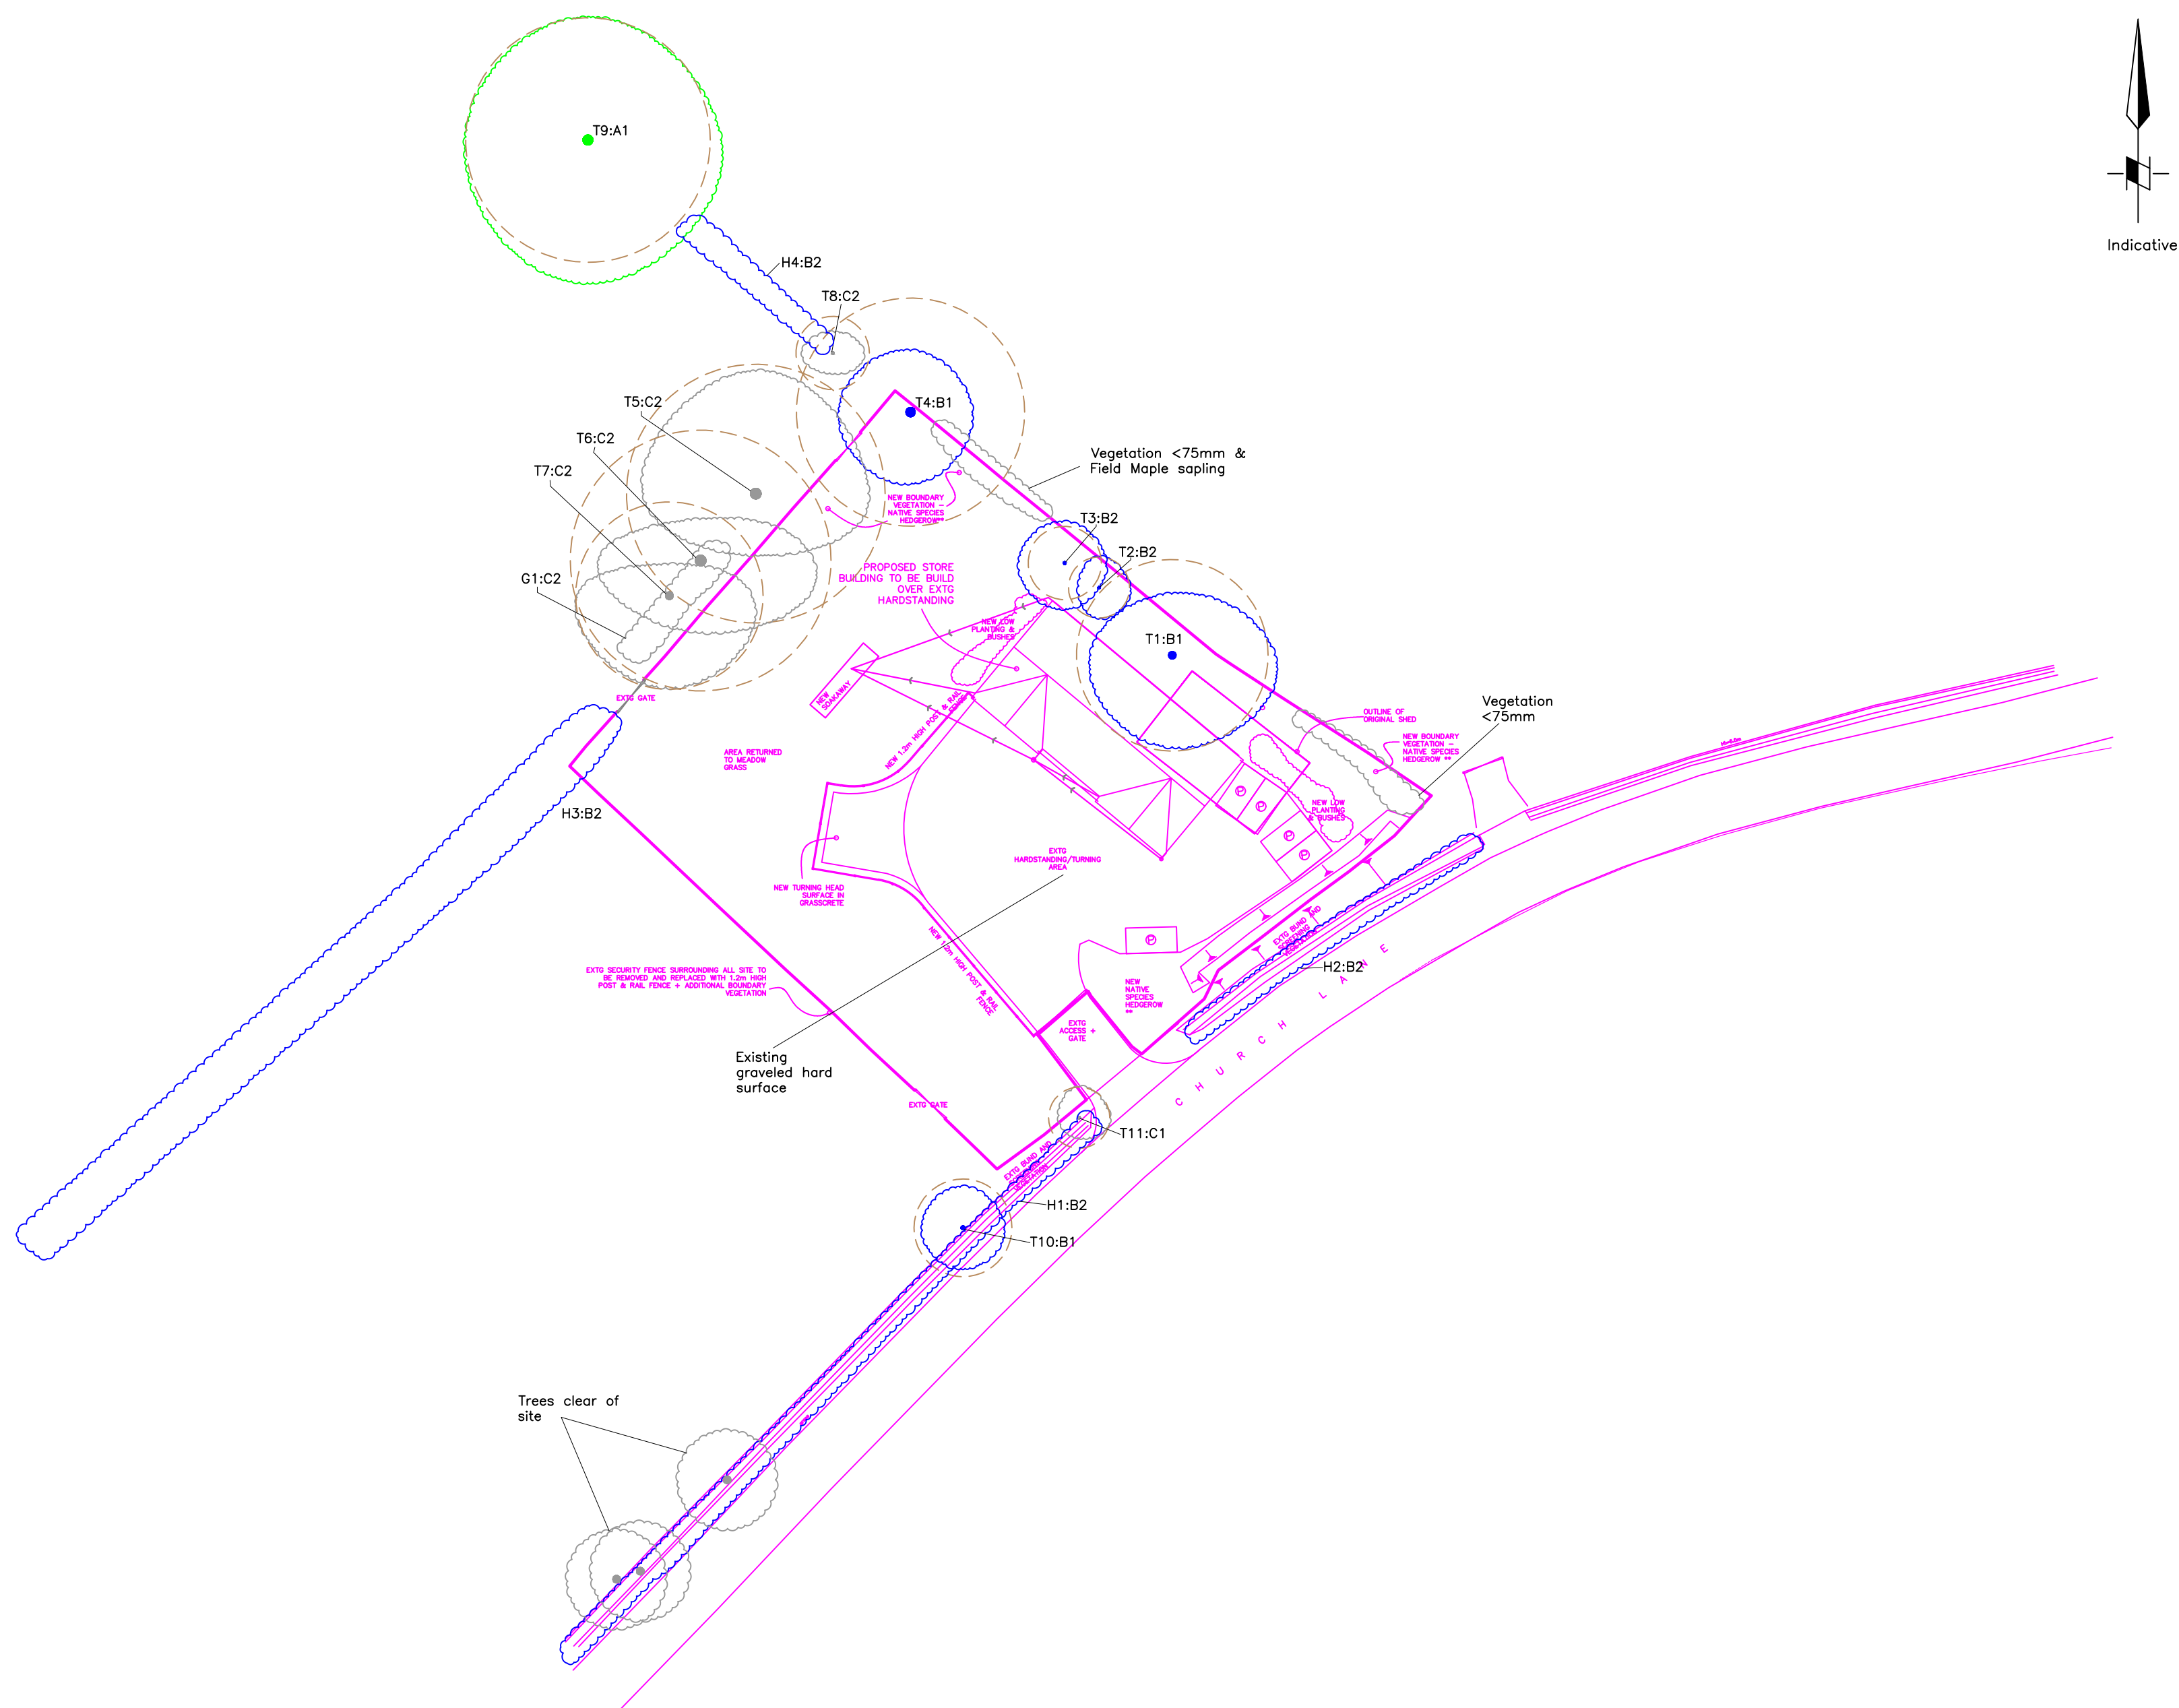
The surveyed trees are illustrated on this Constraints Plan which is prepared in accordance with British Standard BS5837: 2012 'Trees in Relation to Design, Demolition and Construction – Recommendations'

- 4.1 For the purpose of this assessment, the proposed site plan is used as a basis for consideration. This takes account of anticipated tree removals, tree protection options and potential alterations to account for arboricultural features; as per s.1.6 and s.2.2 herein, the TCP shows the '*proposed site plan*' as an overlay for review.

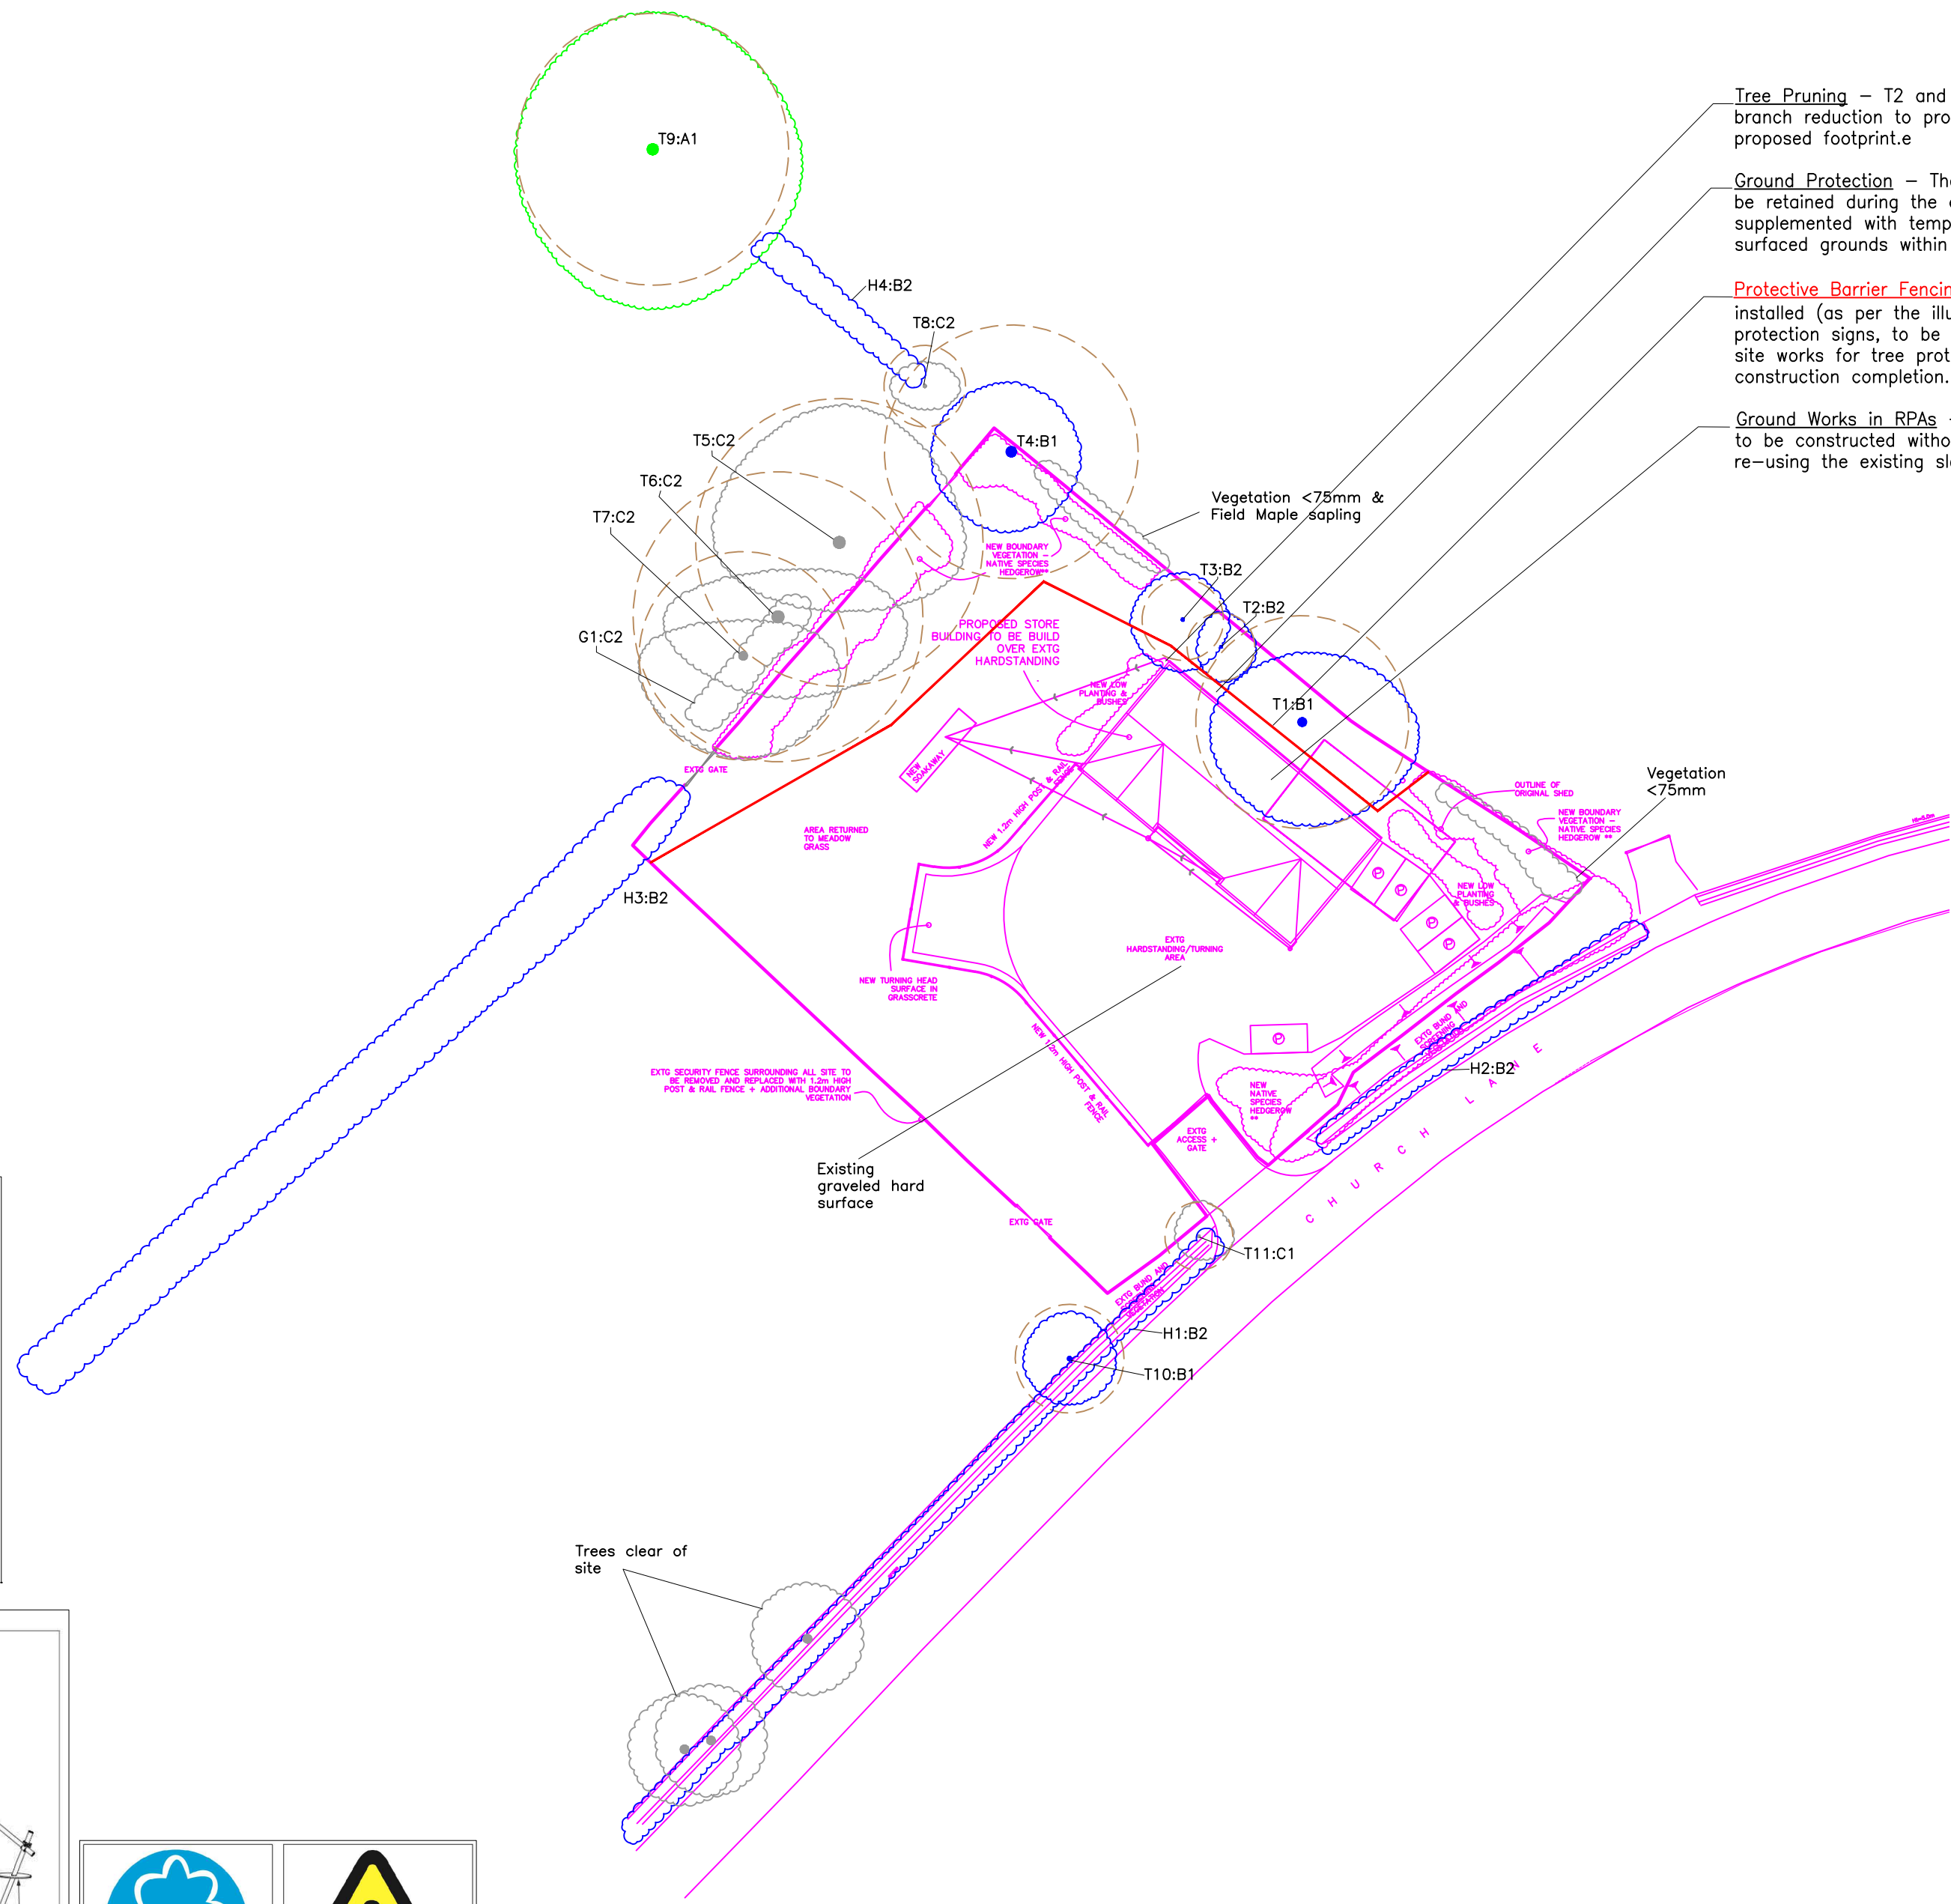
**Tree Pruning** – T2 and T3 to be pruned by lateral branch reduction to provide 1.5m crown clearance to the proposed footprint.

**Ground Protection** – The existing hard surfaces are to be retained during the construction stage, to be supplemented with temporary ground protection for soft surfaced grounds within RPAs outside of PBF.

**Ground Works in RPAs** – the proposed storage building to be constructed without any new excavations and re-using the existing slab foundation.

- 4.2 The proposed new storage unit encroaches the crowns of the 'B' category trees T2 and T3. These can simply be pruned by lateral branch reduction to provide suitable crown clearance for construction access i.e., 1.5 - 2.0m crown clearance from proposed building footprint.

- 4.3 For T1, the crown is clear of the proposed storage building, and the proposed storage building is within the circular Root Protection Area (RPA). However, there is an existing slab in place which will be used for the proposed storage building, hence, the building will be constructed without any new excavations within the RPA of T1.

- 5.1.1 The following restrictions are considered relevant for tree protection purposes which are illustrated on the appended Tree Protection Plan:
- a) Tree works; are to be completed prior to any site works: additional tree works (or leaning against or attaching of objects to a tree) are not permitted unless agreed in writing by the council.
