## BS:5837 ARBORICULTURAL REPORT

ARBORICULTURAL METHOD STATEMENT

SILVER BIRCHES  
HEATH RIDE  
FINCHAMPSTEAD  
BERKSHIRE  
RG40 3QJ

**Project:** Permitted demolition of the existing dwelling & erection of a replacement dwelling.

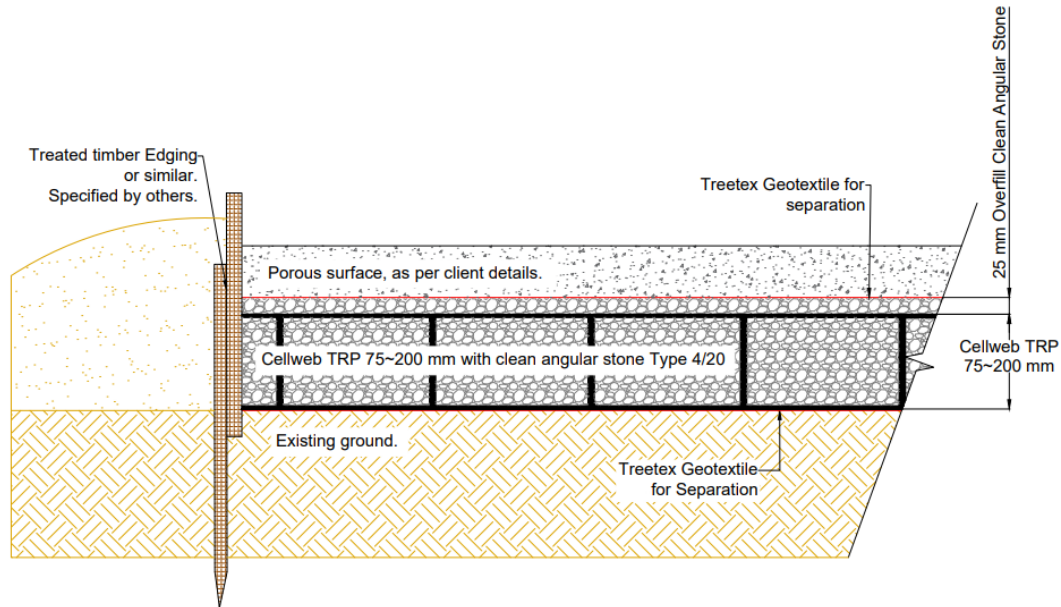
**Figure 2 - Indicative no-dig driveway construction using Geosynthetics Cellweb cellular confinement subbase.**

The new driveway and parking area at the front of the dwelling will be porous and installed using a no-dig construction. Timber or aluminium edging boards will be installed to provide an upstand of approximately 200mm between the ground level and finished driveway surface to contain the porous resin surface as per the manufacturer's recommendations.

A Cell web system (such as Geosynthetics Cellweb) 150mm deep will then be opened out and pinned in place between the edging boards. Pin spacing will vary according to the site conditions but will generally be required at 1m – 2m centres on flat surfaces, mainly placed around the perimeter of the area and where adjacent sections of the cellular confinement system abut each other, with less in the middle of the area.

Where necessary, following completion of the development, topsoil can be used to grade the edge of the surface to meet the adjacent ground levels.

Posts should be sunk to mark the edge of the driveway and prevent vehicles from leaving the driveway when maneuvering.
