## HERITAGE STATEMENT. Date: 24.07.2025

### 11 HEADLEY ROAD, WOODLEY, BERKSHIRE. RG5 4JB

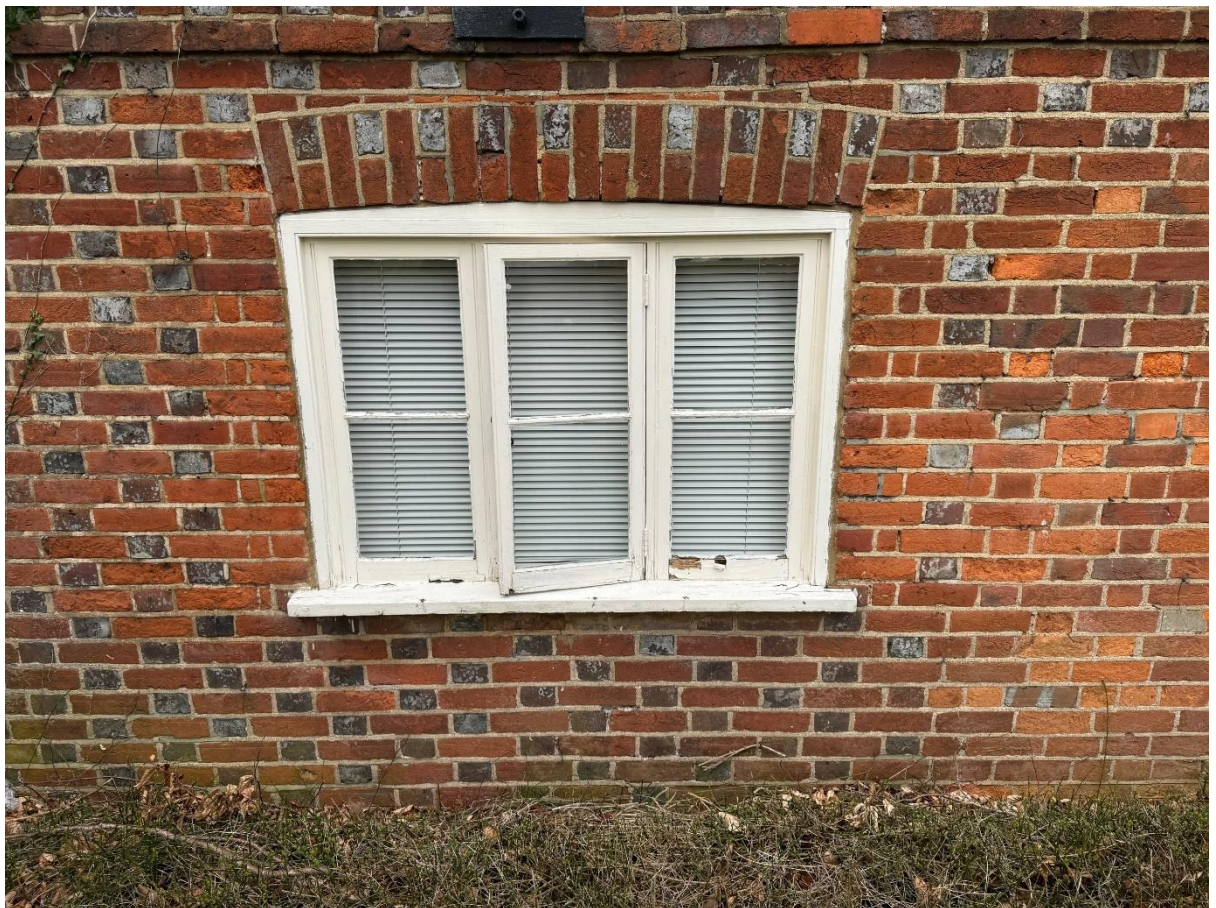
6. Two windows facing south (front elevation) are in a very poor state of repair and beyond economic or feasible repair. These windows are numbered C to D on the

accompanying drawing. Two Windows numbered A and B on the accompanying drawings have fixed and openable lights that are beyond economical or feasible repair, but the window frames are sound enough to be retained although a new planted cill nose will be required.

**Window D showing typical decay to cill, casement bottom rails, swollen shut casements etc. All windows (A to D) are similar although A and B have sound frames.**

7. Like wise the porch is decayed beyond economic or feasible repair, although the roof can be salvaged.
8. It is intended to carefully remove the two original front windows (C to D) and replace them with like for like single glazed soft wood windows detailed to match the existing 100%, including the beading detail to the opening light frame uprights. Windows C and D will have a matching spandrel infill panel to the head. The windows will be painted white.
9. It is intended to carefully remove the fixed and openable light casements to windows A and B. The existing frames will be retained, the old decayed planted cill nose removed and replaced a new planted cill. The fixed light and openable light casement will be replaced with new single glazed soft wood lights to match existing 100%, including the beading detail. The windows will be painted white.
