# LEVEL MONITORING

## for SMS (AVI, PRE)

**5 Sharpthorpe Close, Lower Earley, Reading, RG6 4DB**

| Report Date: | 6 February 2025 |

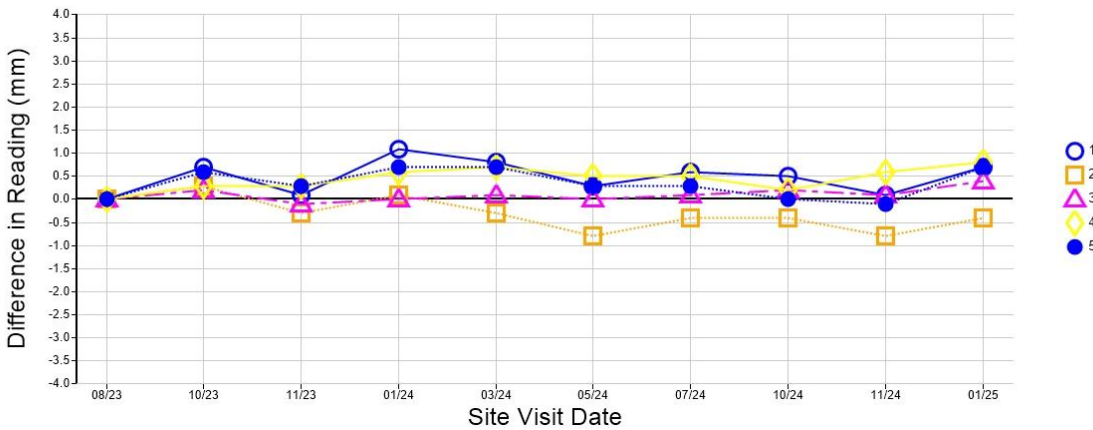
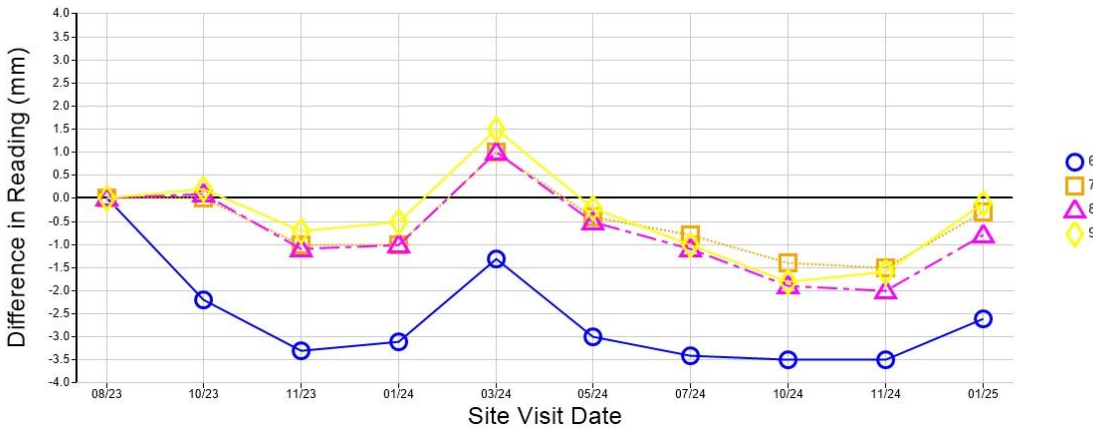
Level Monitoring Difference Graphs

The following graphs display the progressive movement that each Level Monitoring Station recorded at each separate site visit date to give an overall look at how much the property is moving.

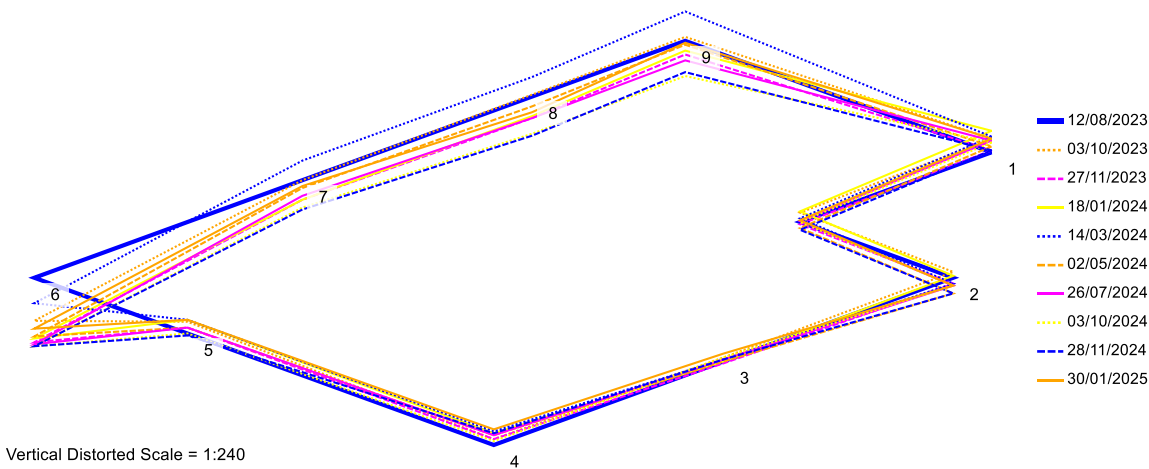
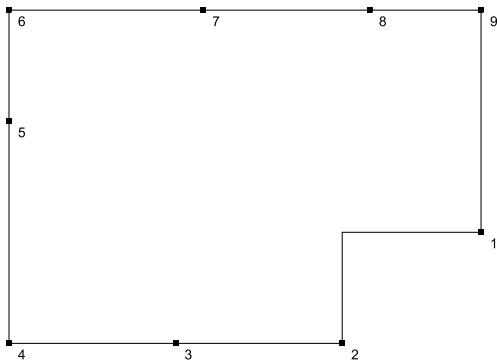
## Level Monitoring Displacement Map

The following image shows an isometric representation of the movement of the property, based on the Level Monitoring Stations that were installed.
