Heritage Assessment- Kitchen:

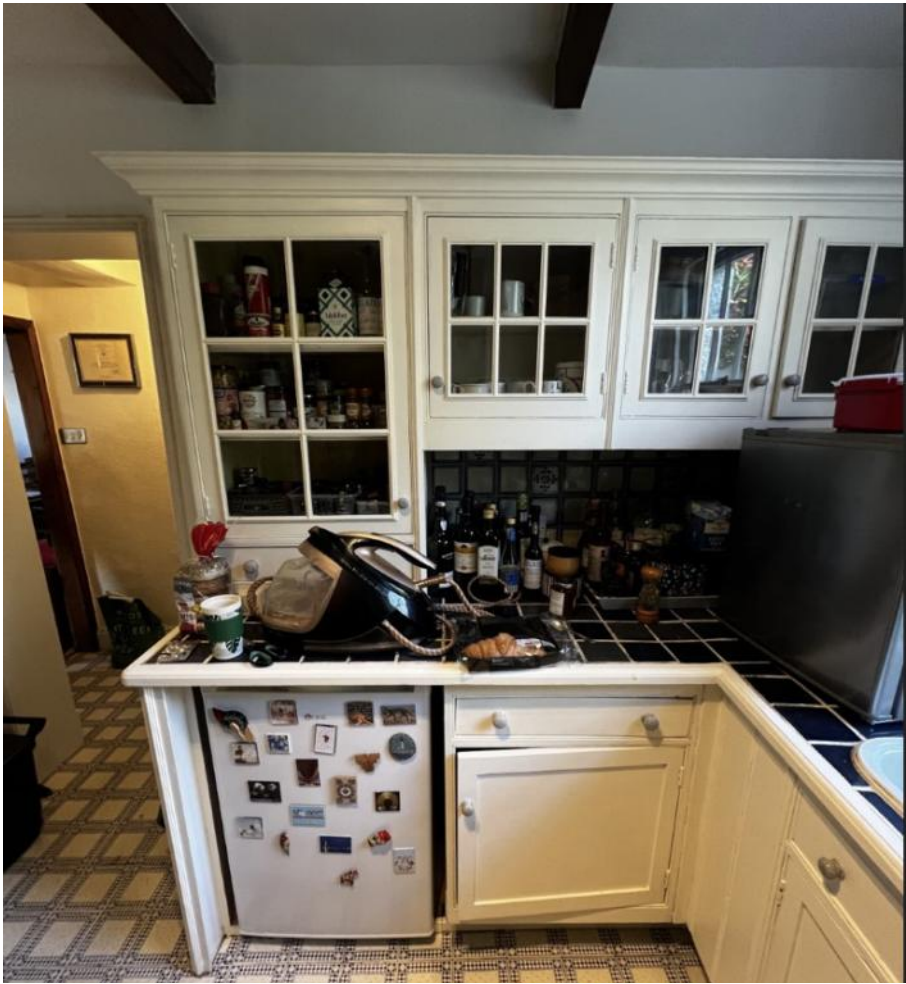
The kitchen features exposed timber joists, contributing to a traditional aesthetic in line with the character of the property. An existing Aga and chimney breast are present, with the latter constructed in a stretcher bond brickwork pattern, suggesting it may be a later addition rather than original to the house.

Existing Aga enclosure with stretcher bond mansonry chimney breast above

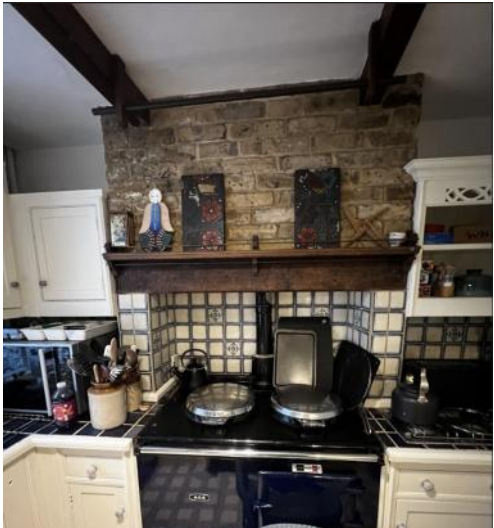
The flooring is tiled, and the walls are partially tiled with a traditional-style kitchen worktop. While these finishes align with a classic design, the materials—particularly the wall and floor tiles—are not considered to have historical significance. A timber sash window provides natural light and is more consistent with the original architectural features of the property.

Timber sash windows

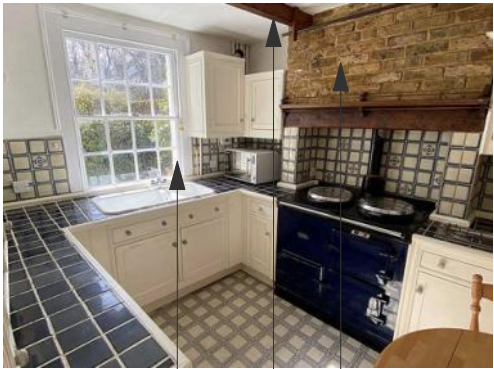
Timber joists

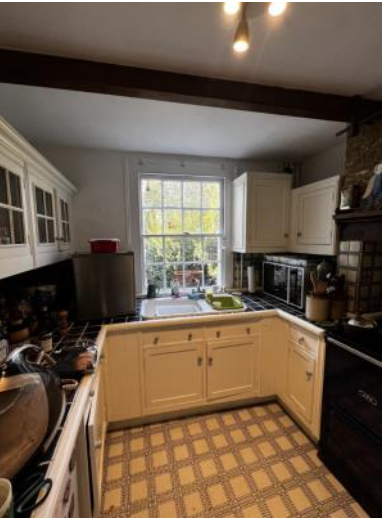
Existing historic wall featuring timber sash windows

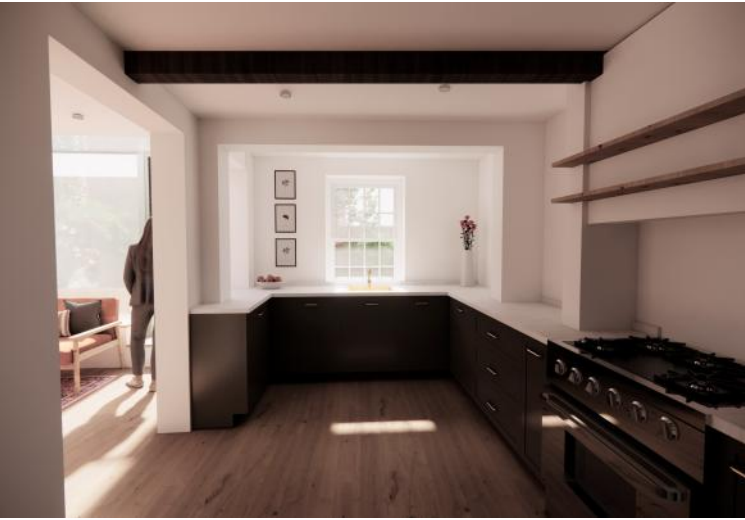
Proposed openings to historic wall to allow for rear extension

The existing kitchen is small, with limited countertop space, poor connectivity to the rest of the house, and insufficient natural light. We propose to extend the rear gable end by 1.5m to create an open-plan kitchen that connects to the garden room and makes full use of natural daylight from the proposed structural glazing. The existing chimney breasts will be retained and the rear bay extension will connect to the existing via structural openings
