**Arboricultural Impact Assessment  
Arboricultural Method Statement  
Tree Constraints Plan,  
&  
Tree Protection Plan**

Spencers Wood Primary School

**Job No:** P5937J3010/NS

**Date:** 15/07/2024

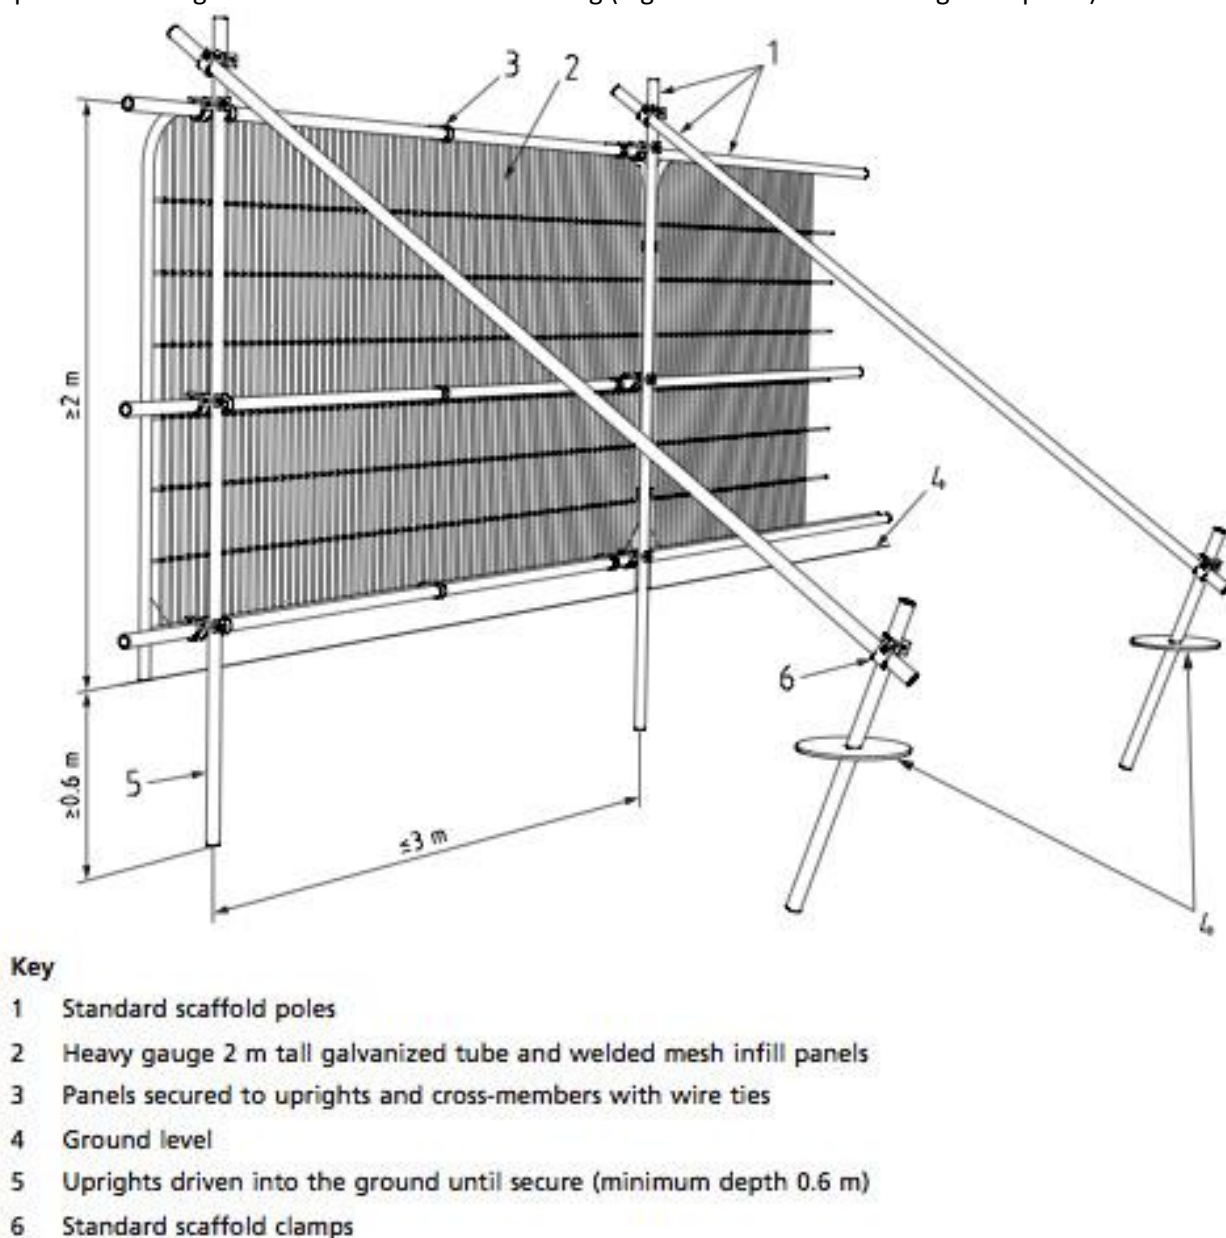
The Tree Protective fencing will be 2.4m Heras fencing as specified in the BS. The fencing will be supported by a scaffold framework with supporting struts firmed into the ground on the side of the trees. The purpose of the supports is to prevent the fencing being moved during the development. Clear signs will be attached to the fencing (e.g. Tree Protective Fencing – Keep Out).

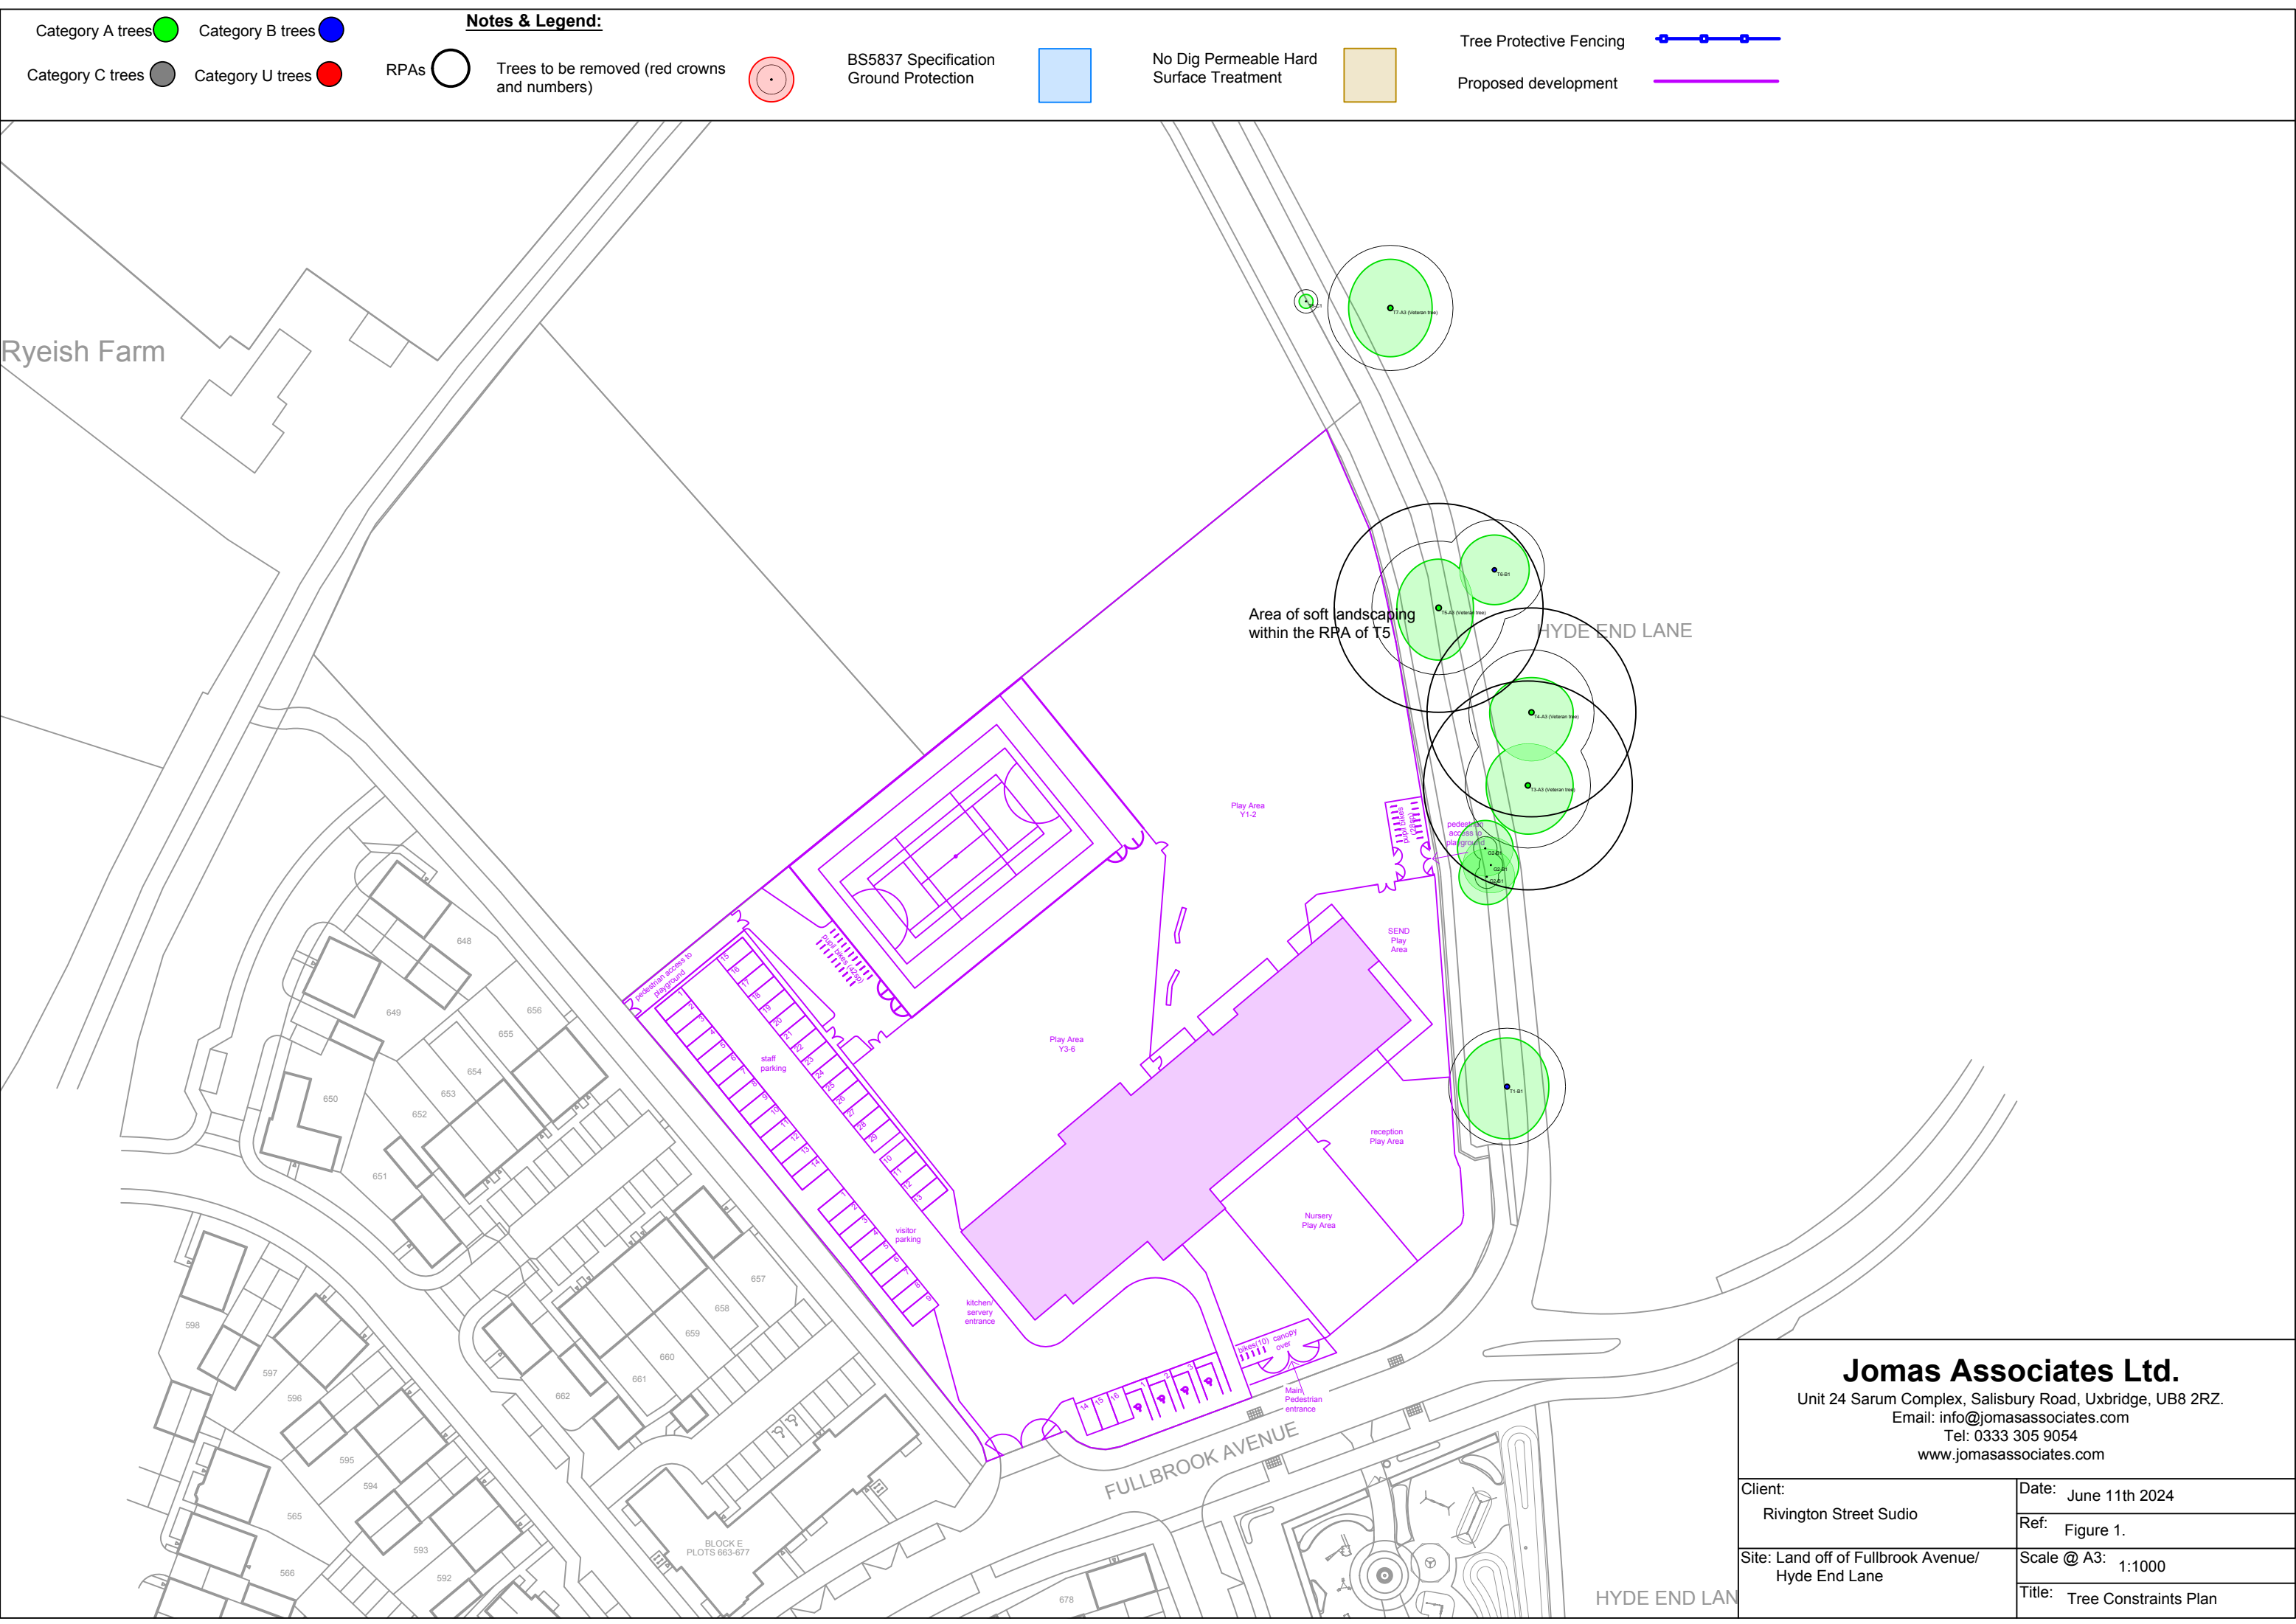
## **(Figure 1)**

The proposal, in this instance, is to construct a new teaching facility with parking and recreation areas as shown in purple on the tree constraints plan (Figure 1). It should be noted that there are four trees on our survey that have veteran tree status, which has been noted on the tree constraints plan.

# **TREE CONSTRAINTS PLAN**

Title: Tree Constraints Plan

With regard to their desirability for retention, the trees surveyed have been graded with their trunks colour coded on the tree constraints plan, and tree protection plan using the criteria contained in BS5837:2012. A summary of this grading is as follows.

In our survey schedule, the RPA for each tree is indicated as the radius of a circle as well as in M<sup>2</sup>. This is also plotted on the tree constraints plan and tree protection plan denoted by a heavy black line which merges the individual RPAs together where there is more than one tree.
