**LAND AT OLD FOREST ROAD, WINNERSH, BERKSHIRE RG41 1HY**

**TREE CONDITION SURVEY, ARBORICULTURAL IMPLICATIONS  
ASSESSMENT AND TREE PROTECTION RECOMMENDATIONS**

**JUNE 2025 (UPDATED JANUARY 2026)**

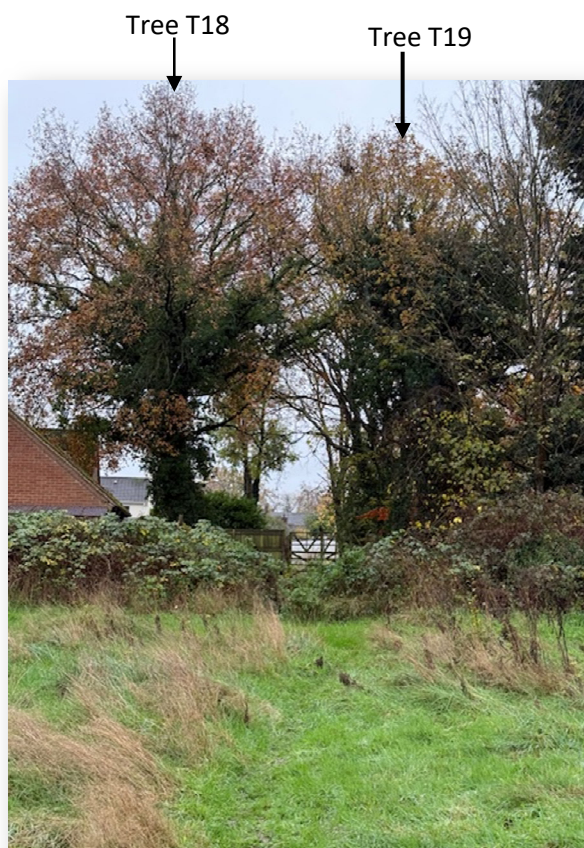
Image 1: View to south east of proposed site access with tree T18 to left & T19 to right (Both English Oak date 19112024)

We believe it will be possible to create a new site access from Old Forest Road (see image 1 below) without felling the category A Oaks. Please refer to GDA drawing numbers 463/01C and 463/02B for tree locations. The Lawson Cypress hedge (shown as G21 on the tree survey plans) has been felled to stumps in the neighbouring property. The Oaks (T18 and T20) will need to be crown lifted along the access road to 6 metres height from existing ground levels, the Ivy growth and dead wood removed, and crown thinned by up to 15%. Trees T19 (Oak) and T36 (False Acacia-group of two) will need to be felled and grubbed up as their trunks will be too close to the edges of the proposed access road although as a category B and C trees their loss will not be as significant as the loss of the category A Oaks under TPO-0507-1989. The Ash Tree T37 will also need to be felled as it cannot be retained in the current road access proposal. Felled trees will be replaced by new tree planting within the proposed site development. There is a provisional TPO on trees T19, T22, and T37 to which the current landowner, Elstree Land, has objected to. We believe that tree T22 (False Acacia) can be retained as it will be set back from the roadway edge by 1.2metres and there is a current level of 51.07AOD near the centreline of the proposed access road with the level by the tree trunk of T22 currently 51.29AOD. With the no dig construction make up being 250mm depth then no significant excavation will be required within the RPA of tree T22. Dead branches and Ivy growth will be removed from this tree. There is a minor incursion of the access road into the RPA of tree T38 (Sweet Gum), and this section of the access road must also be no dig to anticipate future root growth. No dig road sections are shown with hatches on the drawings.

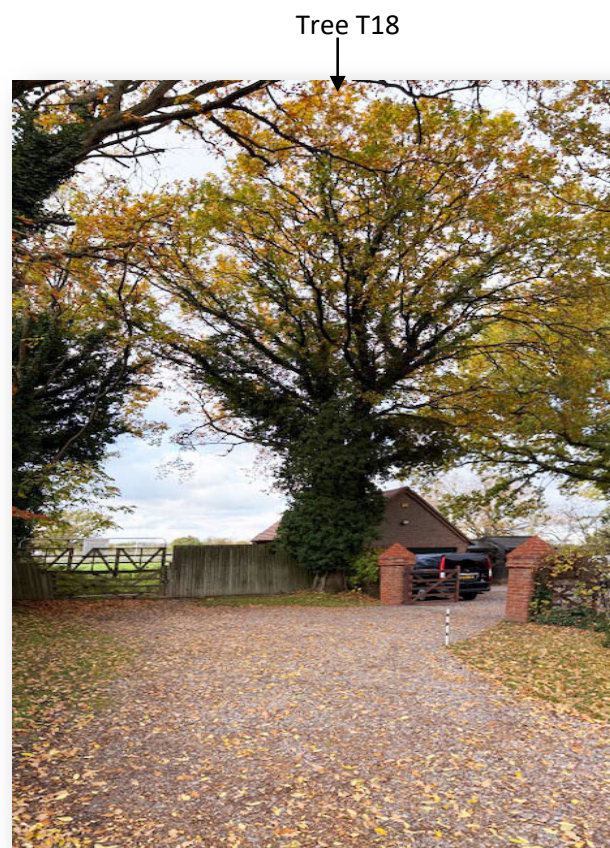
Image 2: View north east of proposed access & tree T18 & Oaklea cottage entrance with no surface tree roots visible in road (date 07112025)

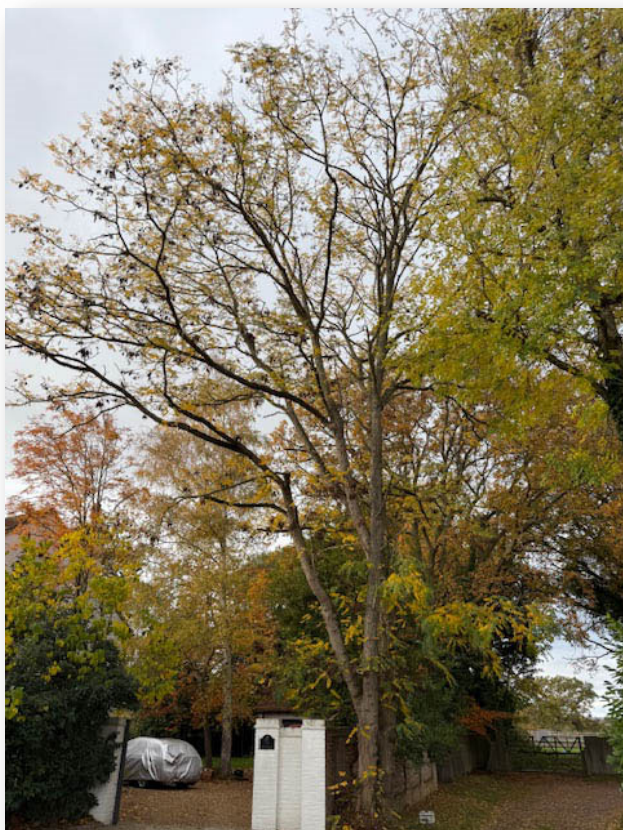
Image 3: Looking north to proposed access road with tree T22 (False Acacia) near The Stables entrance (date 07112025)

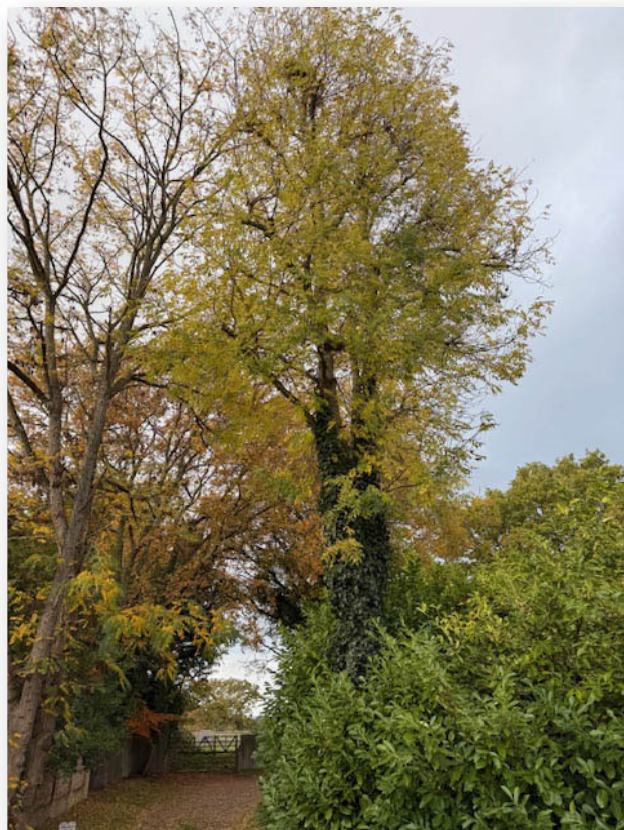
Image 4: Looking north with trees T22 to west and T37(Ash) to east with Cherry Laurel understory (date 07112025)

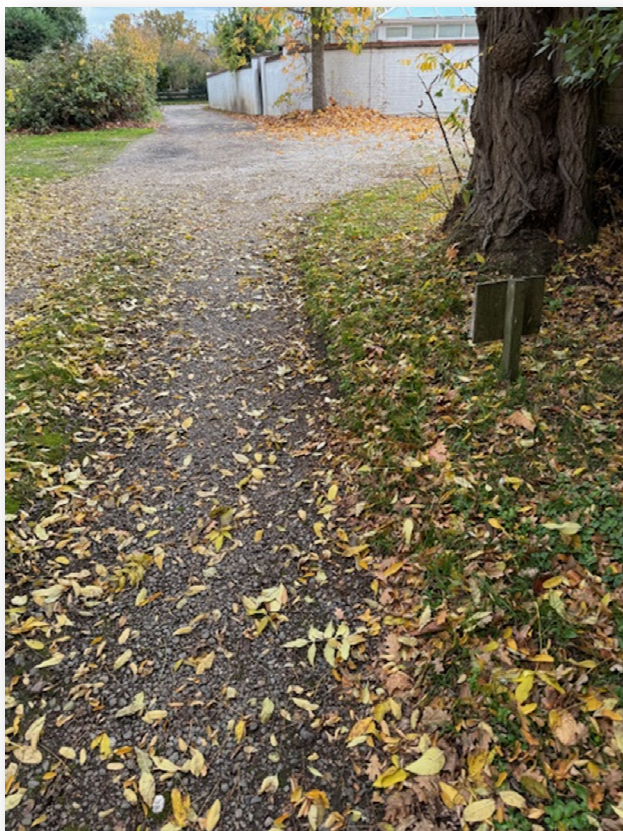
Image 5: Looking south towards Old Forest Road bellmouth with butt of tree T22 (False Acacia date 07112025)

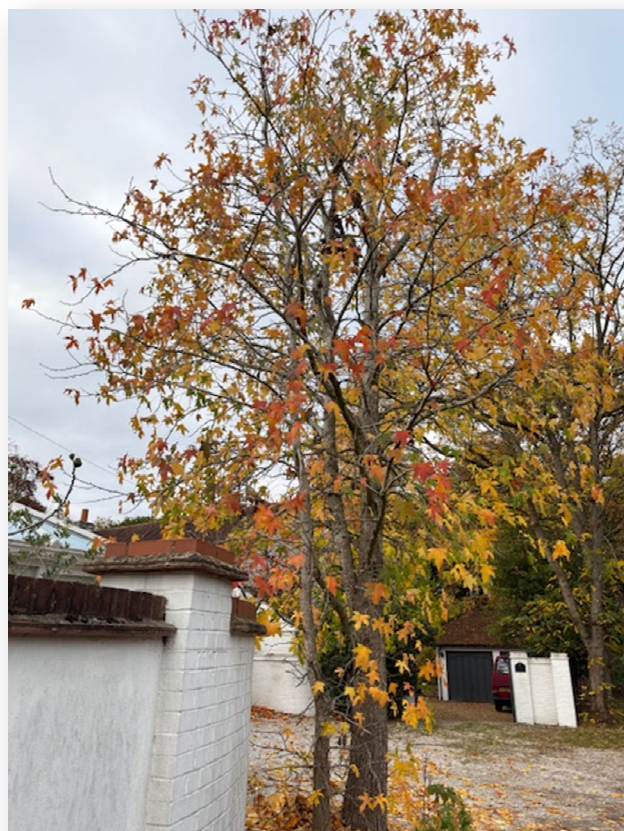
Image 6: View looking north east of retained Sweet Gum Tree T38 by Tootley Hall North entrance (date 07112025)

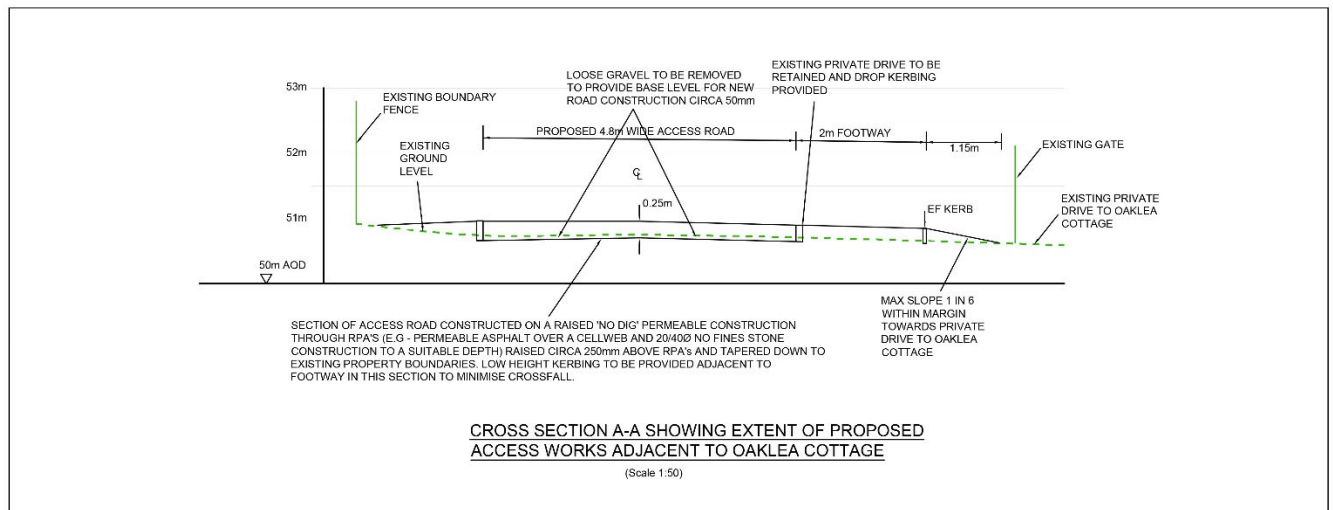
Figure 1: Site Specific Section through 'No Dig' permeable access road adjacent to Oaklea Cottage Entrance prepared by Stuart Michael Associates Consulting Engineers

The access road will need to be constructed on a raised a 'no dig' permeable construction (e.g. permeable block paving or asphalt over a cellweb and 20/40Ø no fines stone construction to a specified depth) where it passes over the tree RPAs and raked down with topsoils and permeable surfacing either side of the access road as shown in figure 1 below. Tree roots that may be close to the existing road surface will be protected during the construction work and will be contained within the permeable construction make up. The access road will contain a pedestrian footpath and speed control cushions and passing places where it narrows. These trees will be protected with a steel tree protection fence that conforms with the construction details shown in section 6.2.2 of British Standard BS5837(2012) and illustrated in figure 2.

- b) **The construction make ups for the proposed access road from Old Forest Road and the link road through the north to south tree belt between the site's east and west parts and elsewhere where tree RPAs may be impacted upon, must be constructed with a no dig permeable construction** incorporating cellular confinement systems (e.g. Cellweb) to sufficient depths, approved by a civil engineer, in accordance with Arboricultural Association Guidance note 12 (ref. 7). Generally permeable surfacing must be incorporated through the site as a component of the SUDS strategy to conform with the Flood and Water management Act 2010. No dig road sections are indicated with hatchings on the drawings.

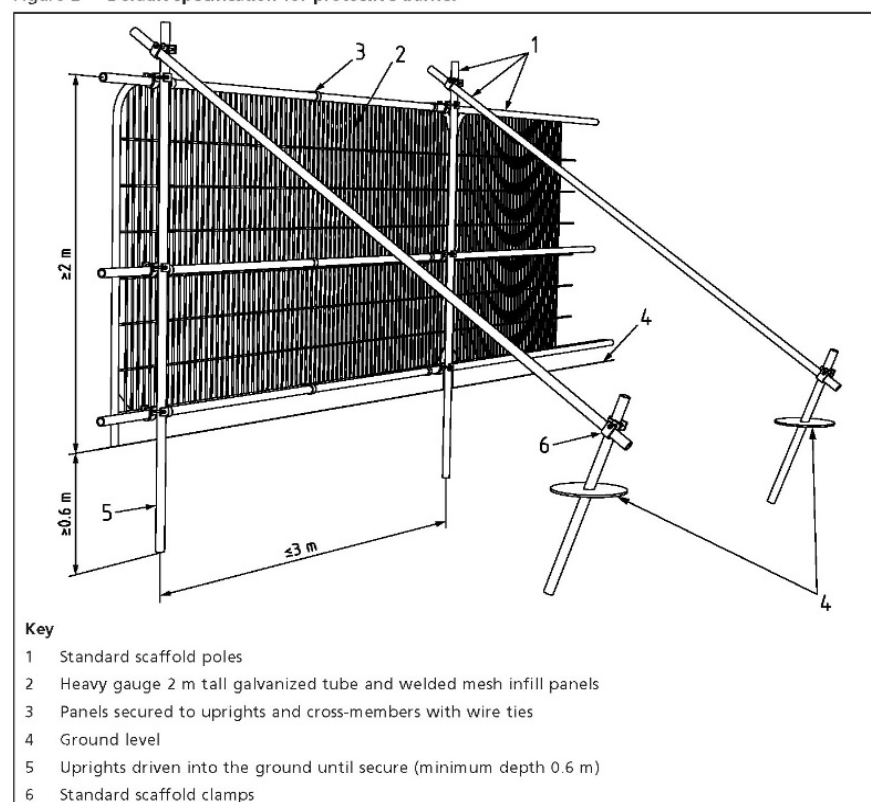
Figure 2 Default specification for protective barrier

Figure 2: Default Tree Protection Fence as stated in BS 5837(2012)

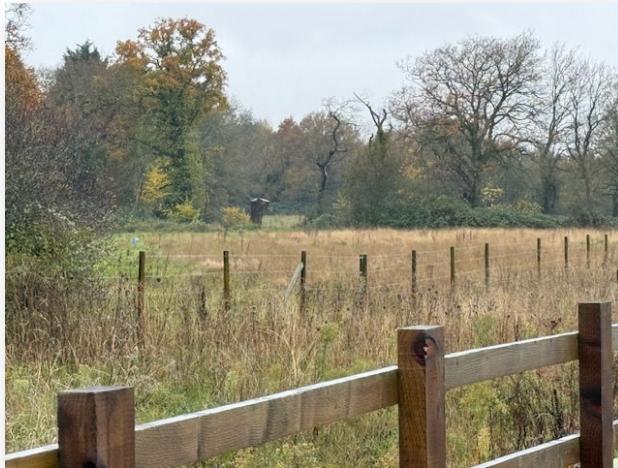
Image 2: View looking south from Toutley Road showing tree belt crossing site from north to south (date 19112025)

There are two separate parcels to the east and west of the site that will be linked with an access road that will need to pass through an existing tree belt that runs across the site from north to south and contains seven trees protected by TPO-0507-1989. Tree T14 is listed as a dead category U tree and tree T13 is an inferior quality category Oak. The current landowner has applied for consent to fell tree T13 as it is deemed to be structural unsound as a significant gap in this tree belt is currently accessed by walkers. Trees T12, T14, and T13 are shown in images 2 and 3 below and their removal and subsequent creation of a gap in the tree line is where I recommend the linking road is aligned through so that it is located a sufficient distance from the trunks of the category A Oaks T11 and T15. The linking road will also need to be constructed as a no dig permeable road to limit the impact on the RPAs and crowns of trees T11 and T15 in a similar construction detail as shown in figure 1.

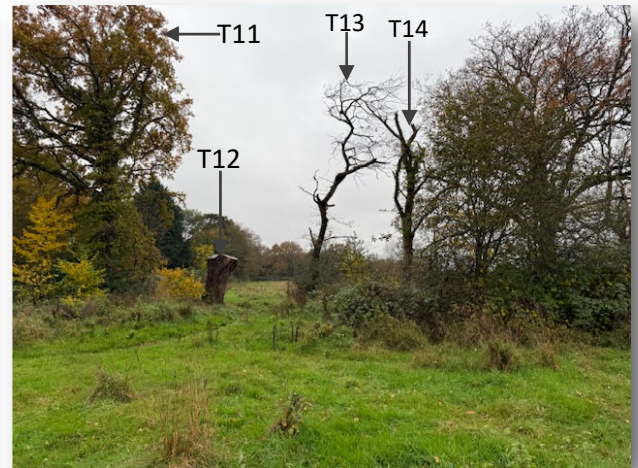
Image 3: View looking east towards potential gap in tree belt where link road can be located if trees T12 (Stump), T13, and T14 are felled (date 19112025)

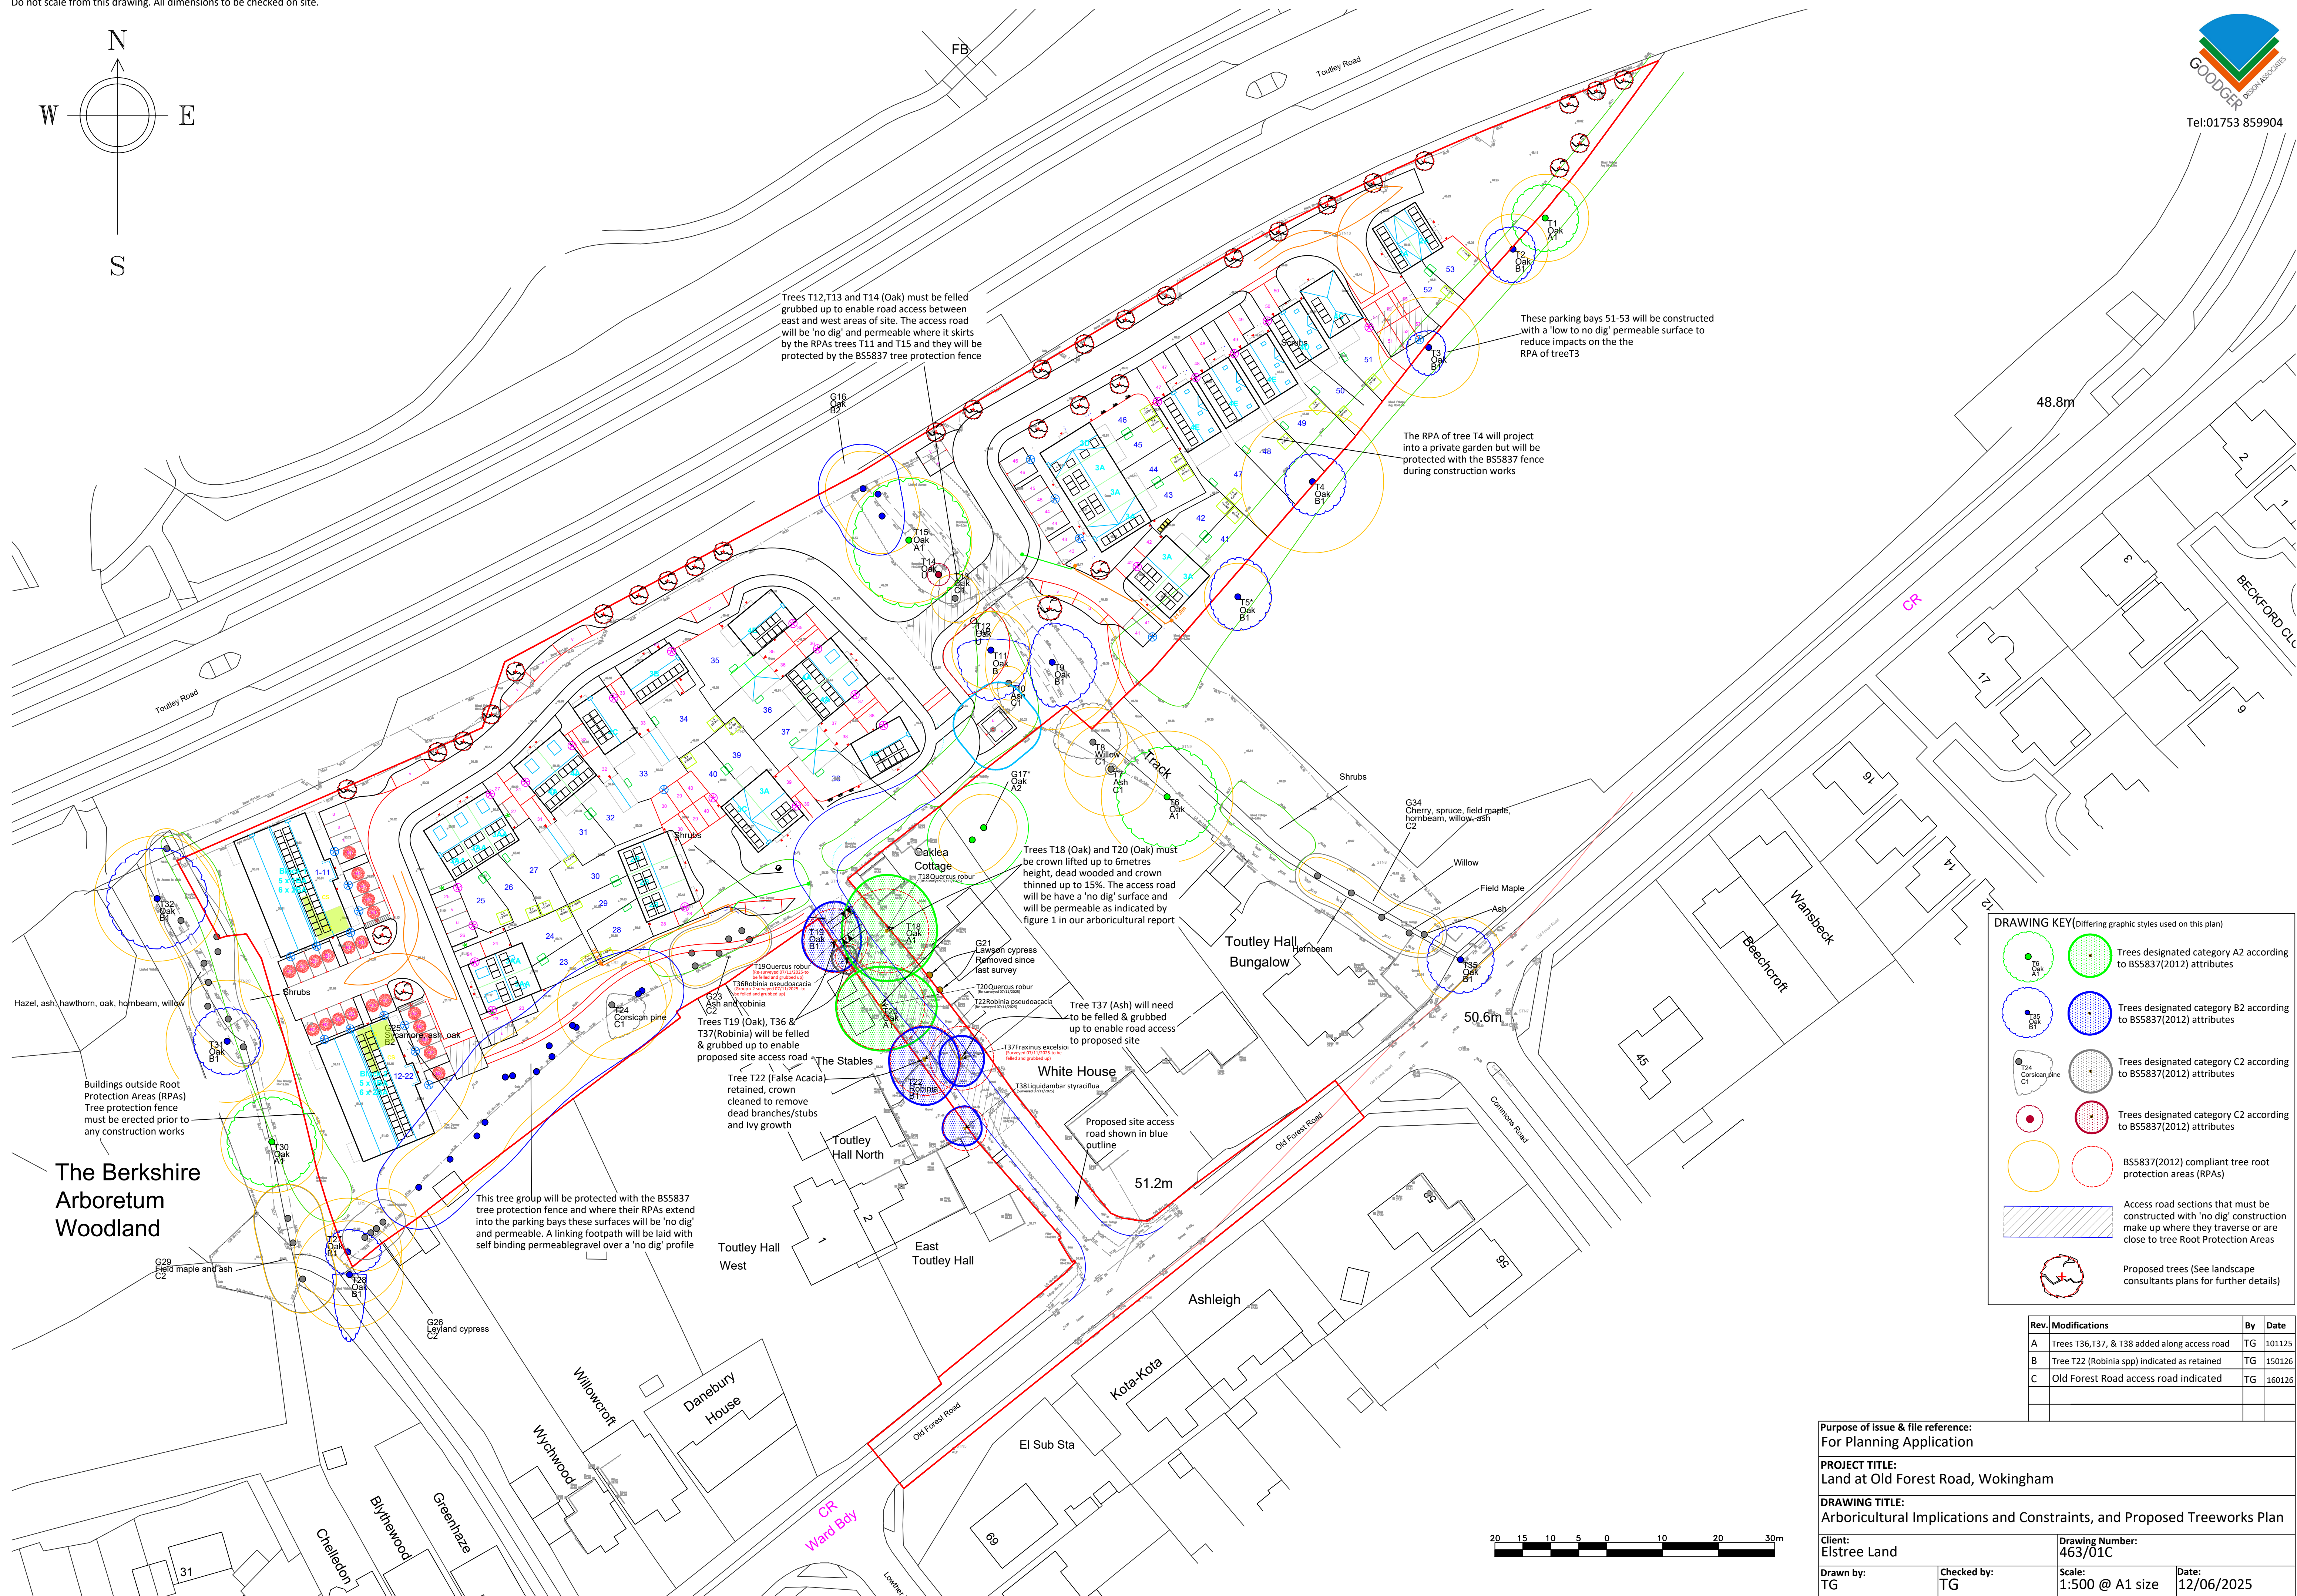
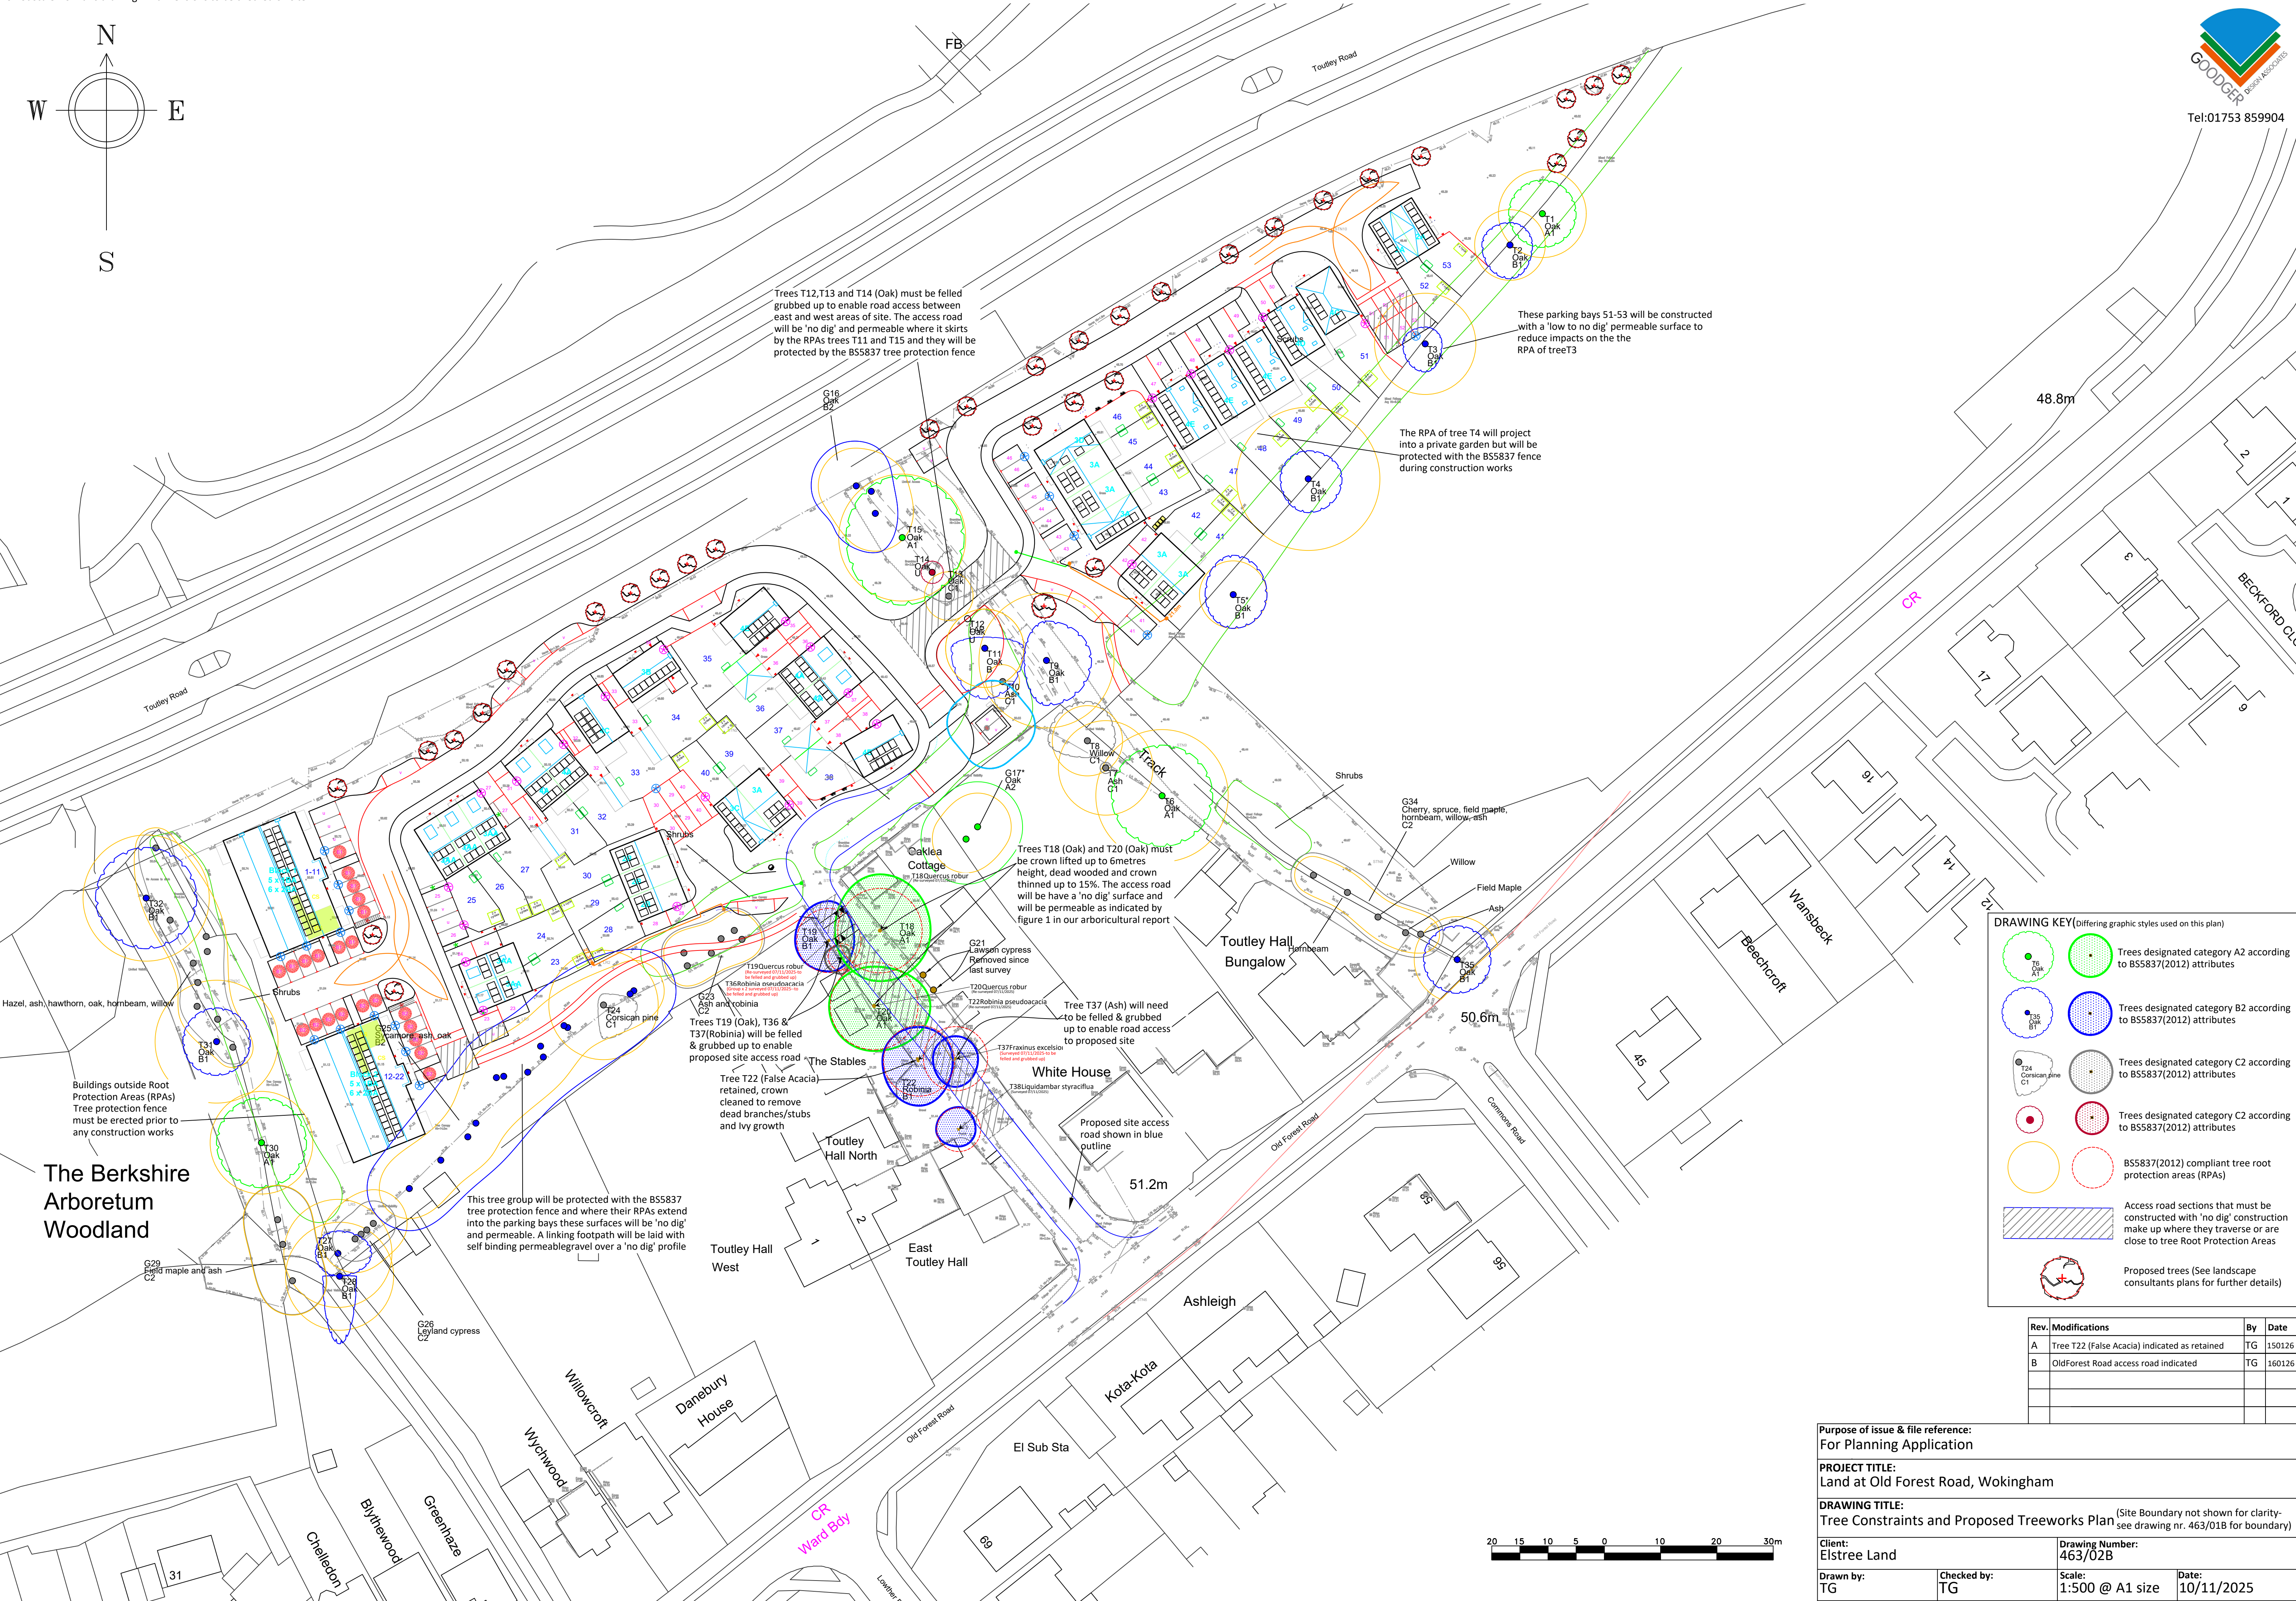
| <b>DRAWING TITLE:</b><br>Tree Constraints and Proposed Treeworks Plan (Site Boundary not shown for clarity- see drawing nr. 463/01B for boundary) | | | |

Access road sections that must be constructed with 'no dig' construction make up where they traverse or are close to tree Root Protection Areas
-
