## Existing Canopy

## Proposed Canopy

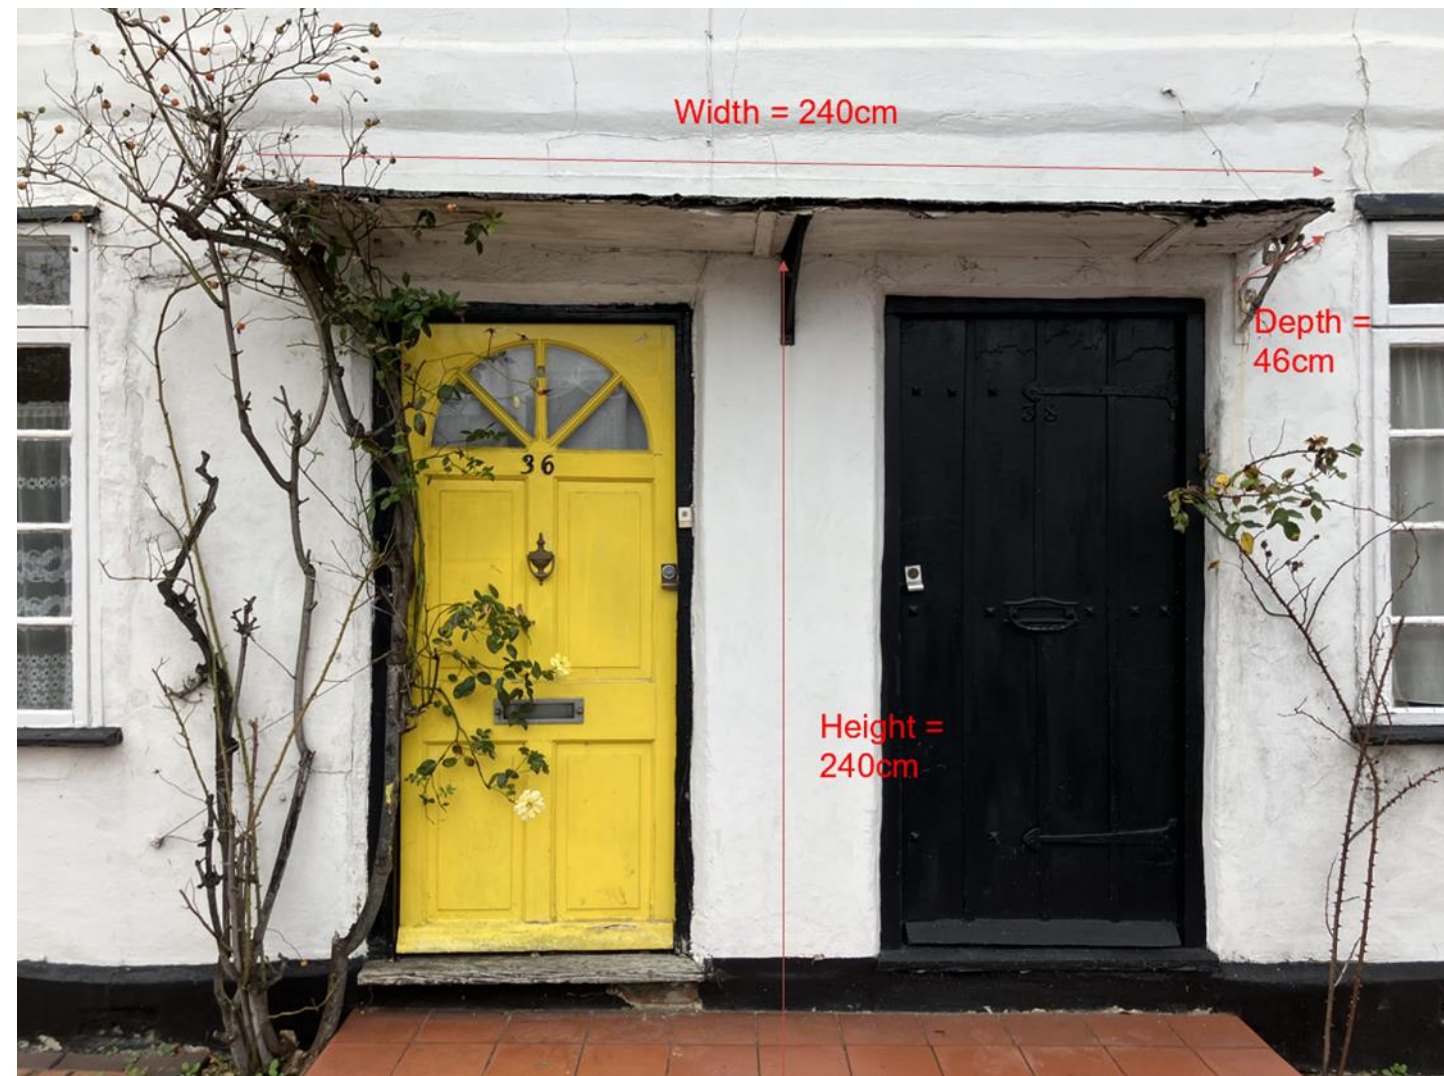
- The existing canopy detail has failed
- The timber substrate is in poor condition and the weathering details are **derogated** beyond use
- Existing brackets are in poor condition

- We propose replacing the structure like-for-like
- This will consist of new timber substrate, new L brackets (in keeping with the heritage features), and new lead covering and flashings
- It will be made with a 3 degree fall.
- P003.10-502\_Proposed\_Replacement\_Entrance\_Canopy-Rev-01
