# MEMORANDUM

| <b>Service</b> | WBC Ecology | <b>App No:</b> | 261690 |
| <b>Address:</b> | 3 Old Bath Road, Sonning, Wokingham RG4 6SZ. | | |
| <b>Proposal:</b> | Householder application for the proposed erection of two front two storey gable extensions, raising of the ridge and eaves height with the formation of a dormer window to the front roof slope, erection of a single storey side extension, erection of a single storey rear extension, erection of a two storey rear extension, installation of two rear dormer windows, formation of a first floor rear balcony, alterations to fenestration, removal of chimney pots and associated external alterations. | | |

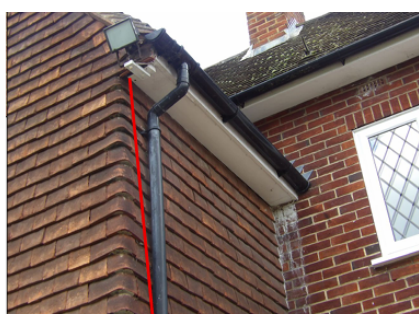
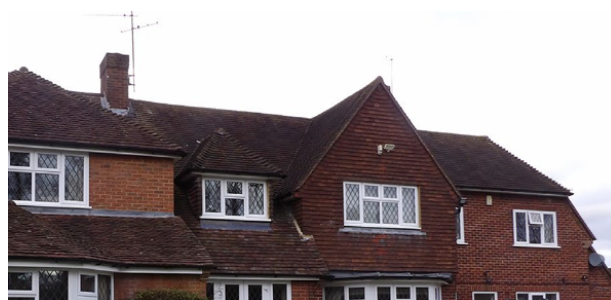
The Preliminary Ecological Appraisal Daytime internal survey found occasional bat droppings were observed under the roof main ridge between the chimney stacks. The DBW external survey recorded slipped tiles on the single storey part of the house on both the front and rear elevations, leaving gaps suitable for crevice-

dwelling bats. The Ecologist recorded a section of soffits and fascias on the rear elevation which are not tight to the wall with access gaps or splits. There are some gaps in the hanging tiles on both elevations. The Ecologist assessed that all the gaps on the building could afford roosting opportunities for crevice dwelling bat species or allow access into the building for bats.

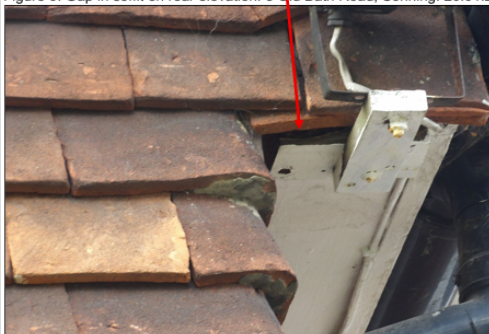
Figure 9. Gap in soffit on rear elevation. 3 Old Bath Road, Sonning. 20.01.26
