# South Wokingham Phase 2B

## Tree Mitigation for Condition 64

On Behalf Of Miller Homes and Kier Property | P19-0052\_164C | December 2025

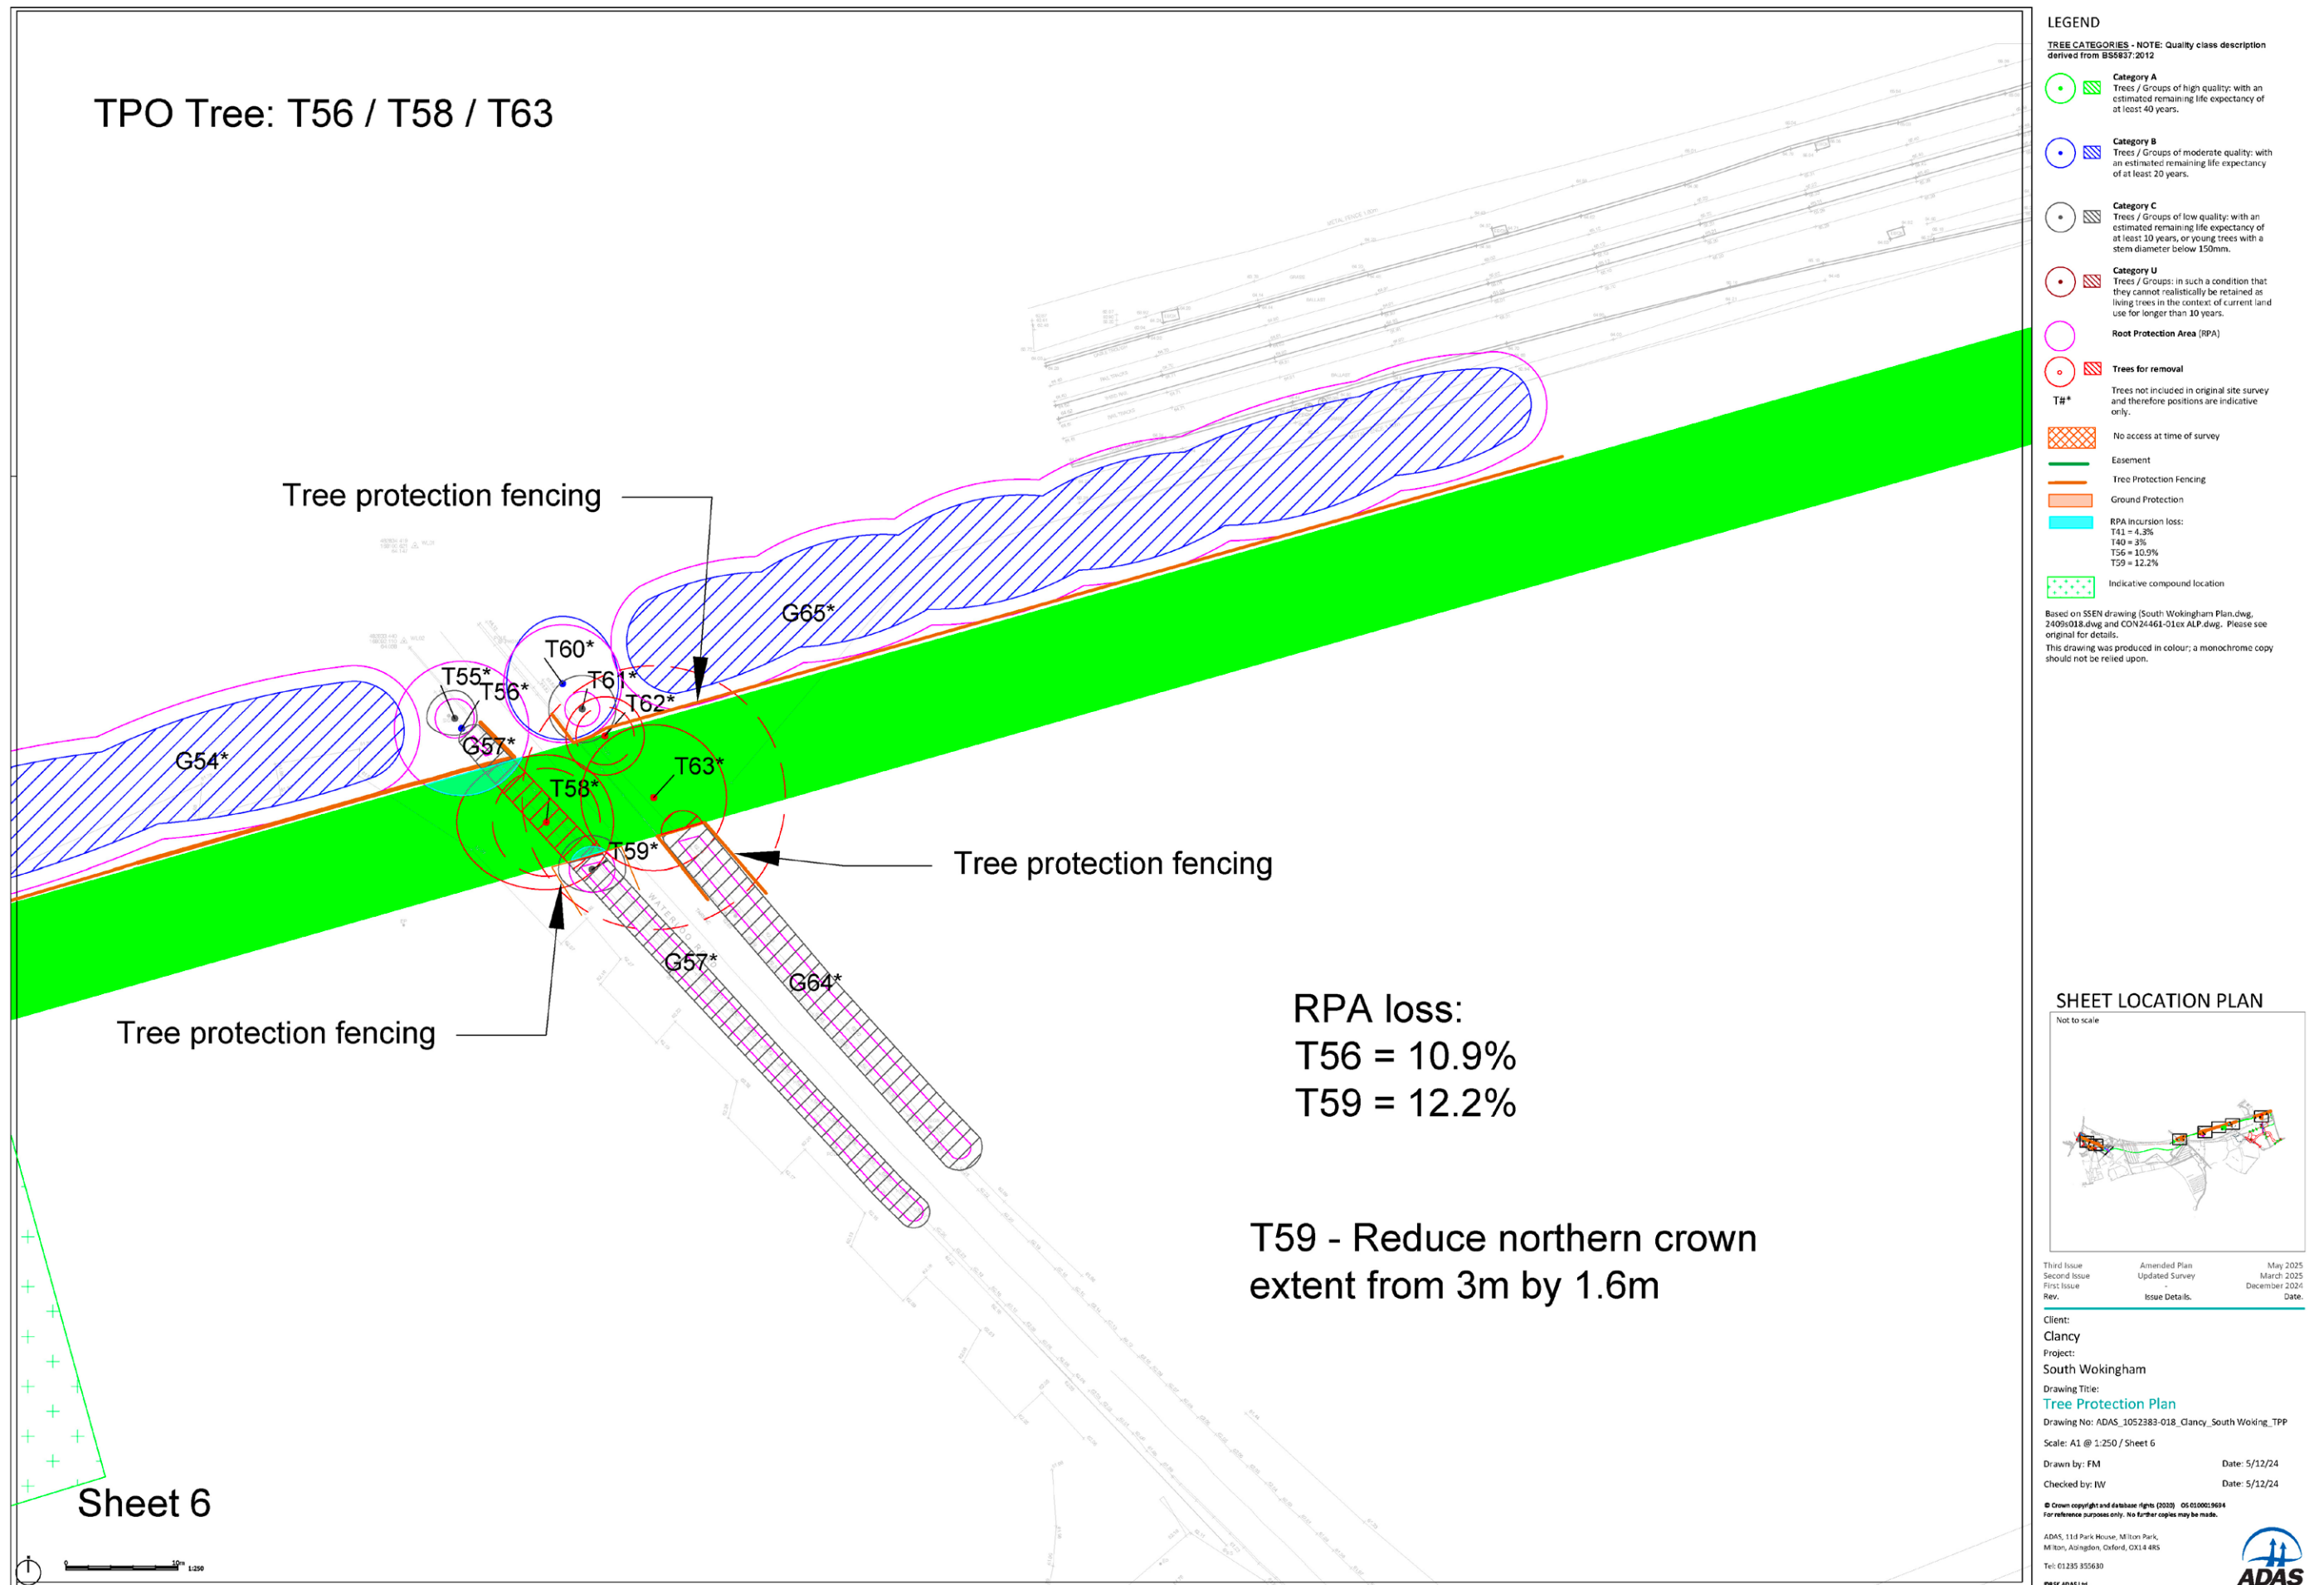
FIGURE 1: LOCATION OF T58, T62 & T63 – TREE PROTECTION PLAN PRODUCED BY ADAS (ADAS\_1052383-018\_CLANCY\_ SOUTH WOKINGHAM\_TPP)

- 1.5 The SSE design for the undergrounding of the overhead electricity lines along the northern part of the Site and the associated easements are unable to avoid the presence of a notable tree (T63 as shown on the ADAS Arboricultural Method Statement (AMS) ref. 1052383-18 dated December 2024 – appendix 1), and legal implications means a re-design would lead to major risks to the programme. Technical review has been undertaken; however, the retention of the tree is currently not considered to be feasible.

- 1.11 The trees affected by the proposed service route are as follows:
  - T58 – English Oak.Early mature specimen shown on recent tree survey plan as category ‘B’.

- T62 – English Oak Early mature specimen shown on recent tree survey plan as category ‘B’.
  - T63 – English Oak Mature specimen, reviewed for potential veteran status, shown on the ADAS tree survey as category ‘A’, due it being recognised as ‘notable’ on the Woodland Trust’s Ancient Tree Inventory.

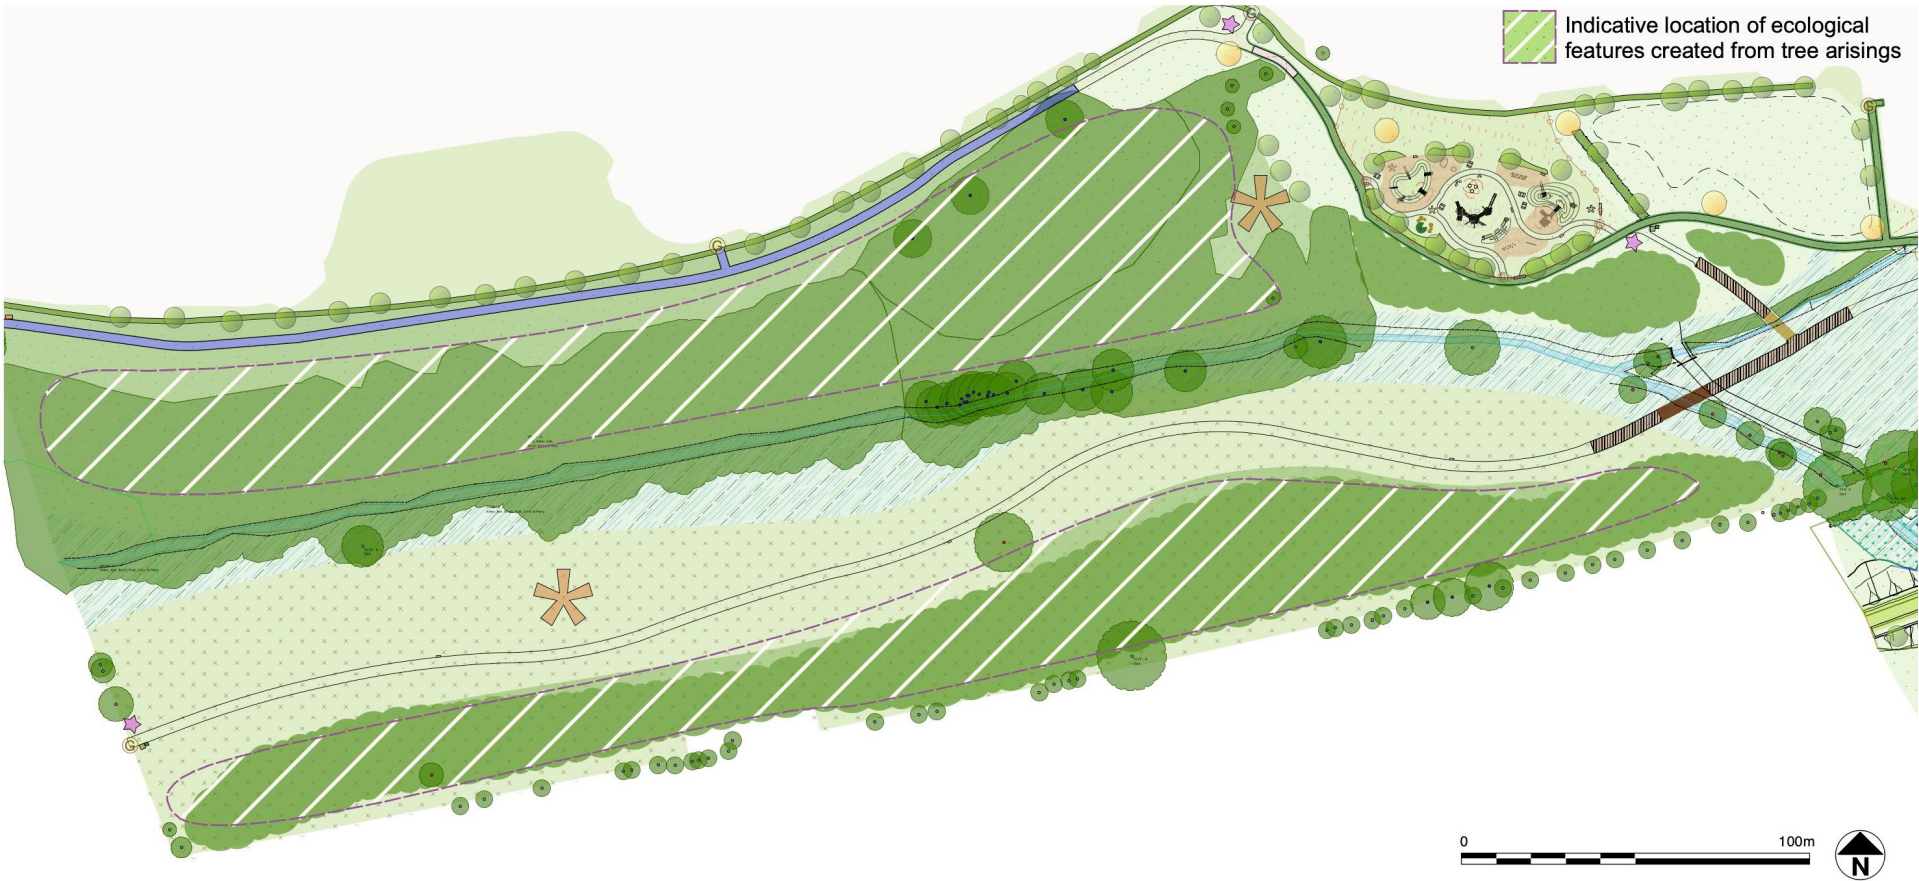
FIGURE 2: INDICATIVE AREAS TO LOCATE TREE ARISINGS

2.7 The plan below (figure 2) shows indicative locations for the arisings. The final location should be agreed on site between the client, WBC and project ecologist and landscape architect to ensure their location is suitable for the habitat feature being created and will not prejudice future landscape design or ecological aspiration for the openspace.

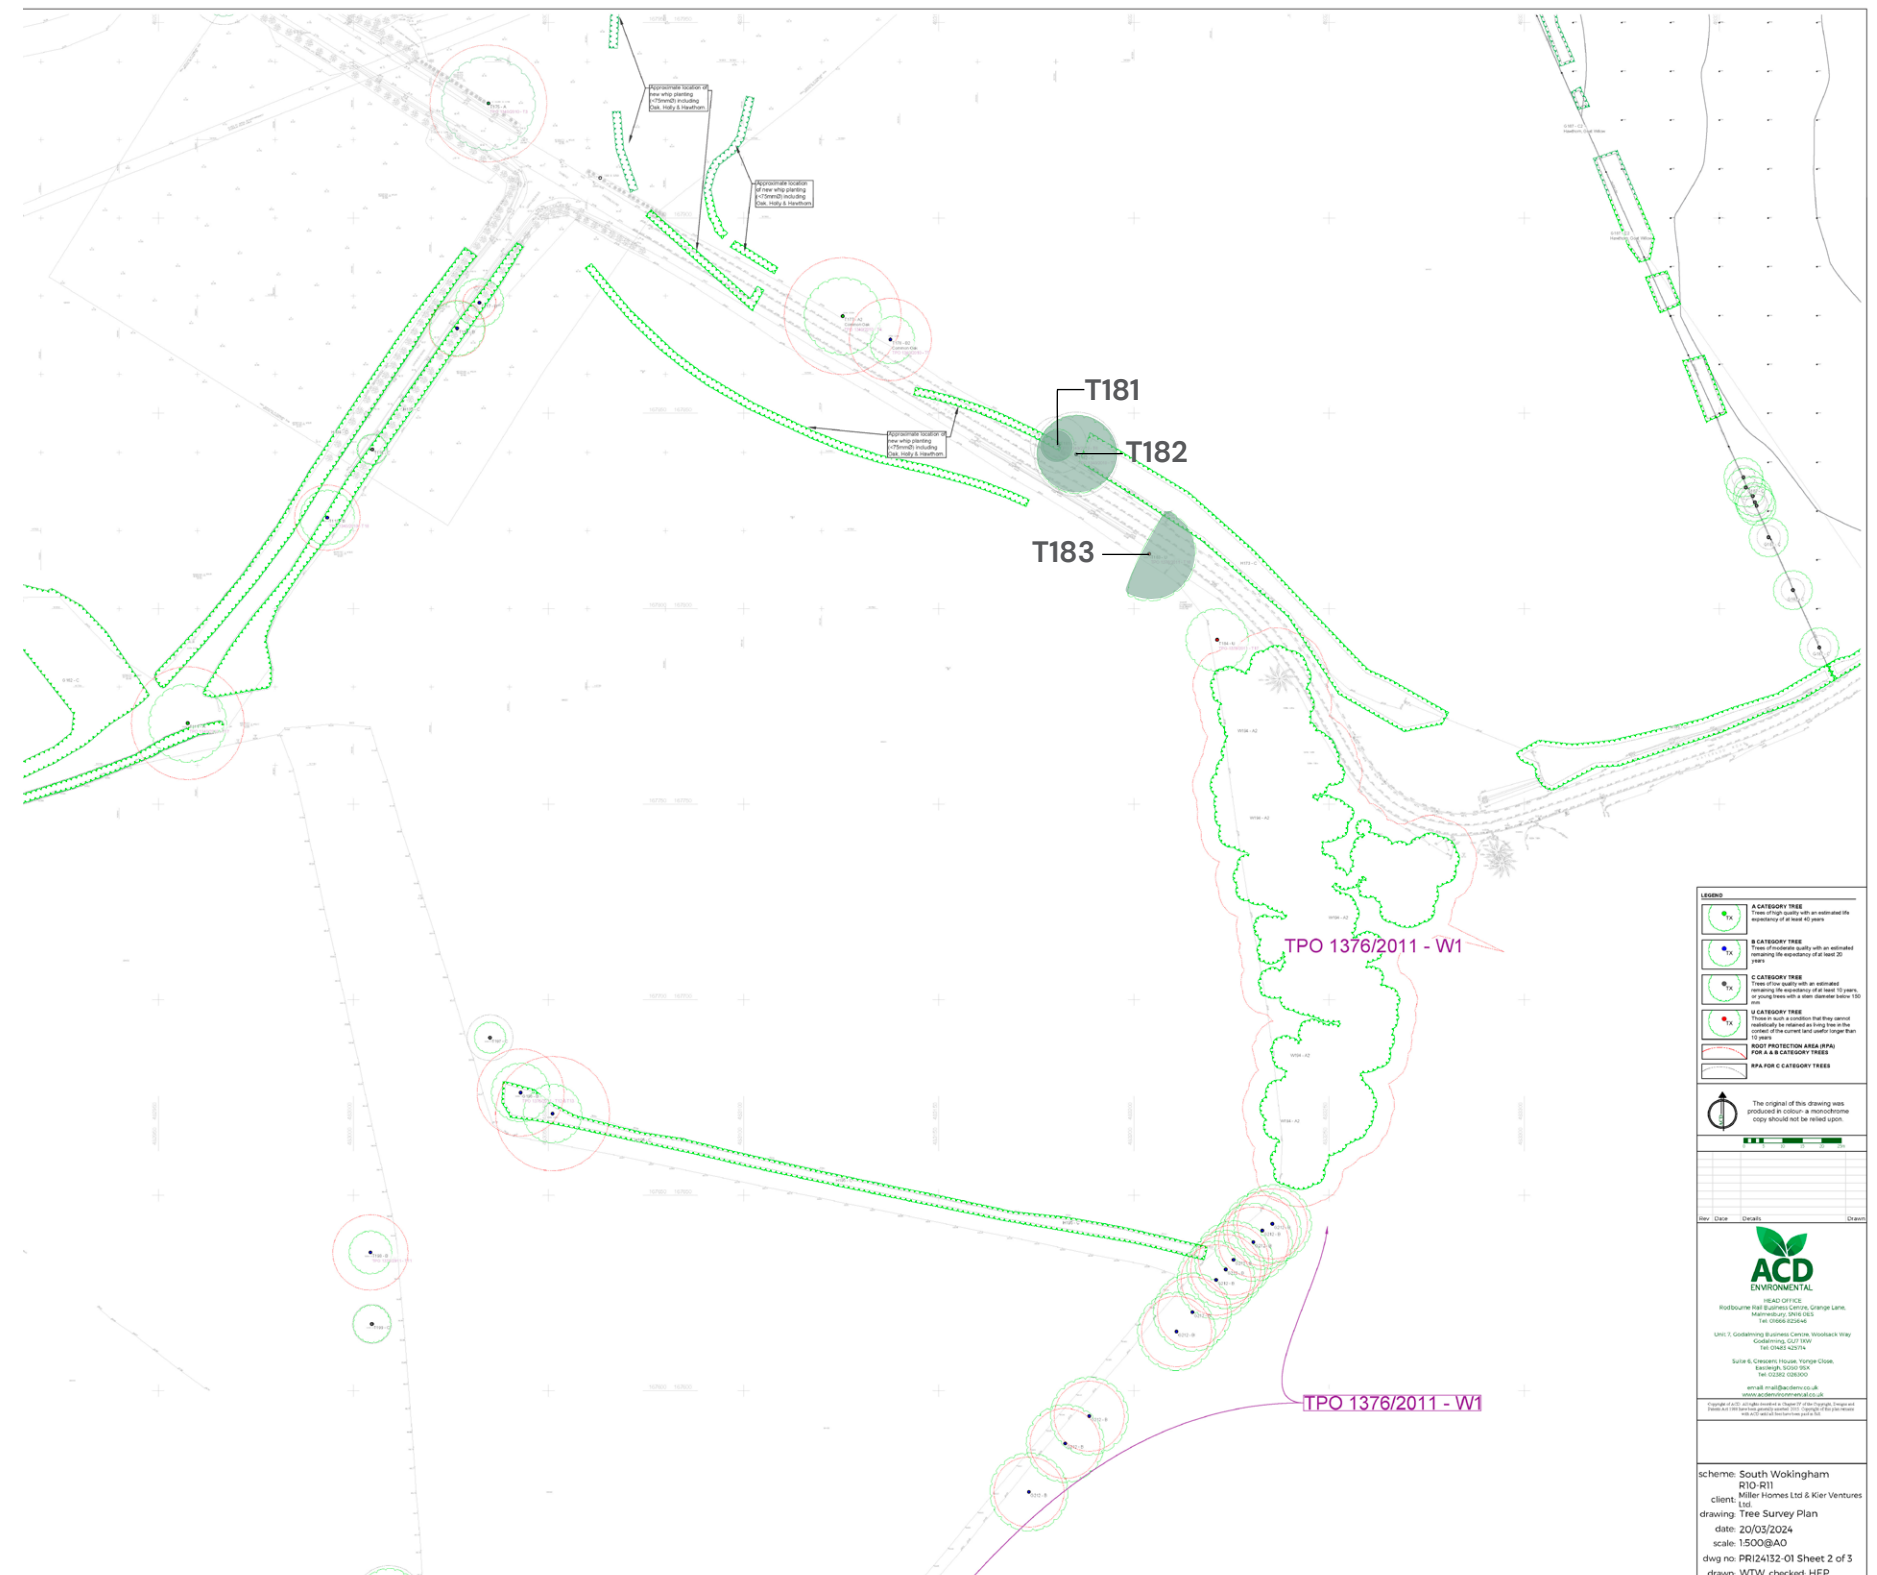
FIGURE 3: LOCATION OF TREES TO BE VETERANISED

- 4.3 Initially T183 (tree numbering is in-line with previous surveys undertaken by ACD Environmental Ltd (ACD) and DPA Arboricultural Consultants (DPA). Refer to adjacent extracts for details of the location of the suggested trees) which is situated on Waterloo Road within the 'R11' parcel should be utilised for the veteranisation process due to its recent stem failure, which has resulted in a large cavity in the primary crown break. It is recommended due to this trees location that remedial work should be implemented regardless of these works as a matter of safety. Further works should also include reducing the remaining crown, utilising the large tear/cavity and adding further holes and coronet cuts into this tree would result in the tree containing multiple features found on veteran trees. This tree is also situated close to an area of Ancient Semi Natural Woodland (ASNW) and therefore would assist with the overall positive ecological benefits of the wider site.

- 4.4 Two further trees, also situated on Waterloo Road are T181 and T182. Both of these trees, with their relative age and category 'C' designations, should also be considered for the veteranisation process. As they are not currently showing any signs of veteran features, all features such as coronet cuts, tears and cavities should be manually implemented. Guidance for this can be found at Sussex' Wildlife Trust Veteranisation page.

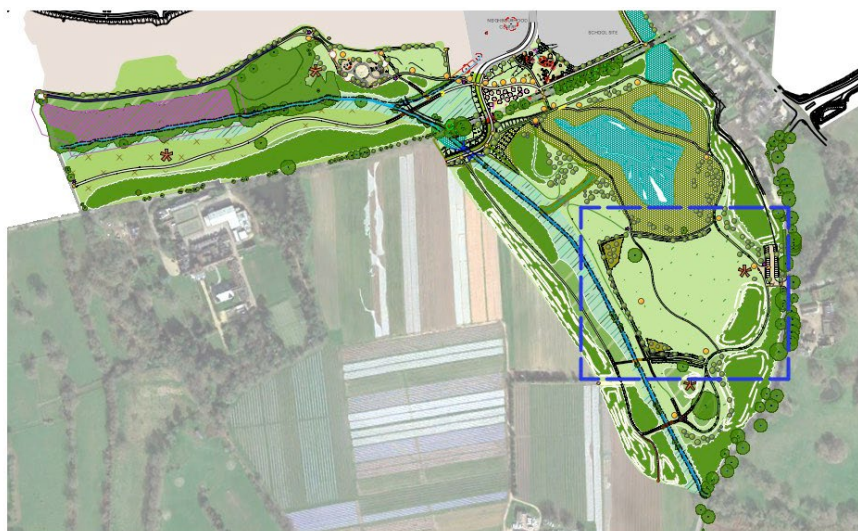
FIGURE 4: INDICATIVE LOCATION OF PROPOSED TREES WITHIN HOLME PARK SANG

- 4.9 The plan opposite (figure 4) and overleaf (figure 5) shows indicative locations for tree planting. Details regarding the exact location and species will come forward as part of the residential reserved matters or relevant discharge of conditions applications to be approved by WBC.

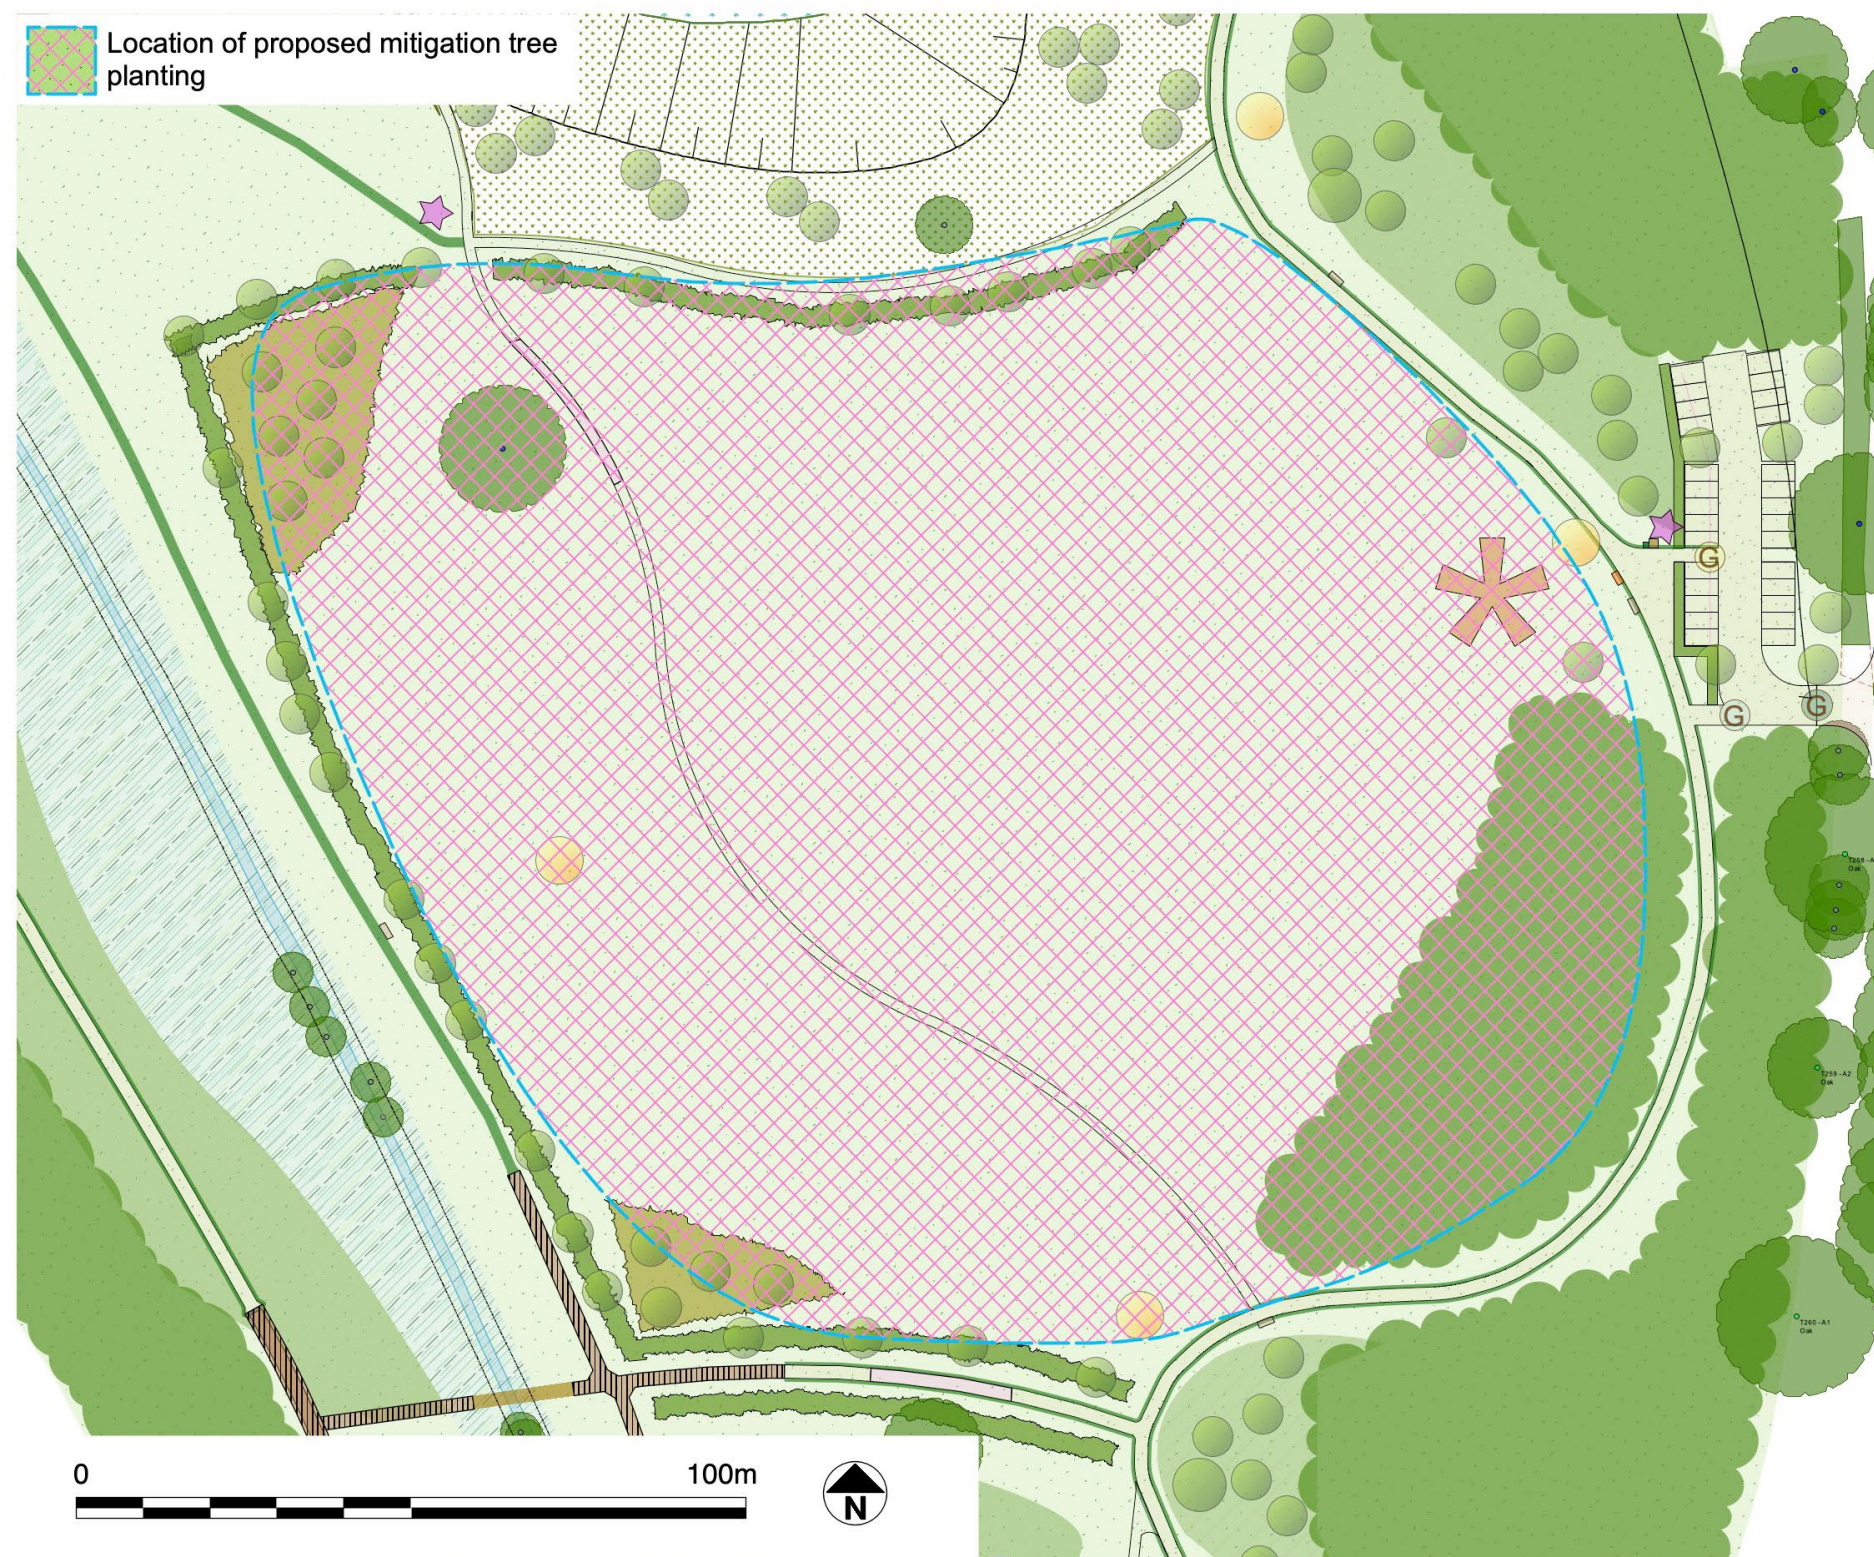
FIGURE 5: INDICATIVE LOCATION OF PROPOSED TREES WITHIN RESIDENTIAL AREAS
