NATURAL HISTORY MUSEUM ACCESS ROAD, SHINFIELD

CONDITION 11 – DRAINAGE SYSTEM

UNIVERSITY OF READING

11 OCTOBER 2024

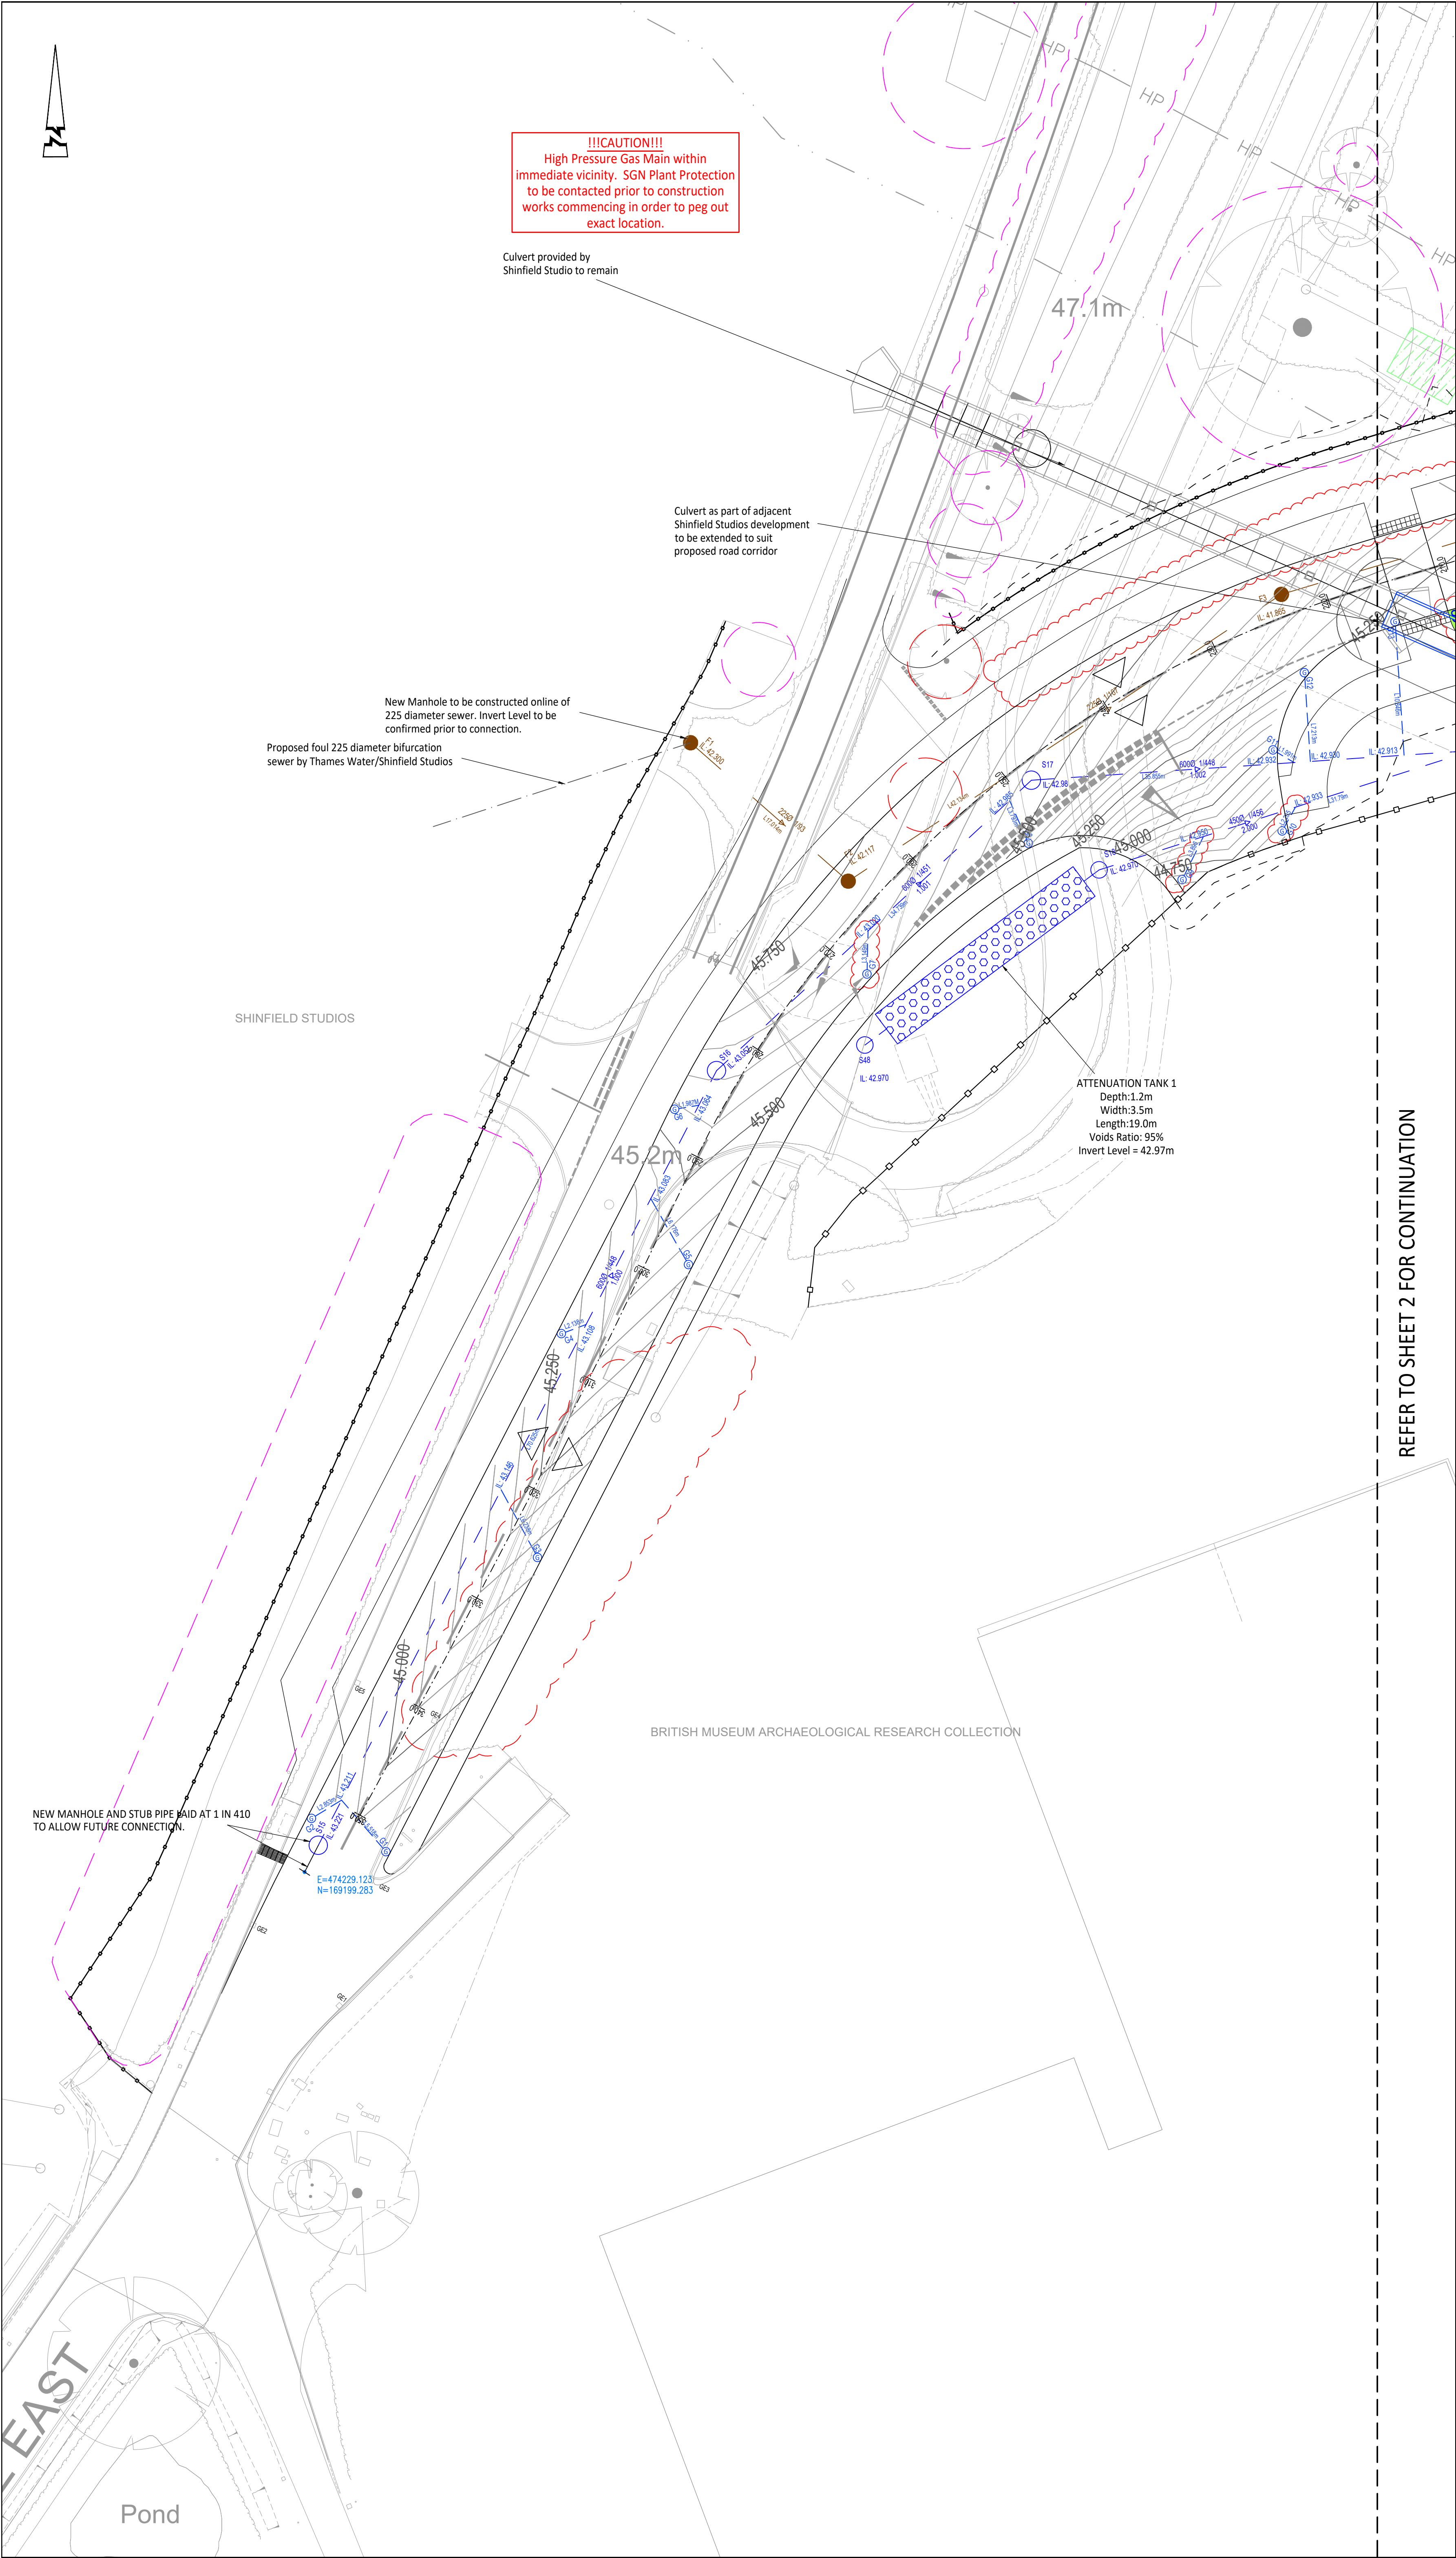
ATTENUATION TANK 1  
Depth:1.2m  
Width:3.5m  
Length:19.0m  
Voids Ratio: 95%  
Invert Level = 42.97m

- 3.1. The Greenfield runoff rates have been calculated using the online HR Wallingford tool and can be found in **Appendix A**.
- 3.2 Full calculations demonstrating the capacity of the proposed attenuation features to cater for the 1 in 100 year flood event with a 40% allowance for climate change and runoff controlled at Greenfield rates (QBAR) can be found in Appendix B.
- 3.3 Drawings HD065-501 NHM Access Road Drainage Layout Sheet 1, HD065-502 NHM Access Road Drainage Layout Sheet 2 and HD065-503 NHM Access Road Drainage Layout Sheet 3 reflecting the Infodrainage calculations can also be found in Appendix B.

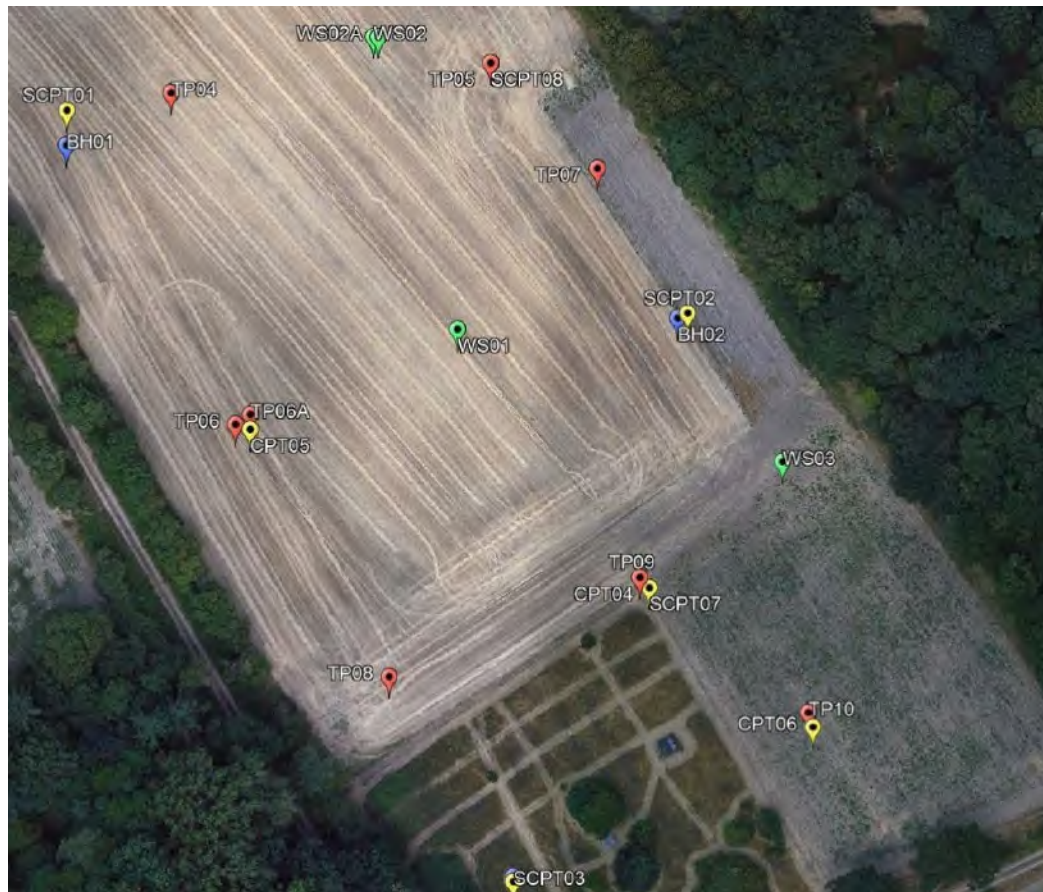
Figure 1 – Ramboll NHM Ground Investigation location

4.1.2 Both reports relate to ground investigations undertaken for the proposed construction of the NHM storage buildings to the south-east of the proposed roundabout and immediately east of the spur road leading south from the proposed roundabout. It is noted that a second interpretative report was prepared by Ramboll (UK) Ltd focused on interpretation of land contamination. This report has not been made available for review, The investigation area and distribution of exploratory holes are shown on Figure 1, below.

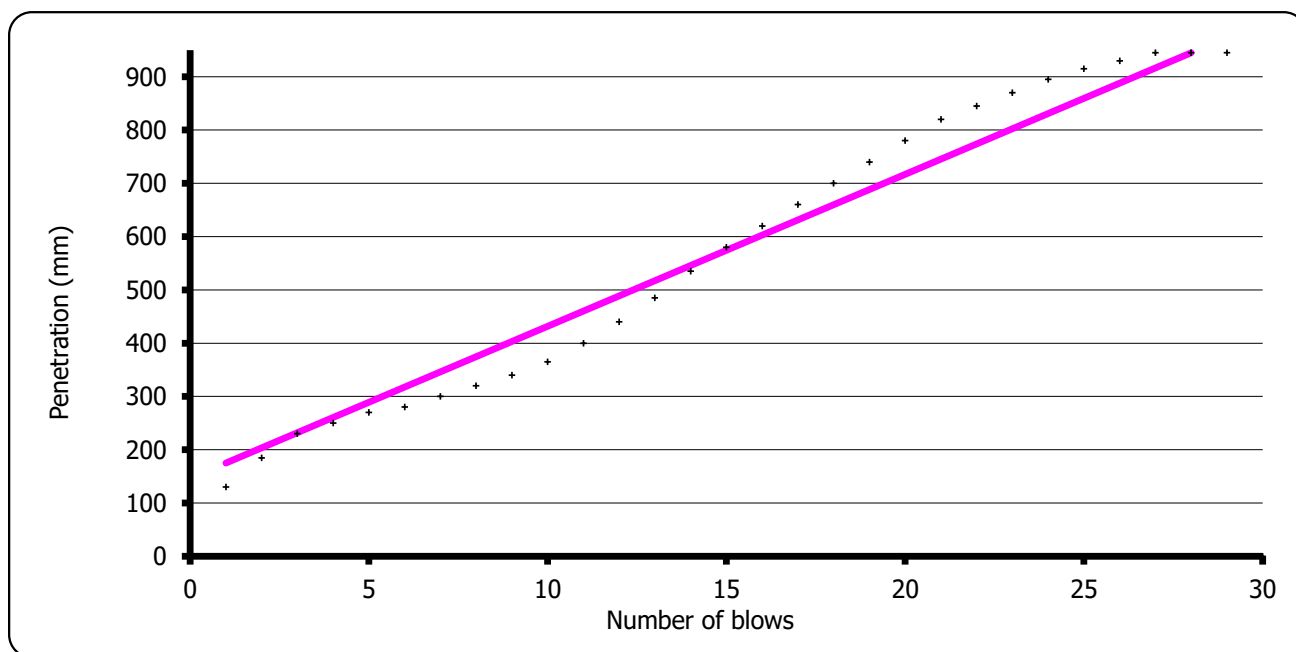
**Rate of Penetration**                      **28.5185 mm/blow**

$$\text{Log}_{10}(\text{CBR}) = 2.48 - 1.057 \text{Log}_{10}(\text{Rate of Penetration})$$

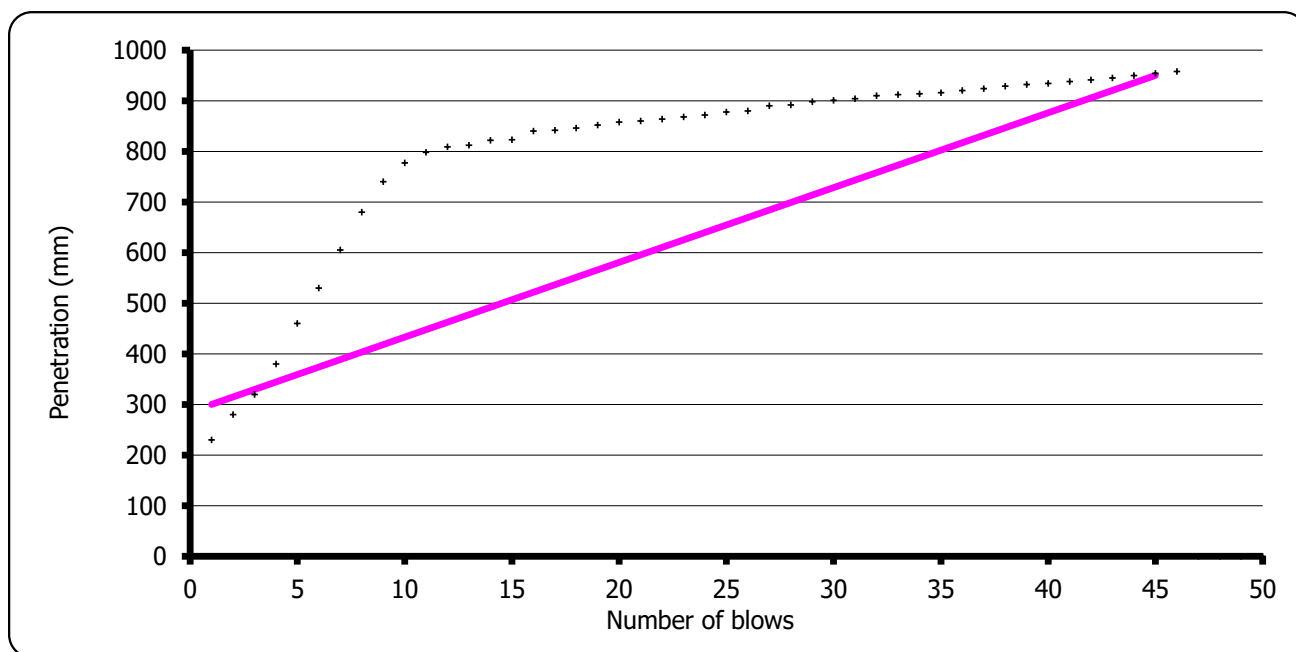
**Rate of Penetration**                      **14.7727 mm/blow**

$$\text{Log}_{10}(\text{CBR}) = 2.48 - 1.057 \text{Log}_{10}(\text{Rate of Penetration})$$

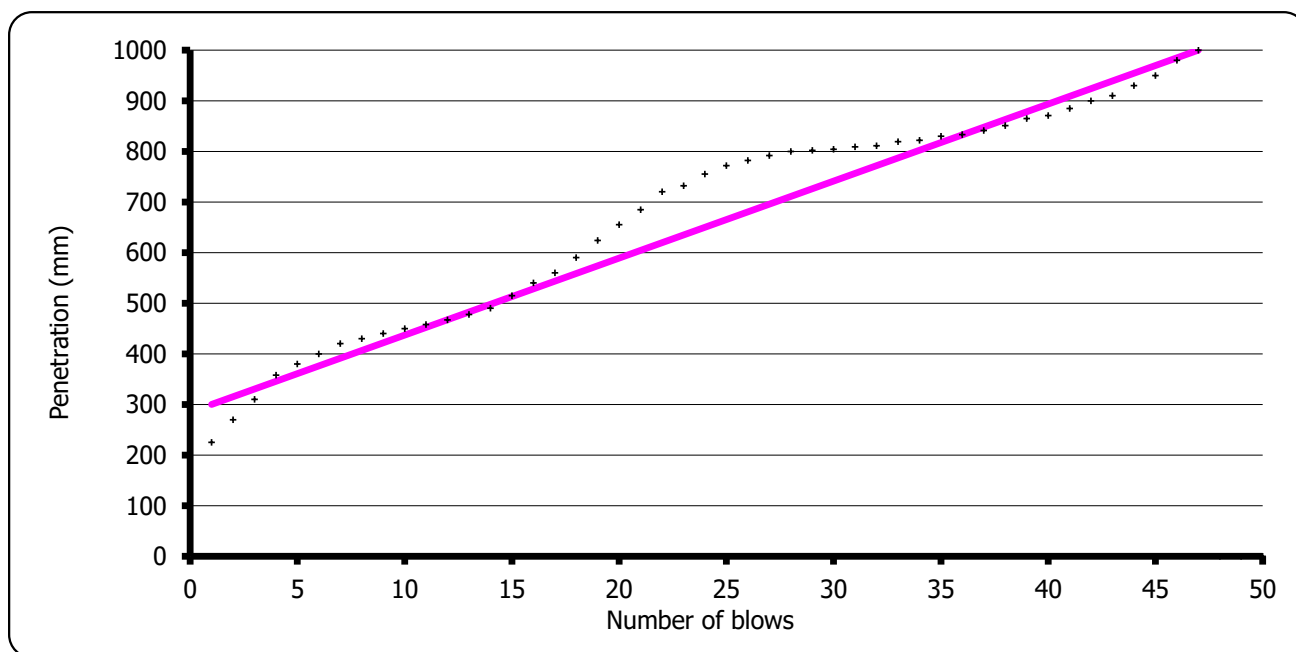
**Client:** RPS Group  
**Client ref:** 794-ENV-GDE-20318  
**Location:** University of Reading  
**Contract Number:** 71315  
**Date tested:** 28/02/2024  
**Test Position:** DCP03  
**Depth (m) :** GL  
**Equipment Used:** TRL - Dynamic Cone Penetrometer 1  
**DCP Cone Angle:** 90°  
**Tested By:** Ashley Davies

**Rate of Penetration**                      **15.2174 mm/blow**

$$\text{Log}_{10}(\text{CBR}) = 2.48 - 1.057 \text{Log}_{10}(\text{Rate of Penetration})$$

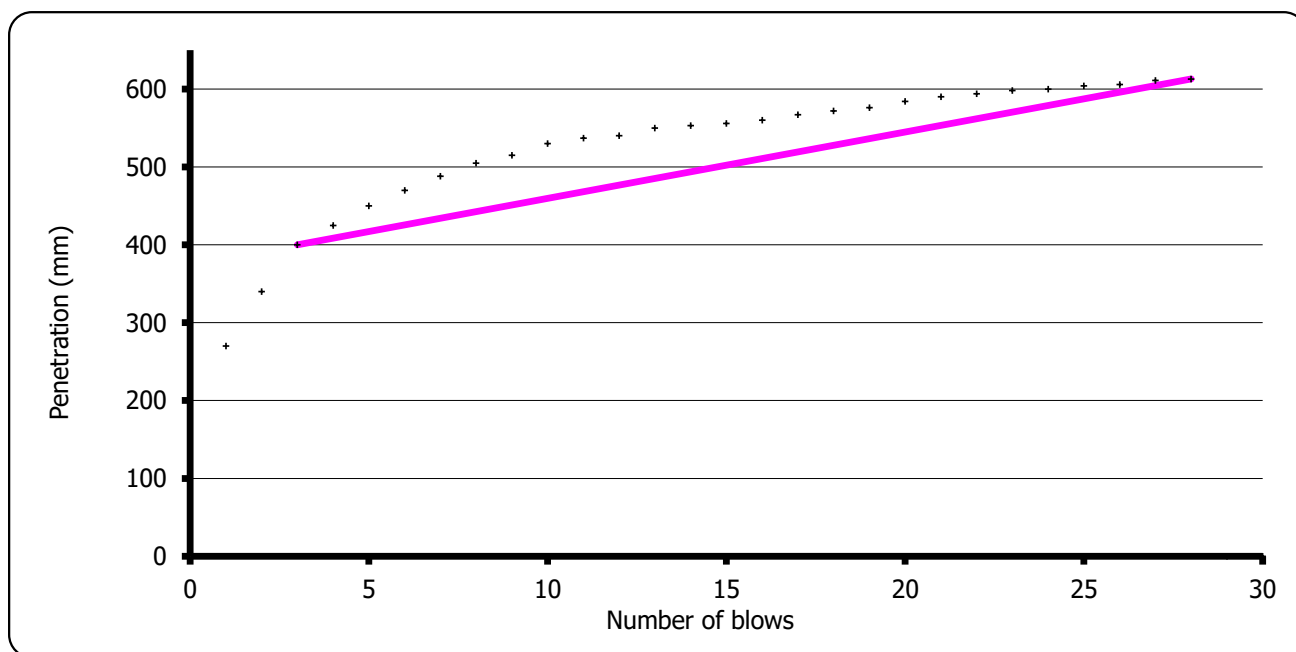
**Rate of Penetration**                      **8.5200 mm/blow**

$$\text{Log}_{10}(\text{CBR}) = 2.48 - 1.057 \text{Log}_{10}(\text{Rate of Penetration})$$

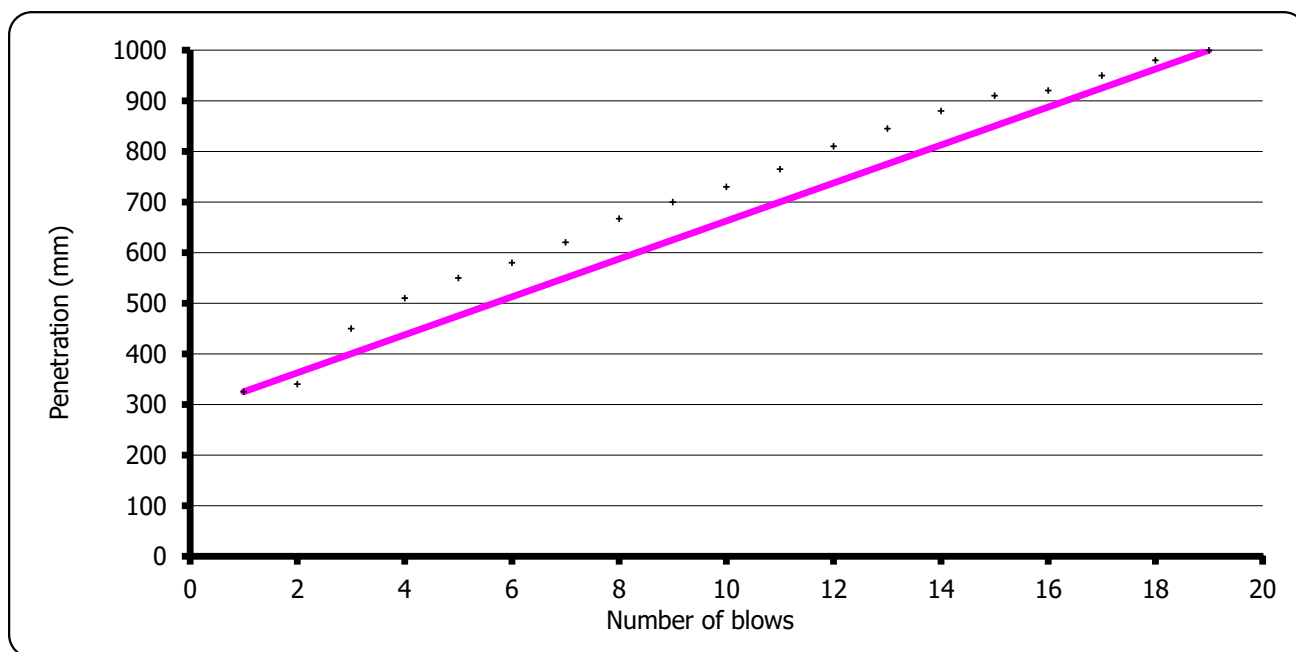
**Client:** RPS Group  
**Client ref:** 794-ENV-GDE-20318  
**Location:** University of Reading  
**Contract Number:** 71315  
**Date tested:** 28/02/2024  
**Test Position:** DCP05  
**Depth (m) :** GL  
**Equipment Used:** TRL - Dynamic Cone Penetrometer 1  
**DCP Cone Angle:** 90°  
**Tested By:** Ashley Davies

**Rate of Penetration**                      **37.5000 mm/blow**

$$\text{Log}_{10}(\text{CBR}) = 2.48 - 1.057 \text{Log}_{10}(\text{Rate of Penetration})$$

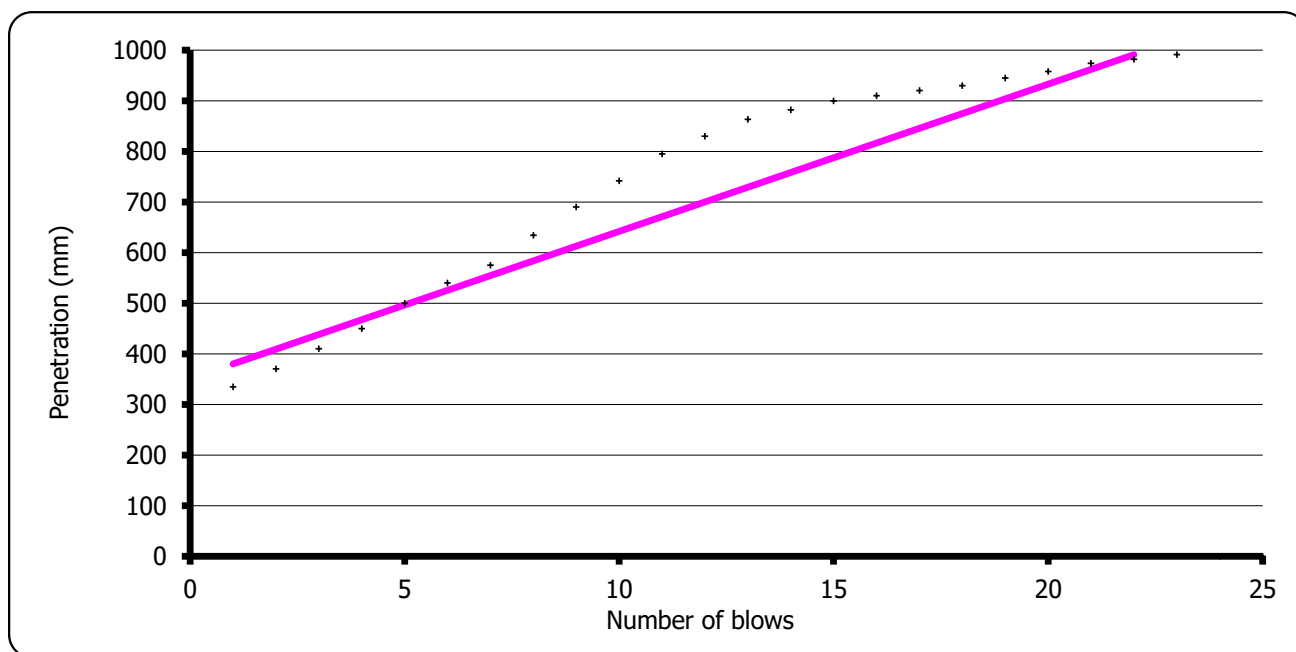
**Rate of Penetration**                      **29.0952 mm/blow**

$$\text{Log}_{10}(\text{CBR}) = 2.48 - 1.057 \text{Log}_{10}(\text{Rate of Penetration})$$

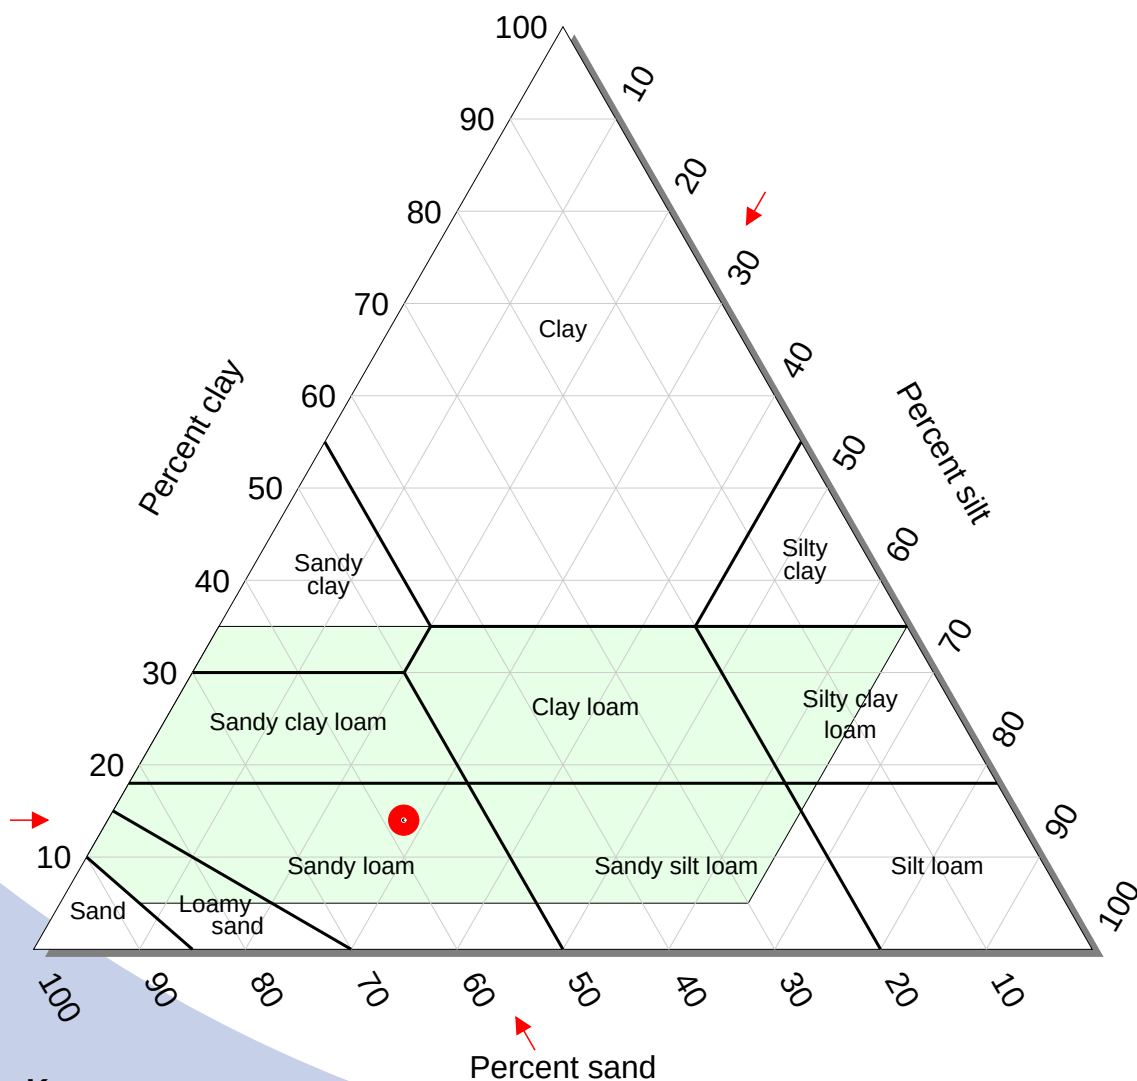
**Fig. 1. Textural Class: Sandy Loam (compliant)**

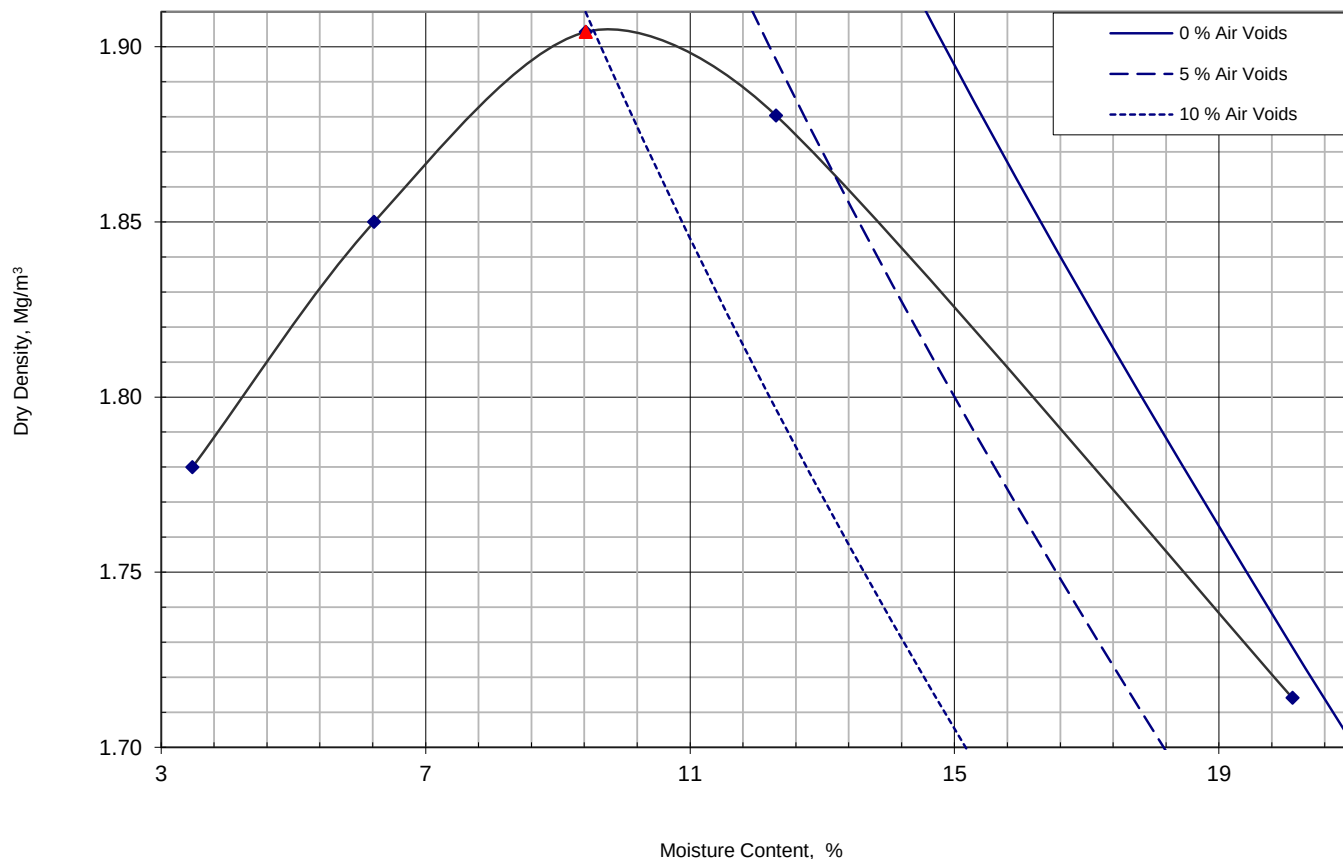
| Compaction Clause | BS1377:Part 4:1990, Clause 3.3 | Sample Type | B |
| Sample Description | Brown fine to medium gravelly sandy silty CLAY | Single or Separate Sample Used | Single |

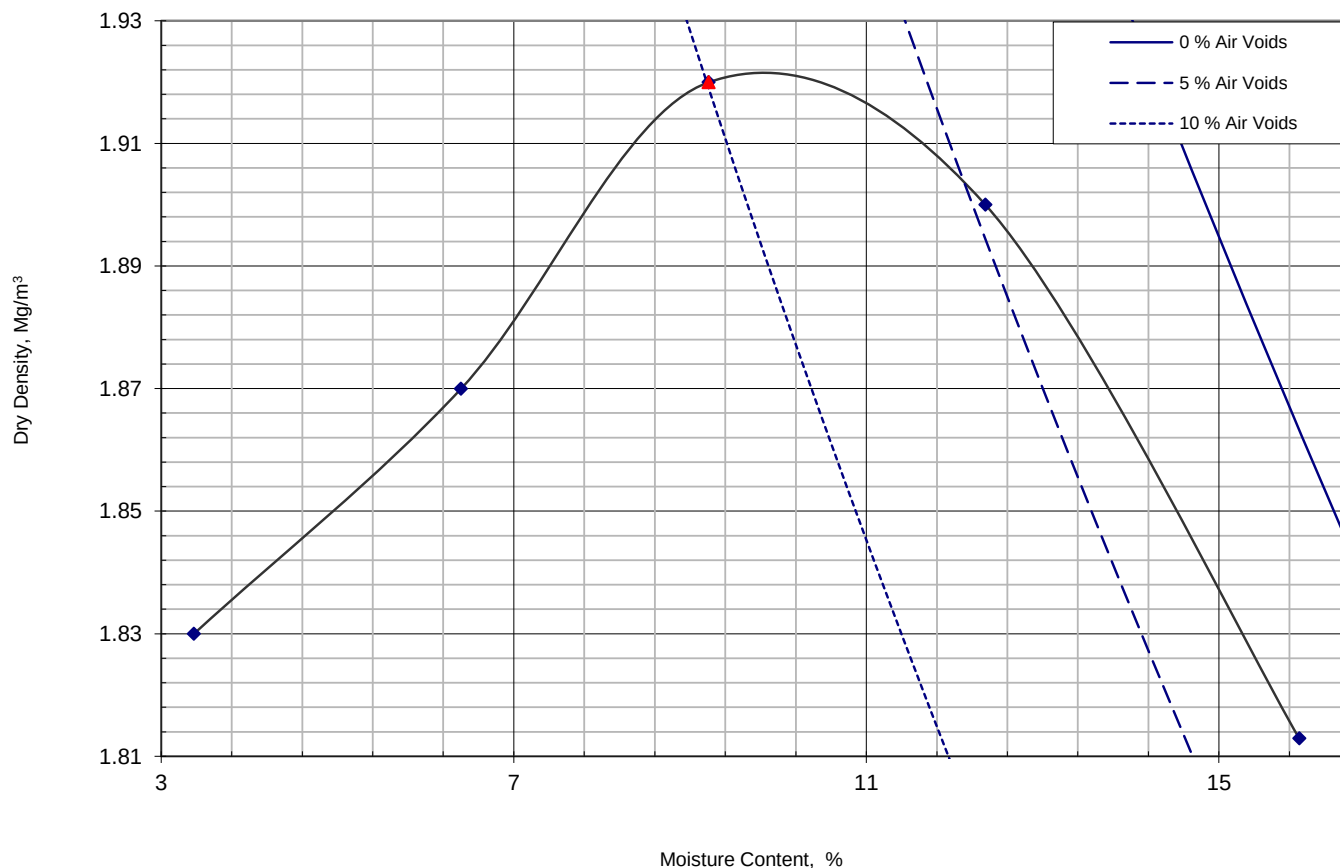
| Compaction Clause | BS1377:Part 4:1990, Clause 3.3 | Sample Type | B |
| Sample Description | Brown fine to coarse gravelly sandy CLAY | Single or Separate Sample Used | Single |

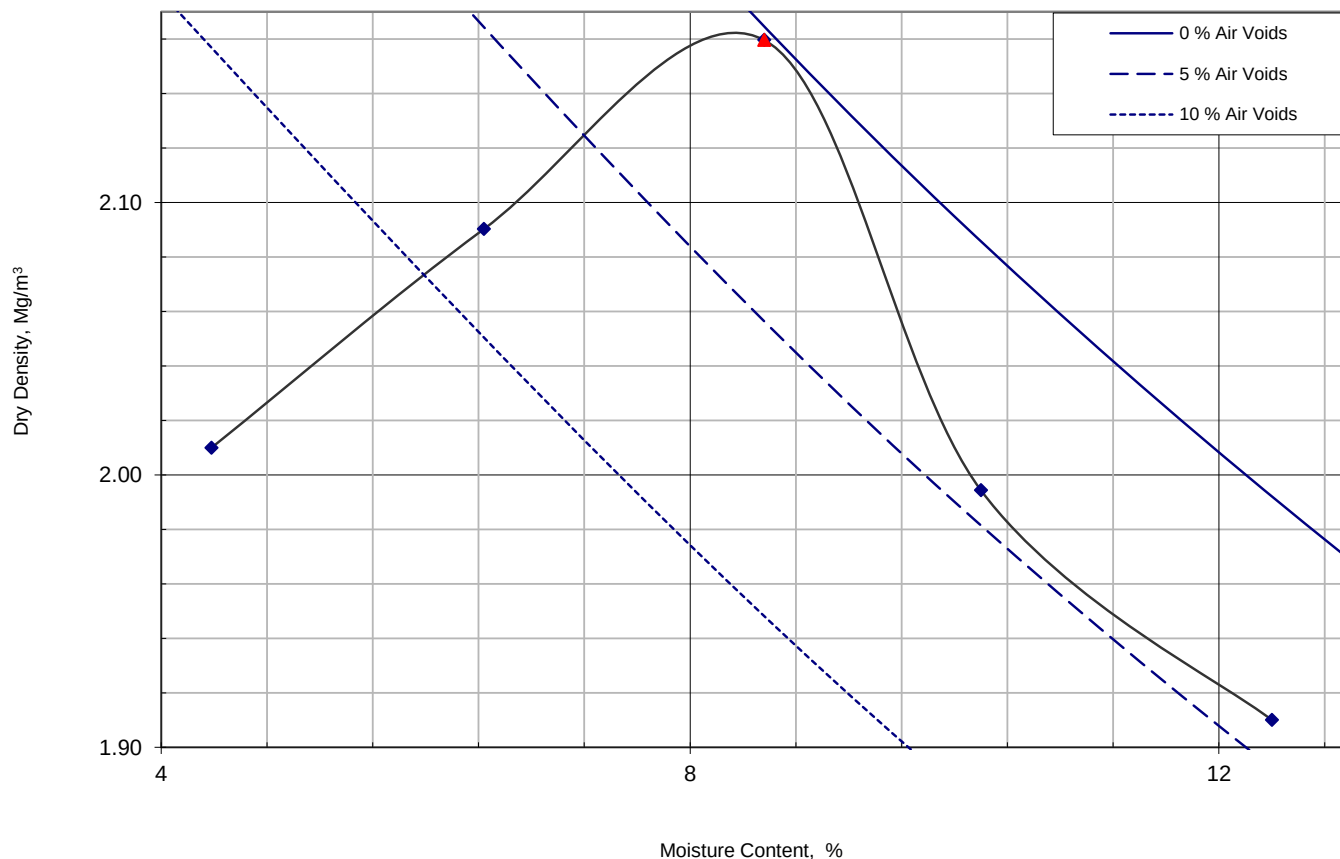
| Compaction Clause | BS1377:Part 4:1990, Clause 3.5 | Sample Type | B |
| Sample Description | Brown slightly silty/ clayey fine to coarse sandy fine to coarse GRAVEL | Single or Separate Sample Used | Single |
