**From:** [REDACTED]  
**Date:** 4 December 2024 at 09:05:48 GMT  
**To:** [REDACTED]  
**Subject:** RE: Photos - 1 of 2

Thanks for sending photos over. I would definitely recommend this tree is removed. It seems unlikely that the roots have yet reached underneath the foundations, but they will do if the tree is left to grow.

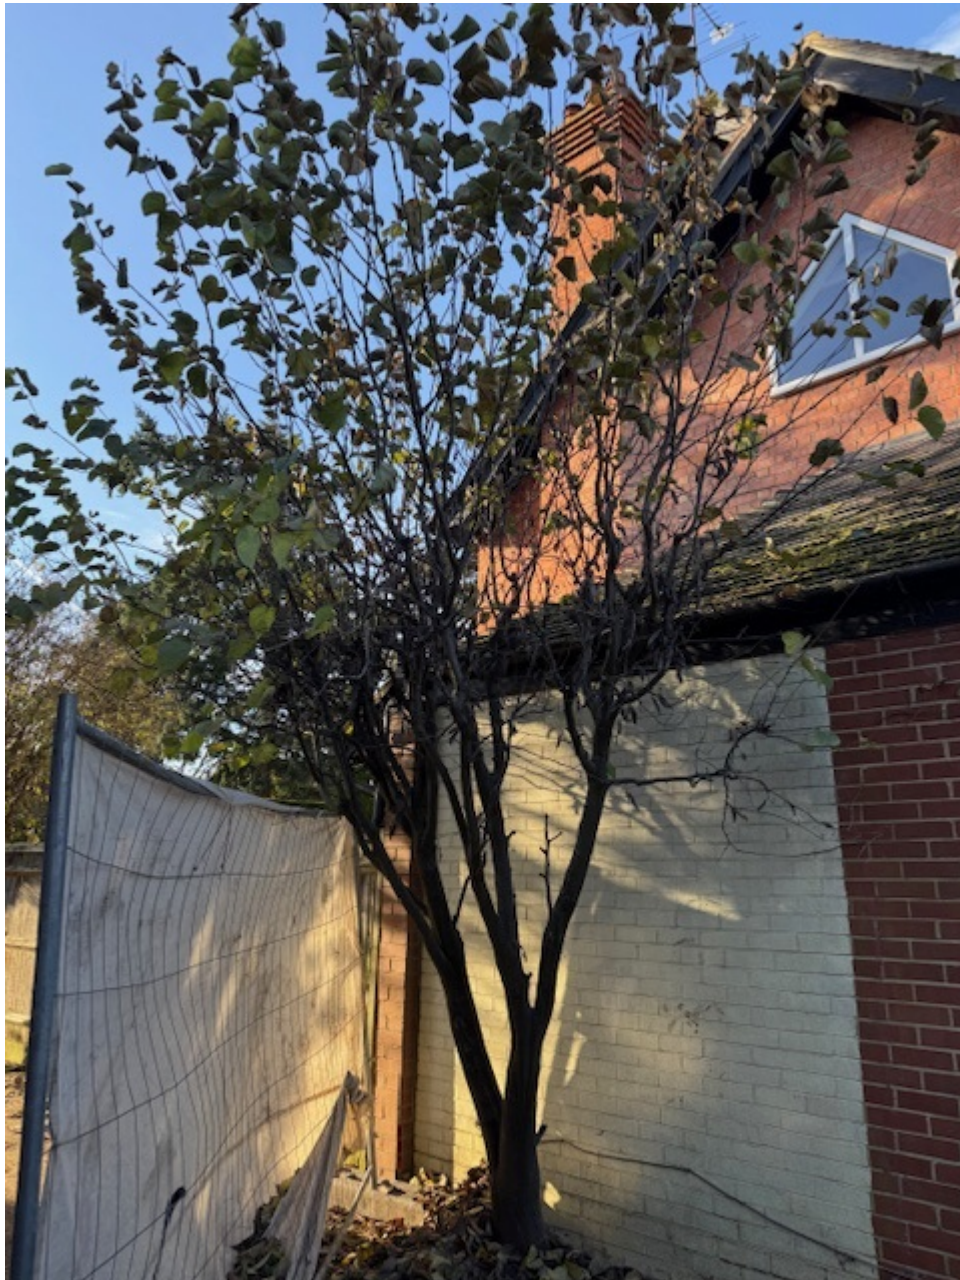
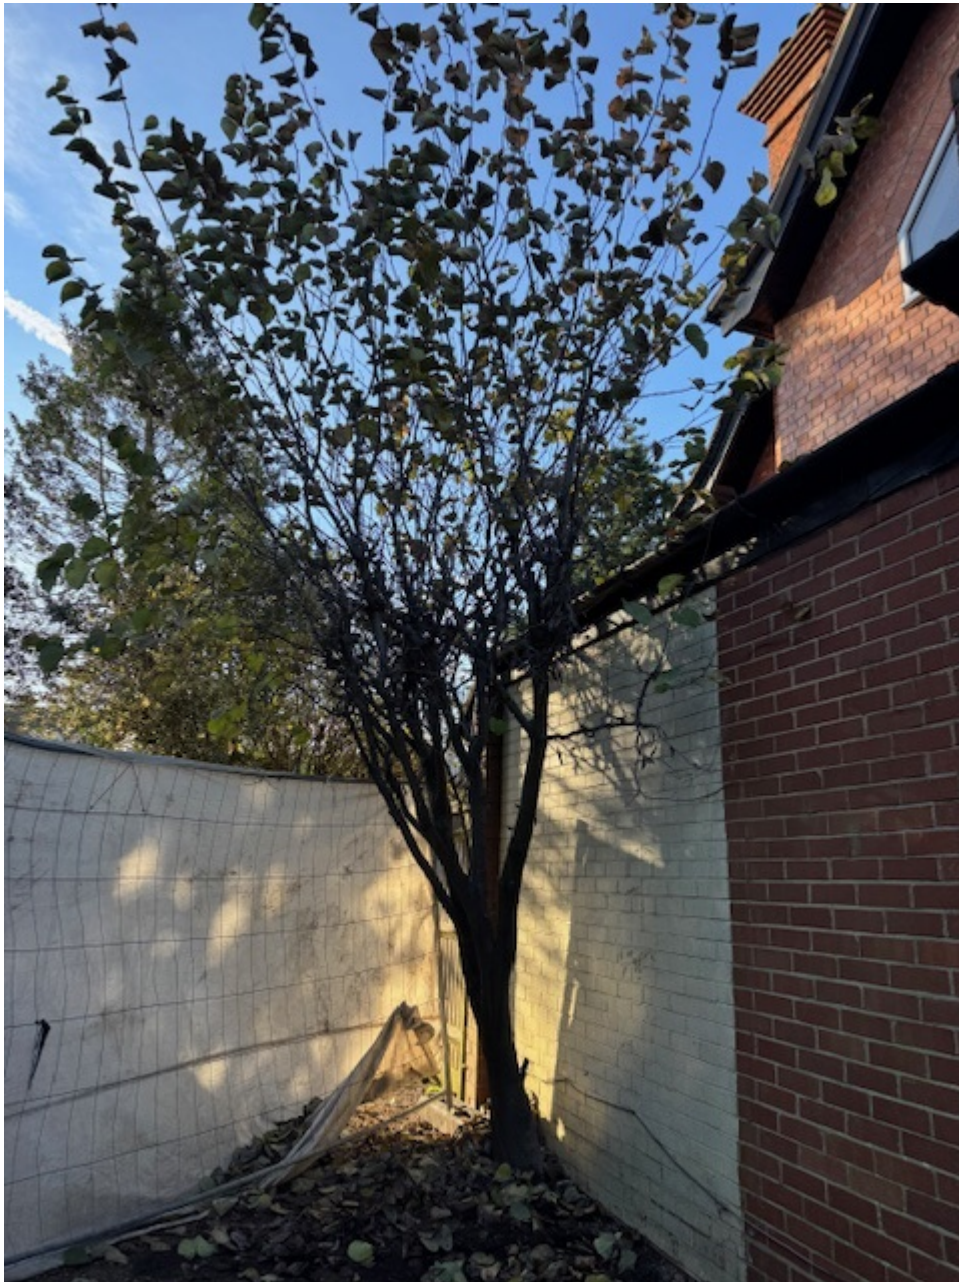
Given the proximity to the wall, it may be difficult to remove the stump without damaging the wall or its foundations. I would recommend the tree is cut down by a competent tree surgeon and the stump is killed.

As per my email last night, please find below a couple of photos of the tree. I've been struggling to send them so I'm sending across a couple of emails. From these photos and your understanding of the foundations, it would be good to understand if you thought the tree could be safely we moved, and in doing so if we would prevent the potential for damage to the next door neighbours foundations in the future.
