# The Old Cottage

Pearson Road, Sonning, RG4 6UH

## Heritage Statement & Design and Access Statement for Proposed Internal Alterations to West Wing

Document No: 1362-HR-A-HS-XX-02  
Rev 02

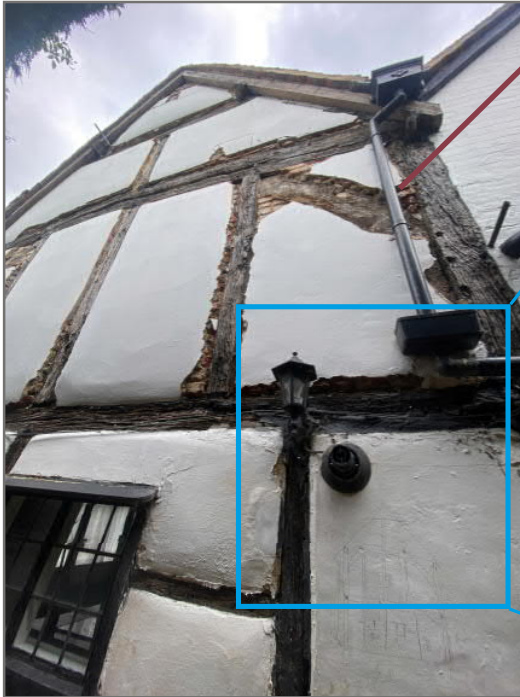
Image 05a: View of West gable

Rainwater downpipe proposed to be replaced with one single vertical length - intermediate hopper to be removed

The removal of rainwater from the West gable current takes a convoluted route across the West elevation at First Floor level, around to the return rear elevation of the Phase 3 construction, previously diverted over what had been the 'boiler house' - since removed under permission 260838. It is proposed to replace the black plastic downpipes and associated hoppers (refer to Images 5a and b, 6 and 7) with aluminium. The rainwater pipes would be removed where redundant.

The replacement of the pipe that ran above the boiler house would create a single vertical drop, whose rainwater would be piped to the existing drainage system at ground level. Where new rainwater goods are proposed the replacement material would be aluminium, painted green as per Image 22, and as agreed with the Conservation Officer to the remainder of the house.

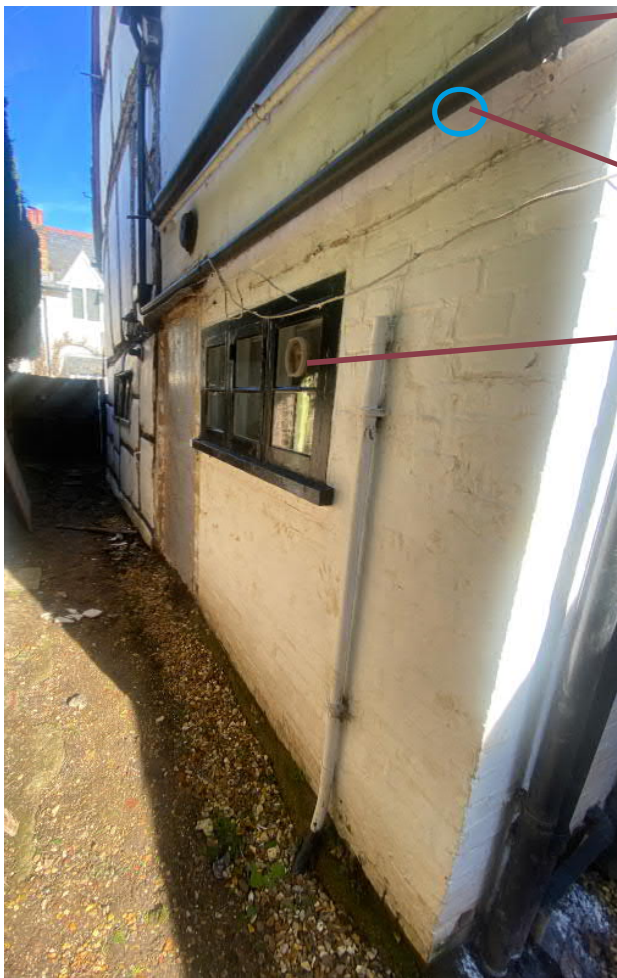
Image 06: View of south elevation of west gable return

Rainwater pipe proposed to be removed

Vent to be removed and glass to be replaced

Hopper and downpipes to be removed and glass to be removed

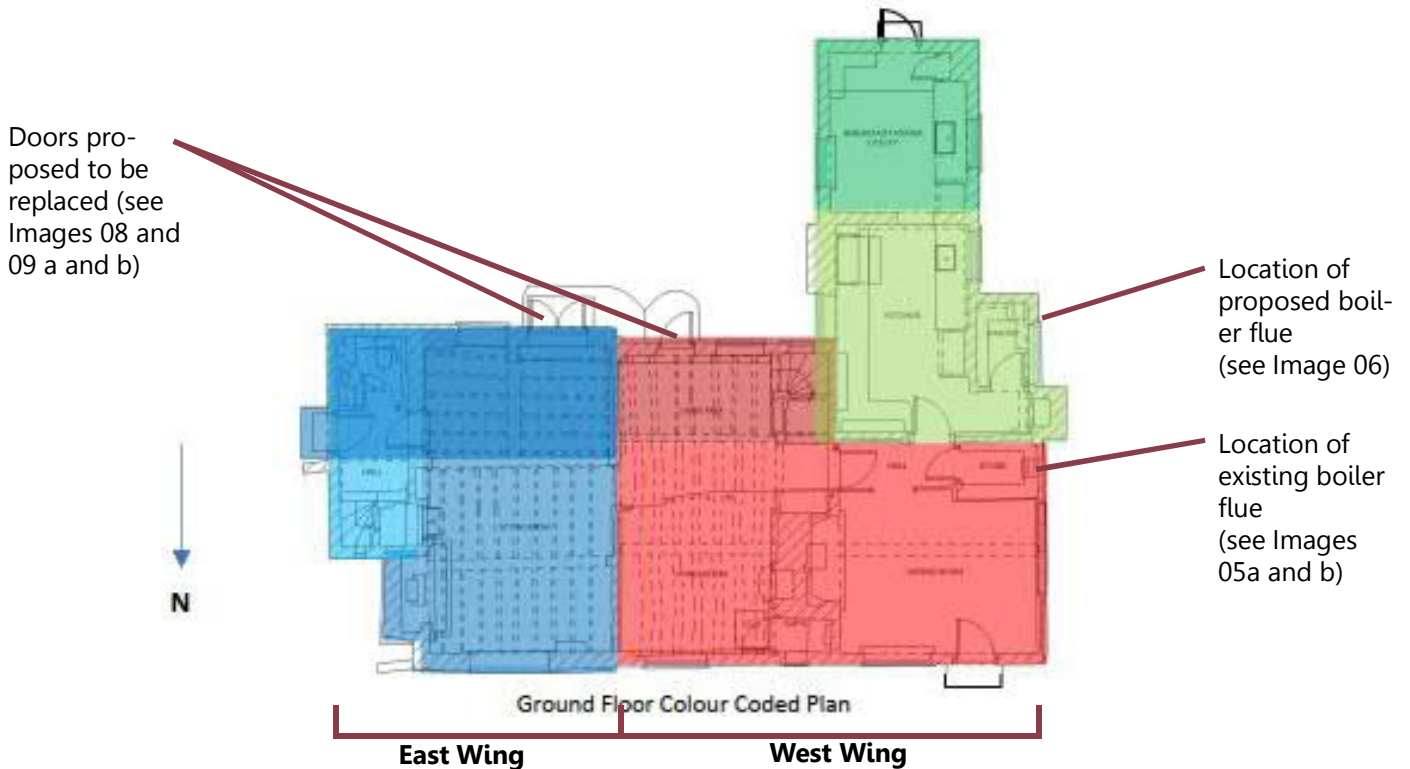
Image 10: Extract from the Heritage Statement showing the Phases of construction colour coded (Workman, 2023)

The existing boiler flue is within the Phase 1 construction (likely 15th century, possibly 14th century); the location for the proposed boiler flue is within the Phase 3 - early-mid C20. Phase 2 is shown in blue, dated by Workman to be 'likely 18th-19th century' construction.

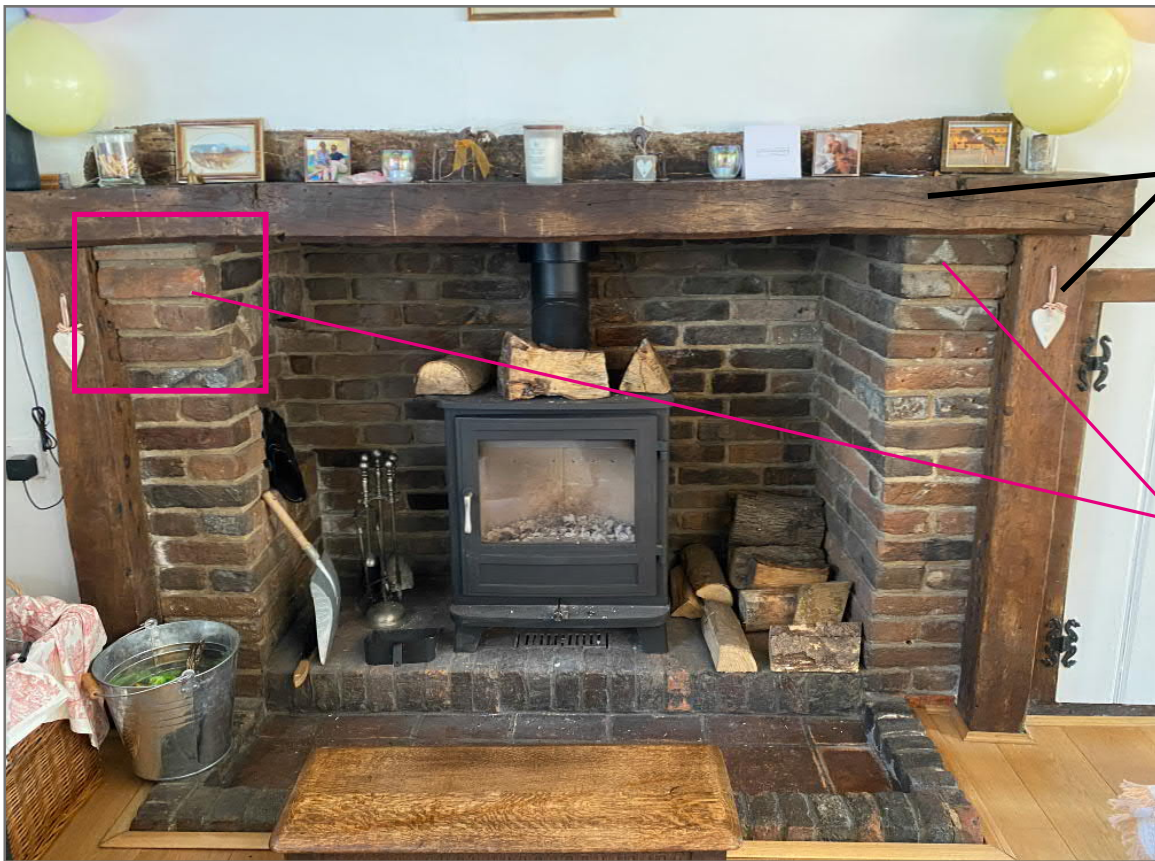
Image 12a: Existing fireplace to Ground Floor (East Wing) with modern brickwork and lintel

Proposal to remove modern lintel and decorative vertical posts

Cut back the corbelled brick detail to both sides, and finish with lime mortar - refer to Image 12b, below

The fireplace to the Living Room (East wing) has been introduced in the late C20: the modern brick and cement mortar will trap excessive moisture in the historic fabric behind. The modern timber mantelpiece and associated posts are proposed to be removed, and the corbelled brickwork supporting the mantel piece (refer to Image 11b) proposed to be cut back to align the brickwork vertically. The fireplace brickwork opening shall be finished with lime mortar and painted with breathable paint.

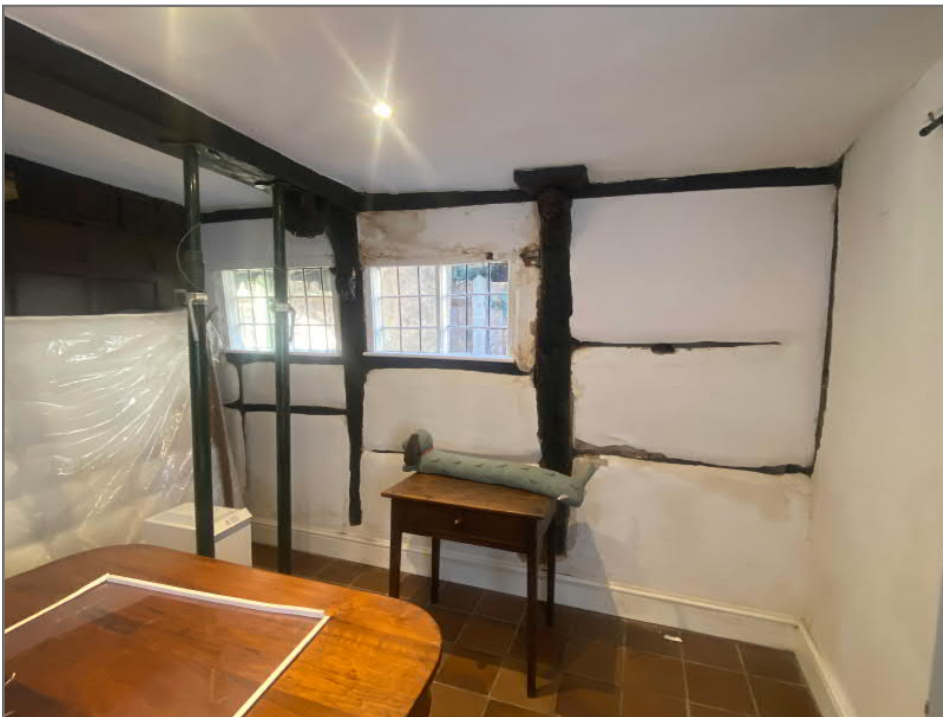
Image 13: Exposed internal timber construction to the Ground Floor West gable: proposal to remove all modern impervious paints and varnish to all historic timbers using soda blasting

Removal of modern impervious paint and varnish to all historic timbers using chemical poultice and sodium bicarbonate - as successfully achieved to the East Wing using the 'soft strip process' approved under application 240507 (the discharge of Condition 3 for listed building application 232299 for internal works to the East wing).

Exposed timbers on the first floor are generally painted with impervious black paint whilst the ground floor timbers are either stained and/or varnished. The finishes are very disfiguring and potentially harmful to the historic timbers over the longer term as these coatings used in the past lack suitable vapour permeability which can lead to timber decay as has been evidenced by the heritage surveyor and engineer in relation to the timbers.

Impervious bituminous black paints used historically, and modern acrylic or alkyd resin-based paints/varnishes in recent past are now understood to trap excessive moisture. It is not considered appropriate to leave such modern coatings in situ due to the risk of raised humidity within the timber and potential wood boring insect attack.

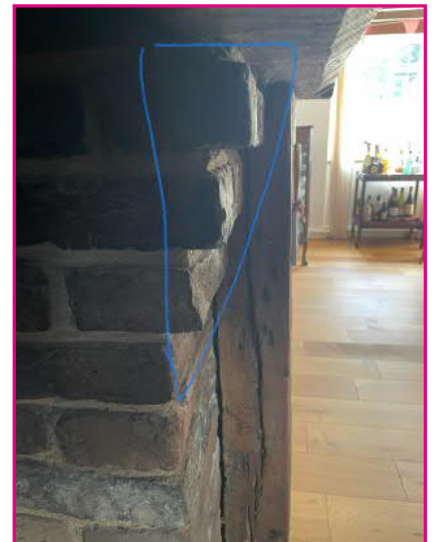
Image 12b: Blue outline shows the corbelled modern bricks - supporting the modern mantelpiece - to be cut back prior to applying a lime plaster finish

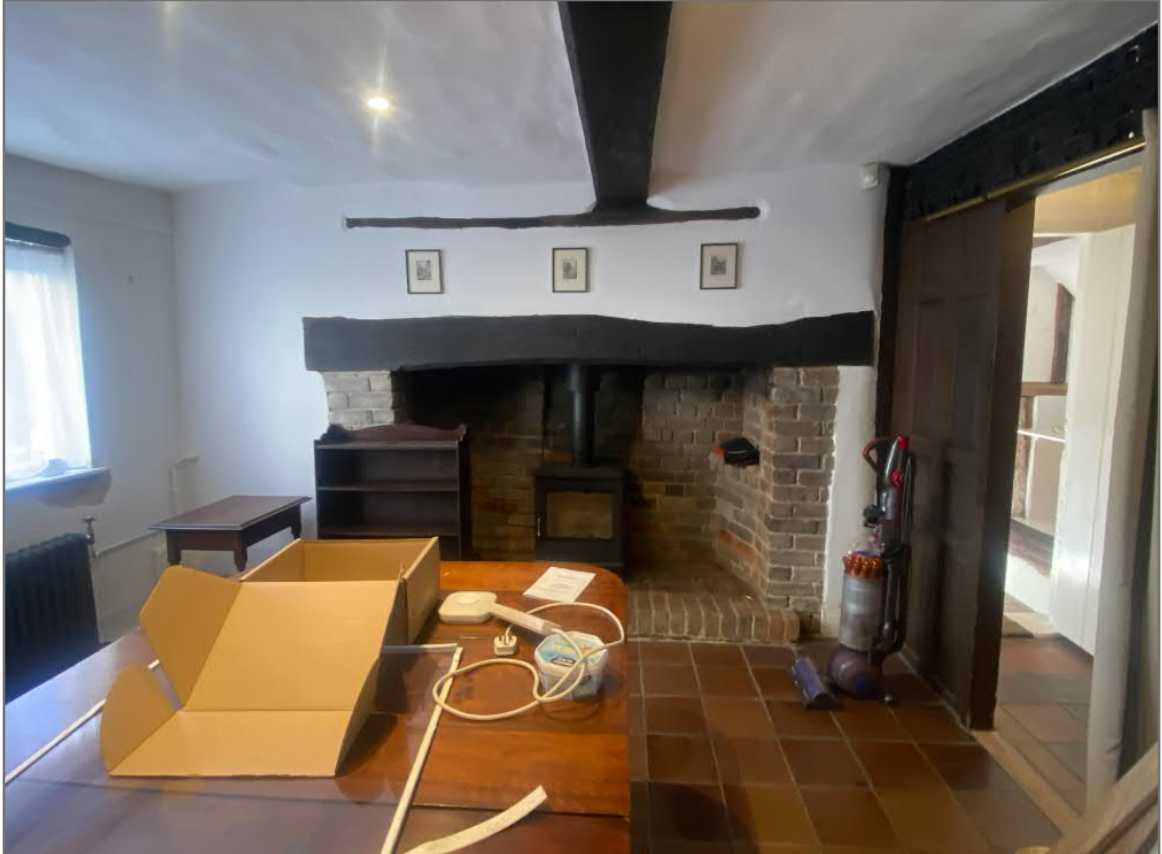
Image 14: Exposed internal timber construction to the Ground Floor West gable (typical): proposal to remove all modern impervious paints and varnish to all historic timbers using soda blasting

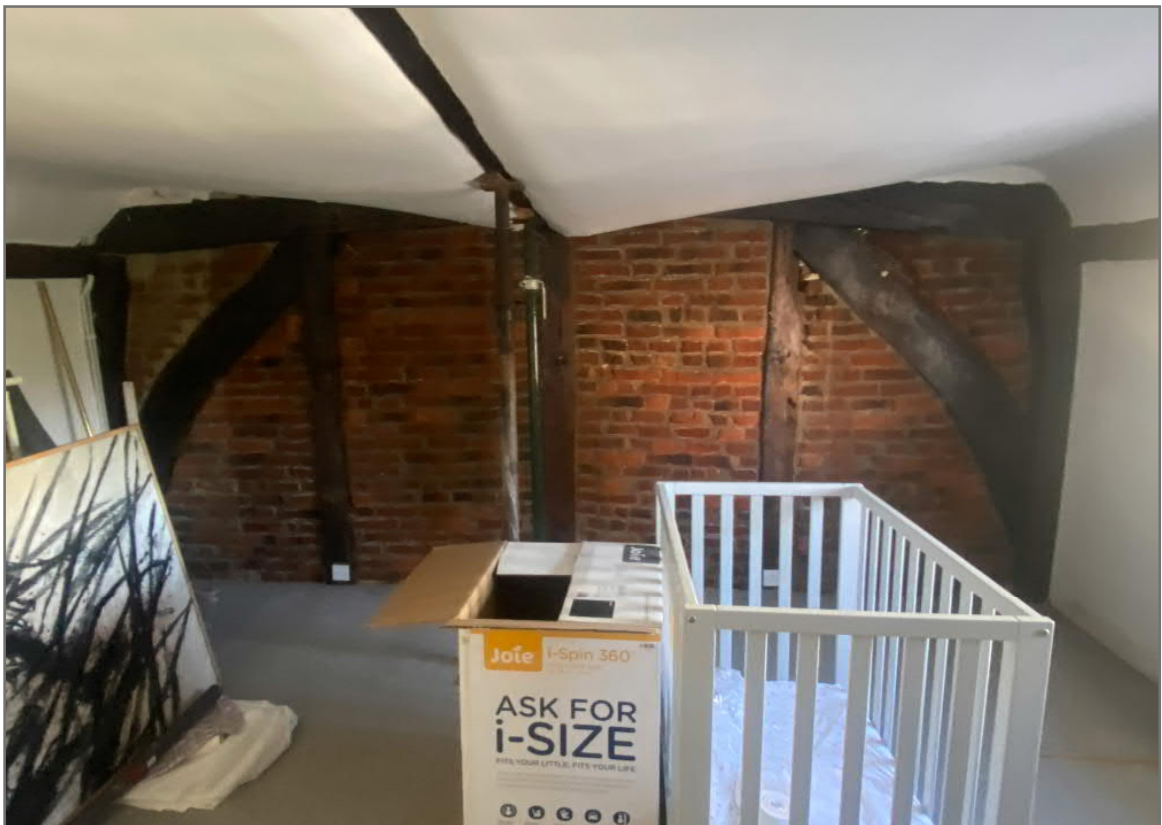
Image 15: Exposed internal timber construction to the First Floor West gable (typical): proposal to remove all modern impervious paints and varnish to all historic timbers using soda blasting

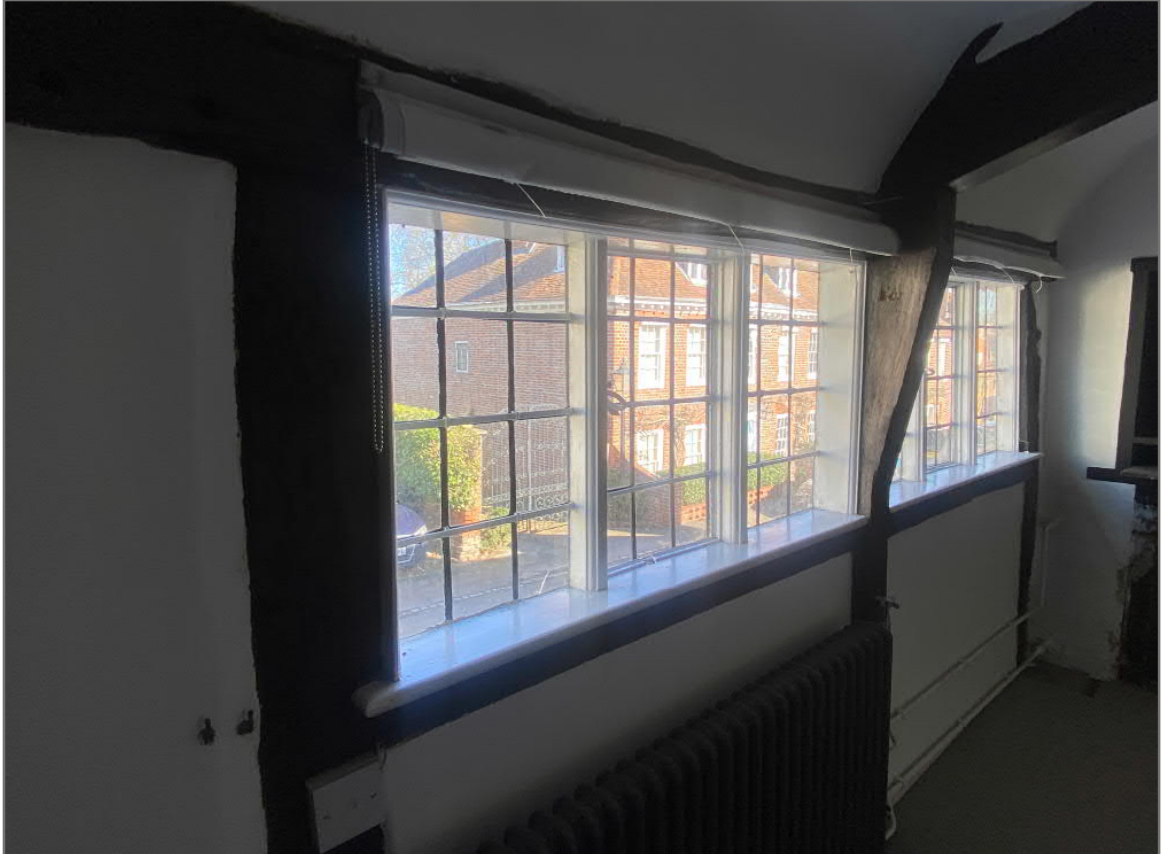
Image 16: Exposed internal timber construction to the First Floor North elevation (typical); proposal to remove all modern impervious paints and varnish to all historic timbers using soda blasting

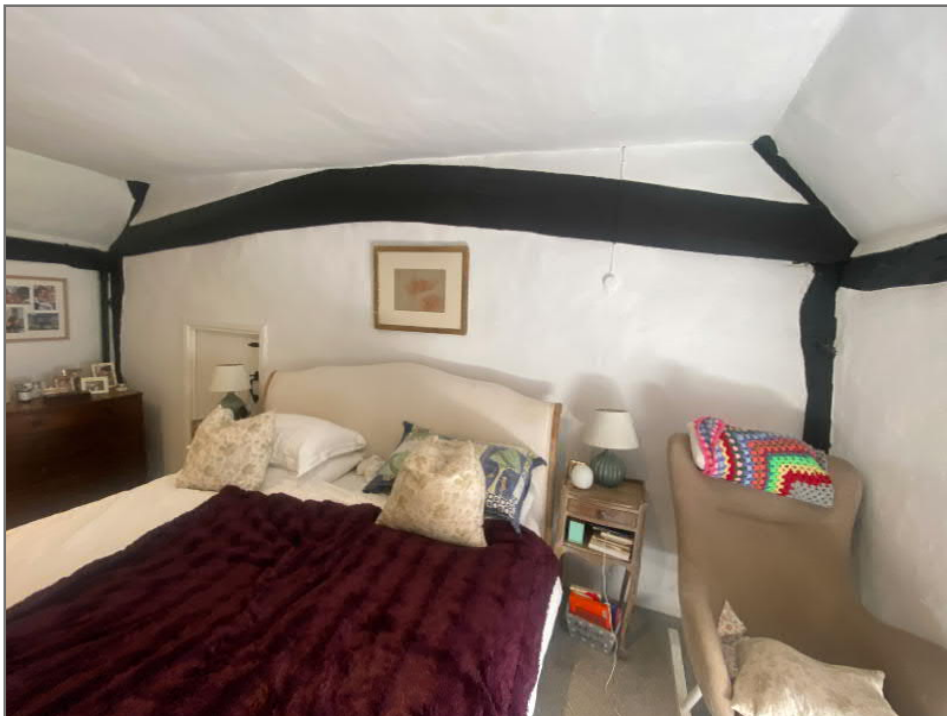
Image 17: Exposed internal timber construction to the First Floor Master Bedroom: proposal to remove all modern impervious paints and varnish to all historic timbers using soda blasting

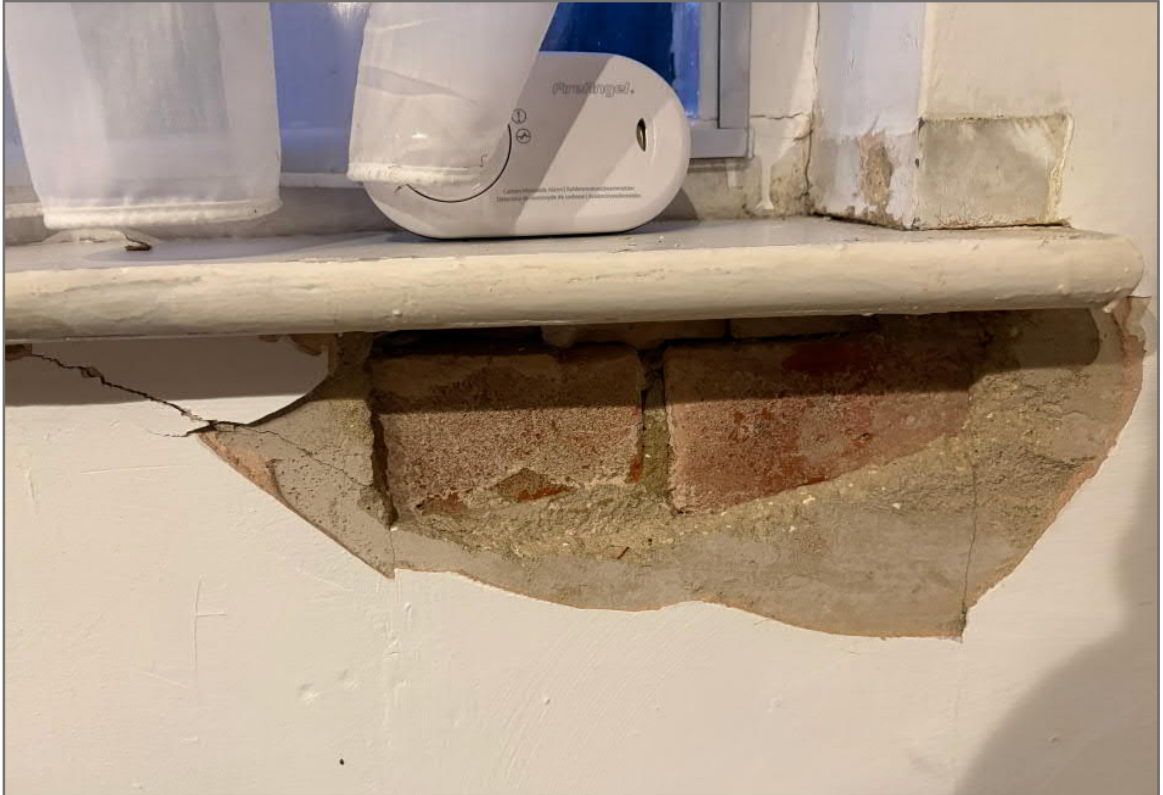
Image 18: Exposed brickwork to the First Floor Master Bedroom: proposed to infilled with lime plaster

Retain all historic lime plaster where possible, repair as required with non-hydraulic lime plaster like for like. This includes the repairing the lime plaster to the brick infill in the Master Bedroom - refer to Image 19.

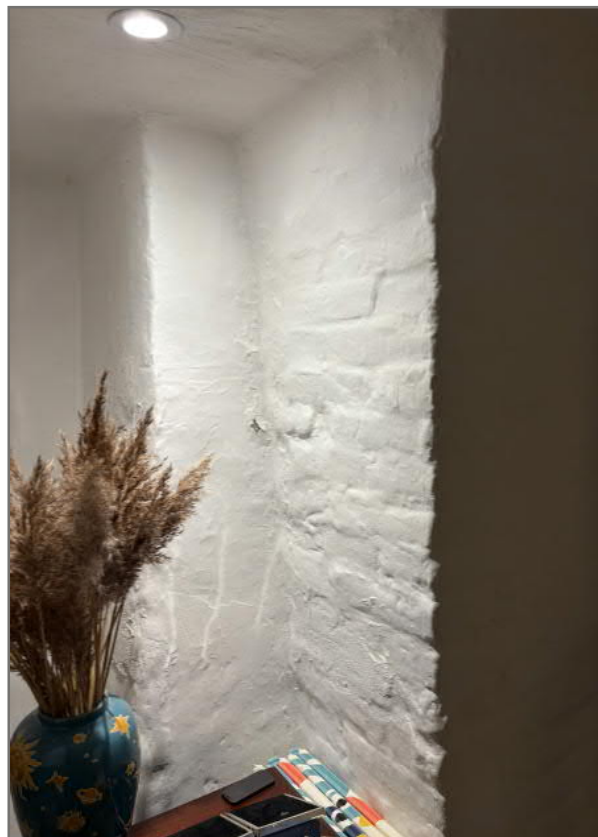
Image 19: Example of area proposed for masonry cleaning

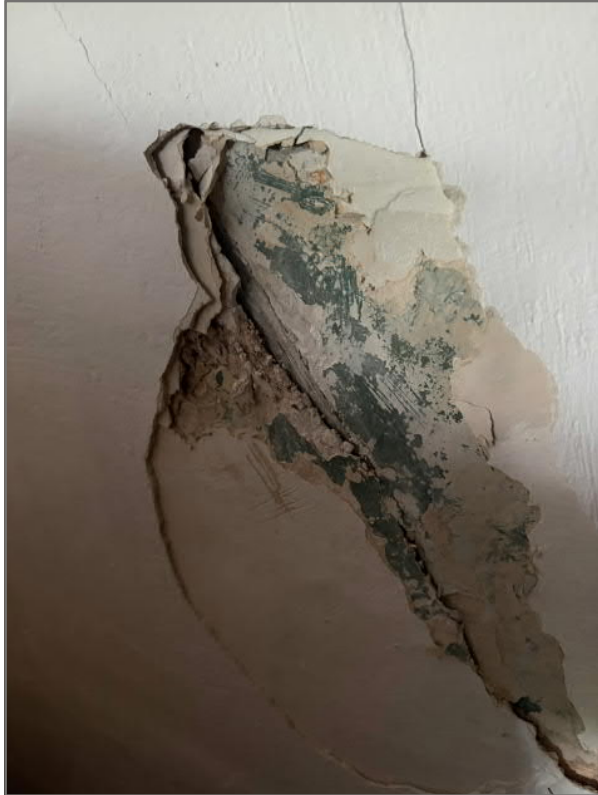
Image 20: Example of wall condition where the proposal is to strip wallpaper where historic lime plaster exists and repair historic lime plaster on a like-for-like basis.

Strip modern wallpaper where historic lime plaster exists and repair historic lime plaster on like for like basis.

It is not considered this proposal requires listed building consent in itself but has been included for the record of works being undertaken to conserve the building. The wallpaper is likely to have conserved historic plaster underneath and removal is proposed to assess underlying condition and so

4.3.3 lime plaster repairs can be progressed on a like for like basis.

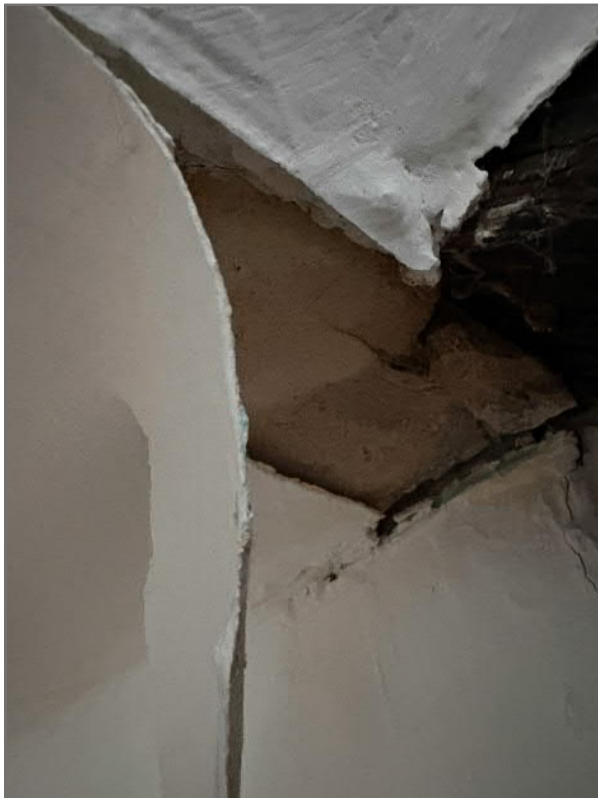
Image 21: Proposal to remove of cement and gypsum materials and replace with a vapour-permeable build-up, or split laths, as appropriate, ready for lime plastering.

Removal of any modern cement pointing and cement/gypsum plaster to all historic masonry. Carefully remove any modern plasterboard/gypsum skim and replace with vapour permeable board/split laths as required ready for lime plastering.

Once the existing modern paint, varnish and wallpaper coatings are removed from the fabric it is expected areas of modern fabric; impervious cement pointing, cement/gypsum plaster and plaster board will be found predominantly on the Ground Floor. It is proposed these materials are removed to enable the building to dry out, restore vapour permeability and enable further repair works to progress.

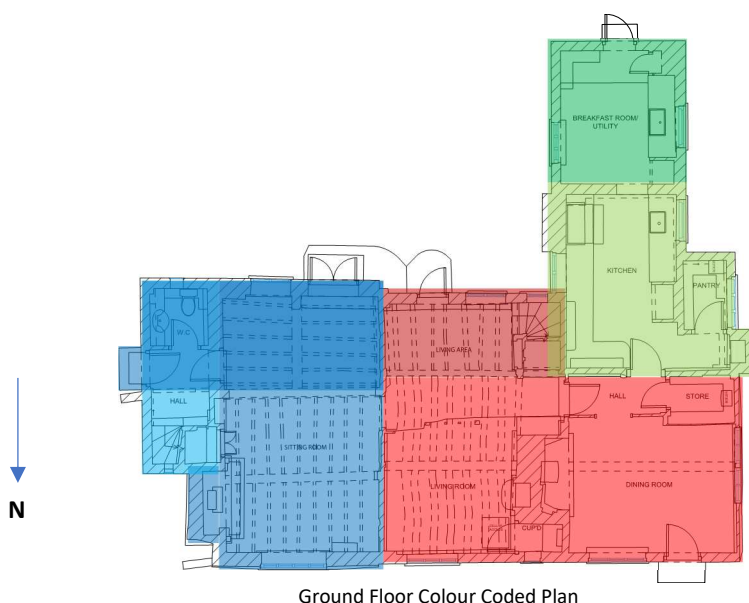
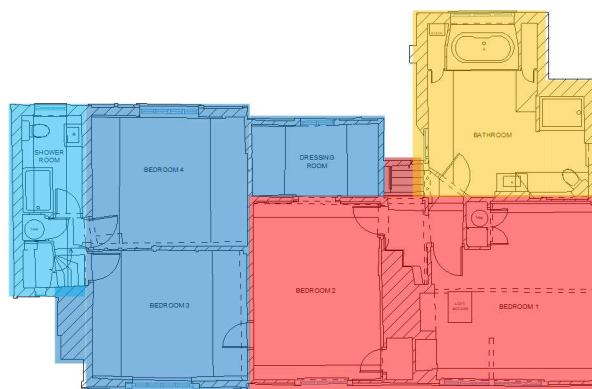
Phase 1: likely C15<sup>th</sup> (possible C14<sup>th</sup>). Predominantly timber framed with smoke blackened and scissor truss roof. The rear 'living area' ground floor element originally with a cat-slide roof may be a slightly later addition or contemporary to this original phase. The dressing room element on first floor is a later phase of historic alteration which likely removed the earlier cat slide roof some of which remains above the staircase. The central chimney stack, floors and ceilings would appear to be later insertion to the primary phase. The primary timber framing to the ground floor in front elevation has been lost and under built in brick, some of which appears to be C20<sup>th</sup> rebuild. It is possible wattle and daub infill panels may still exist within the primary phase but the majority do appear to have been rebuilt in brick.

At present we have limited information on the construction phasing at The Old Cottage. However, based on the historic mapping, inspection of the measured survey and architectural features onsite the current layout would accord with the property having been two separate cottages as indicated by the historic OS mapping and given the awkwardly low access door between bedrooms 2 and 3. Albeit the property may have been one unit without interconnection at first floor when the eastern wing (Phase 2) was initially built.
