Heritage Assessment- Front Rooms and Staircase

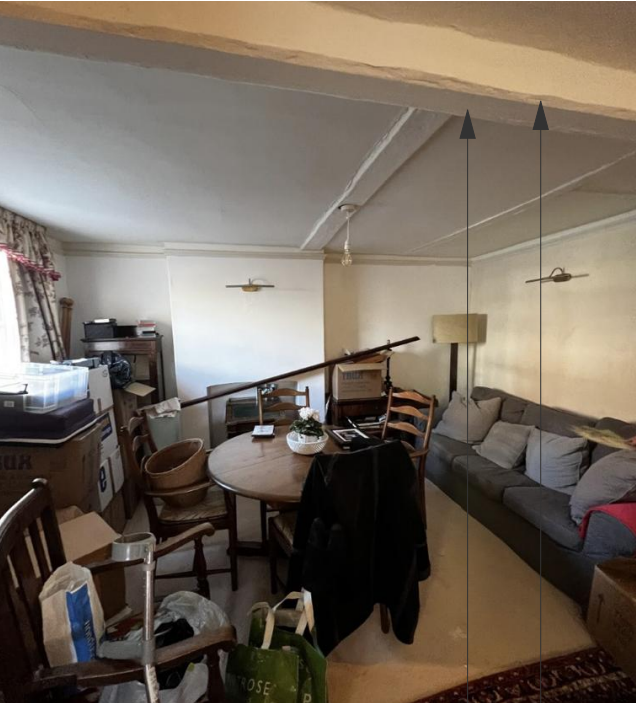
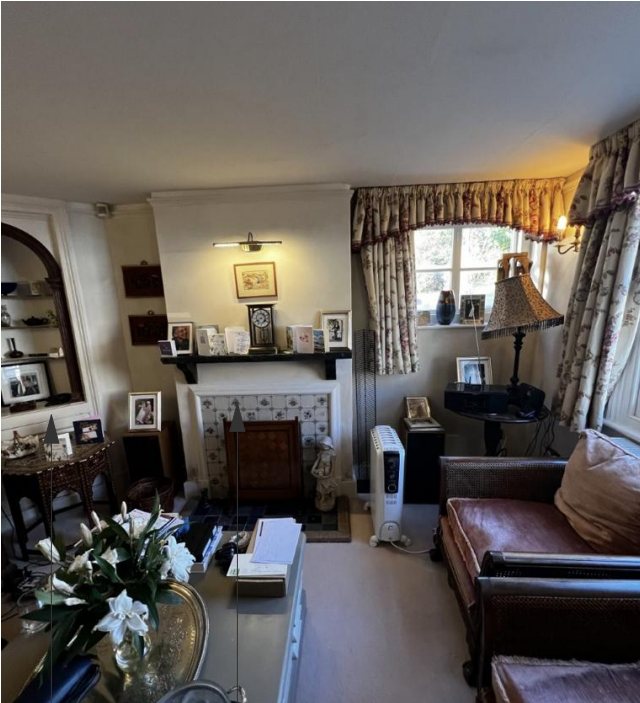
The house features two front receptions rooms with a fireplace each side. Both fireplaces are no longer in use. There are exposed timber joists to the ceiling which have been painted over and a central access door to the rear. Additionally, it is possible to see what is the presumed location of the original staircase and partitions from the cuts in the ceiling.

The existing staircase is carpetted, with timber hand railing to one side and is presumed to have been added as part of the later addition flat roof extension.

- Tiled fireplace
- Alcove detail. Presumed location of original fireplace
- Presumed location of 18th century staircase
- Original timber joists painted white. Presumed location of partition that separated the two front rooms.

Previous condition 9 “Fireplace Alteration / Installation of Wood Burner Stove Notwithstanding the details submitted no works are to be undertaken to alter fireplace to the ground floor front room for the install a wood burner stove until details of the alteration to the fireplace including provision of liner to the flue for the wood burner stove have been submitted to and approved in writing by the local planning authority.”

- o Line the existing flue
- o Retain the existing chimney pot design, of it this is not possible replace with a pot of the same design
- o Remove the existing tile surround with timber architrave. And plaster over with heat retardant plaster
- o Remove the existing slate hearth stone and replace with a larger hearth

Install a new stove in front of the existing opening with a rear flue extending into the existing opening and connecting to the new flue

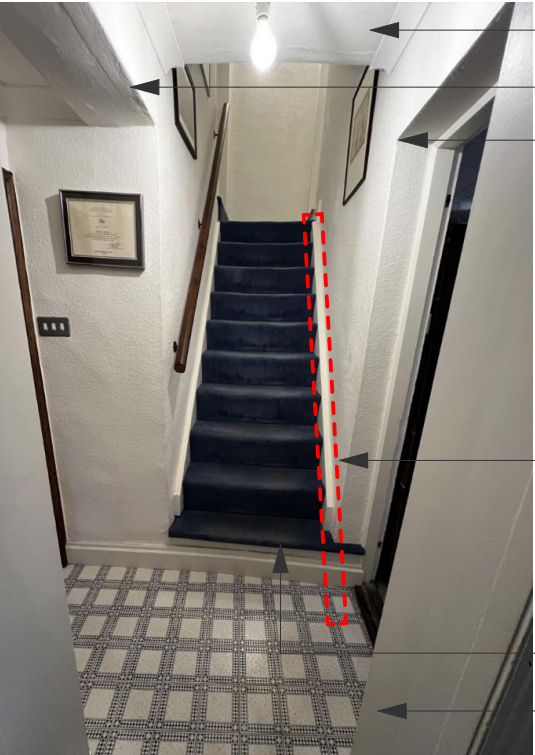
- Existing landing above which causes steep steps
- Original wall
- Presumed late 20th century wall opening for flat roof extension
- Proposed stair lift rail
- Existing staircase
- Existing wall opening to kitchen

The existing staircase will be retained, with the addition of a stairlift to aid mobility for the current owner. Efforts were made to improve the steepness of the stairs, but due to the staircase’s position and lack of space, the best course of action was to retain the existing staircase and add a stairlift.

We propose to raise the floor deck of the rear bathroom to improve headroom in the ground-floor garden room and to address the existing level difference on the upper floor, where there is a steep step to access the rear bedroom, with an additional steep step leading to the adjacent bathroom. By raising the floor deck to match the rear bedroom's height, we will create a continuous floor throughout this part of the building while preserving the existing structure of the bedroom and only altering the floor structure in the bathrooms.
