## BS:5837 ARBORICULTURAL REPORT

ARBORICULTURAL SURVEY, IMPACT ASSESSMENT &  
METHOD STATEMENT

PINEWOOD MINIATURE RAILWAY  
PINEWOOD LEISURE CENTRE  
CROWTHORNE  
BERKSHIRE  
RG40 3AQ

Ref: AIA/AMS 06435 / 2024

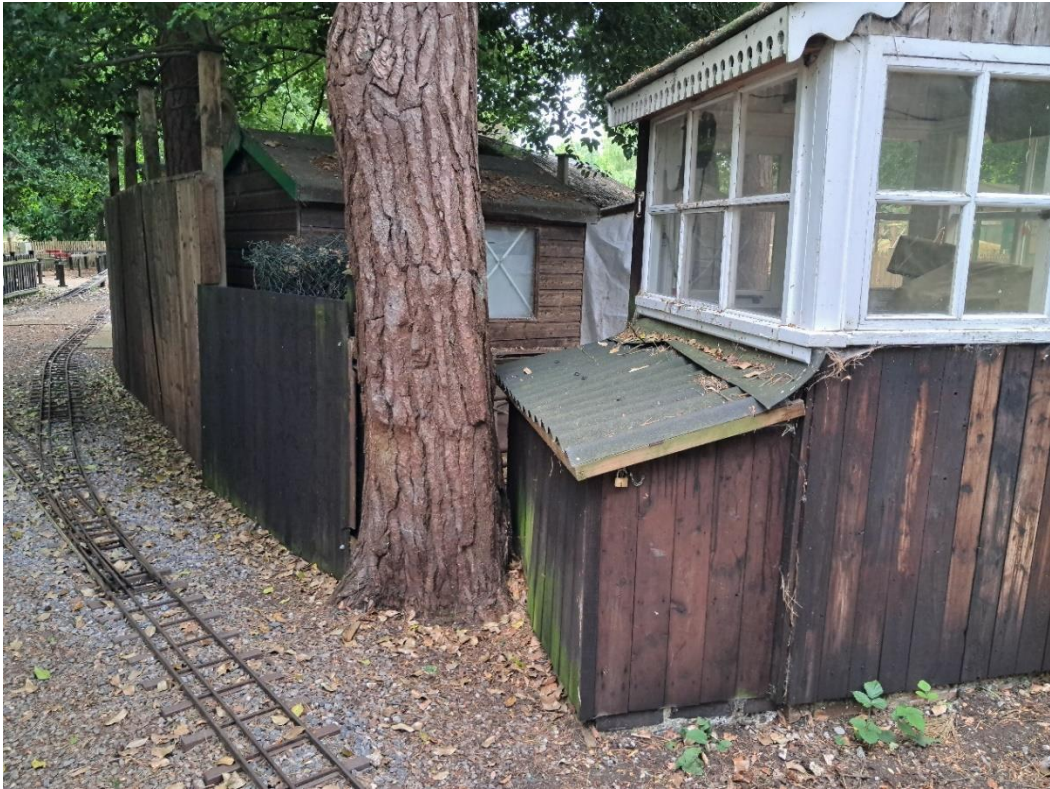
Photo 1 – T3 (Scots pine) in relation to the low-level storage at the rear of the existing shed.

The new signal box is within the root protection areas of four trees, one of which is a category 'B' Scots pines, three are lower grade category 'C' trees (2x Holly, 1x Scots pine). The shed will be largely positioned over the site of the original building structure. A storage compartment to the rear of the existing structure is close to T003 (Scots pine). The replacement building does not have this storage element and the new shed position will be situated at least 200mm away from T003 (Scots pine) to allow for future growing space for the tree's trunk.

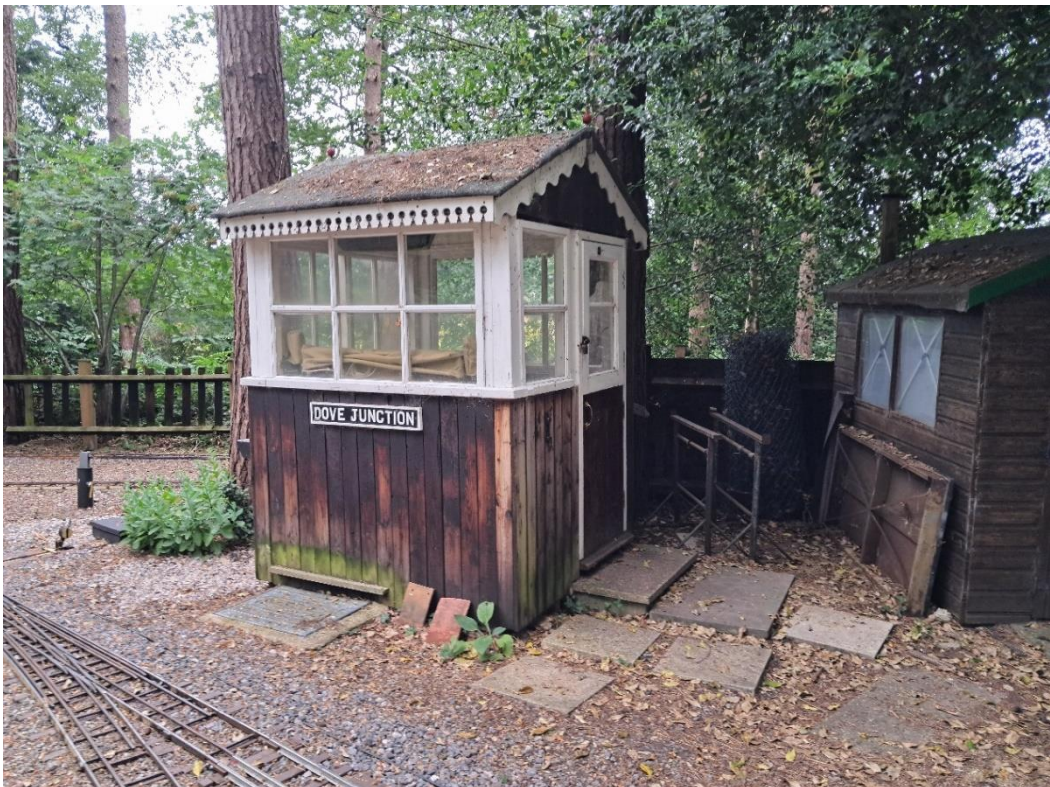
Photo 2 – Existing Signal box.

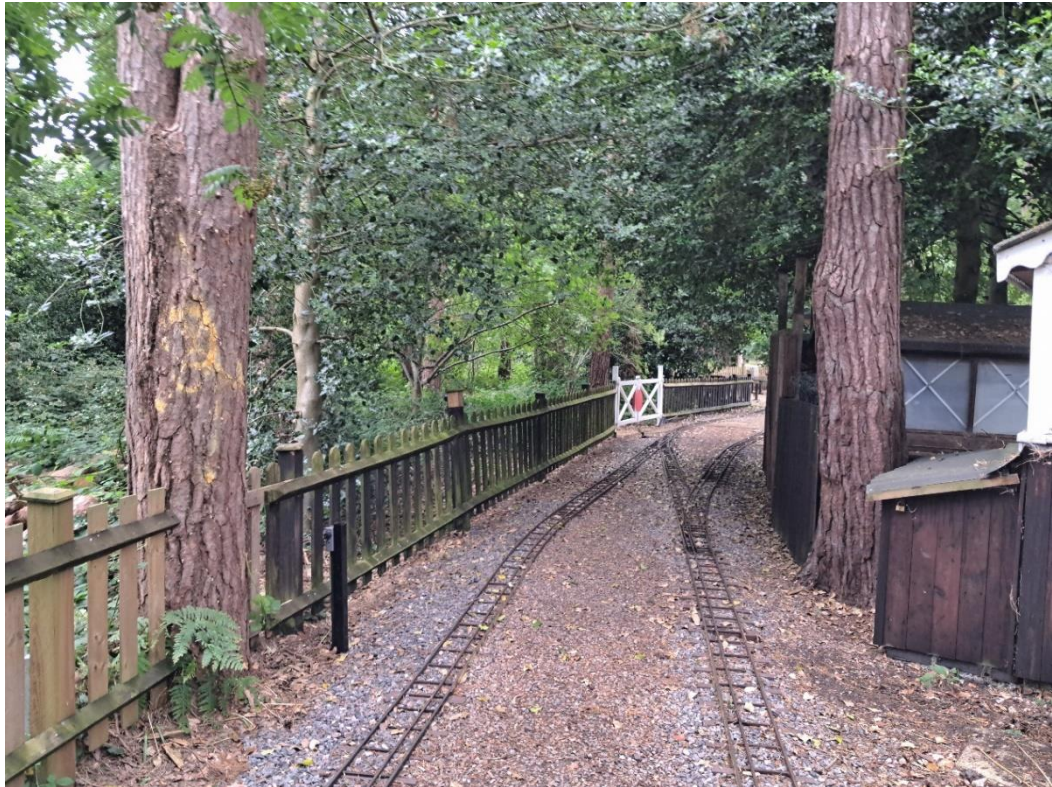
Photo 3 – Access to build area via existing track

Volunteers accessing the build area will do so via the existing railway track, which is levelled with ballast and sufficiently load-bearing not to impact

Materials will be walked to the build area using the existing rail track. There is no vehicle access to the build area.

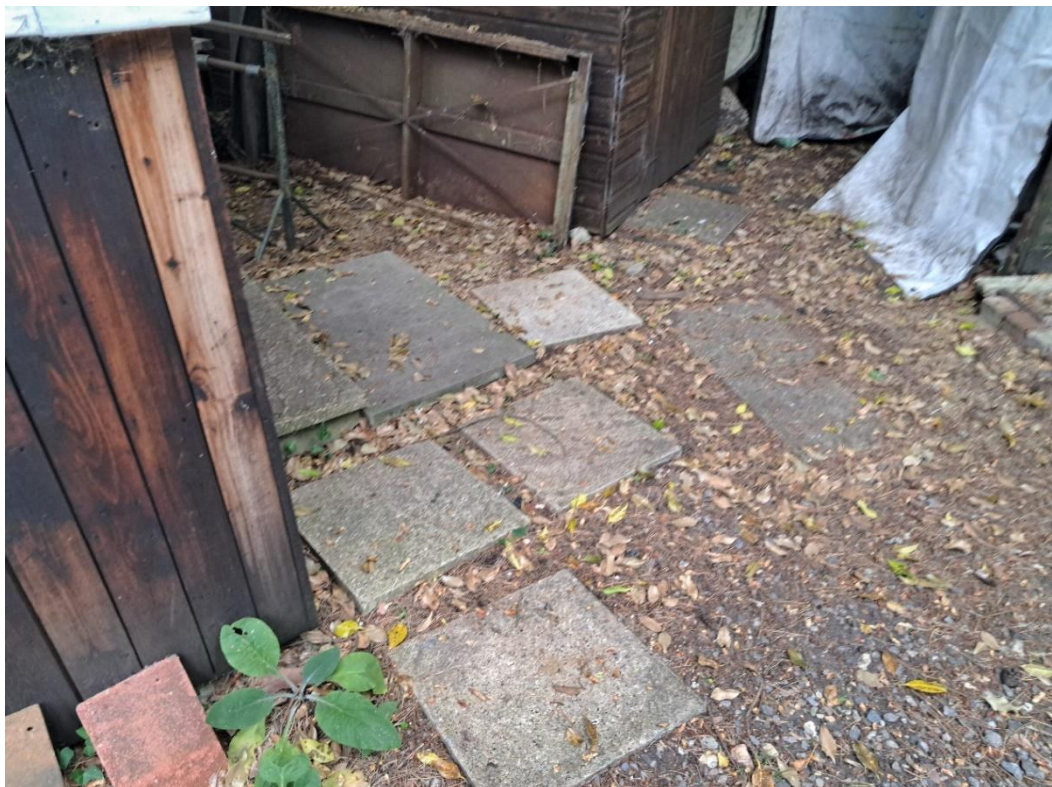
Photo 4 – Replacement shed will be erected onto stacked blocks and pavers

The replacement Signal box will be a lightweight structure erected onto paving slabs or concrete (breeze) blocks placed on the existing ground and stacked where necessary to create a level plinth onto which the base of the Signal Box can be constructed.

The lightweight structure will be erected onto pavers or blocks placed directly onto the existing ground levels and with a void beneath to maintain gaseous exchange to tree roots. Gutters will be directed to a water-butt.
