# REPORT ON A SITE INVESTIGATION

**ORCHARDS PADDOCK,  
BASINGSTOKE ROAD,  
SWALLOWFIELD, READING,  
BERKSHIRE RG7 1PT**

**26/13364/GO**

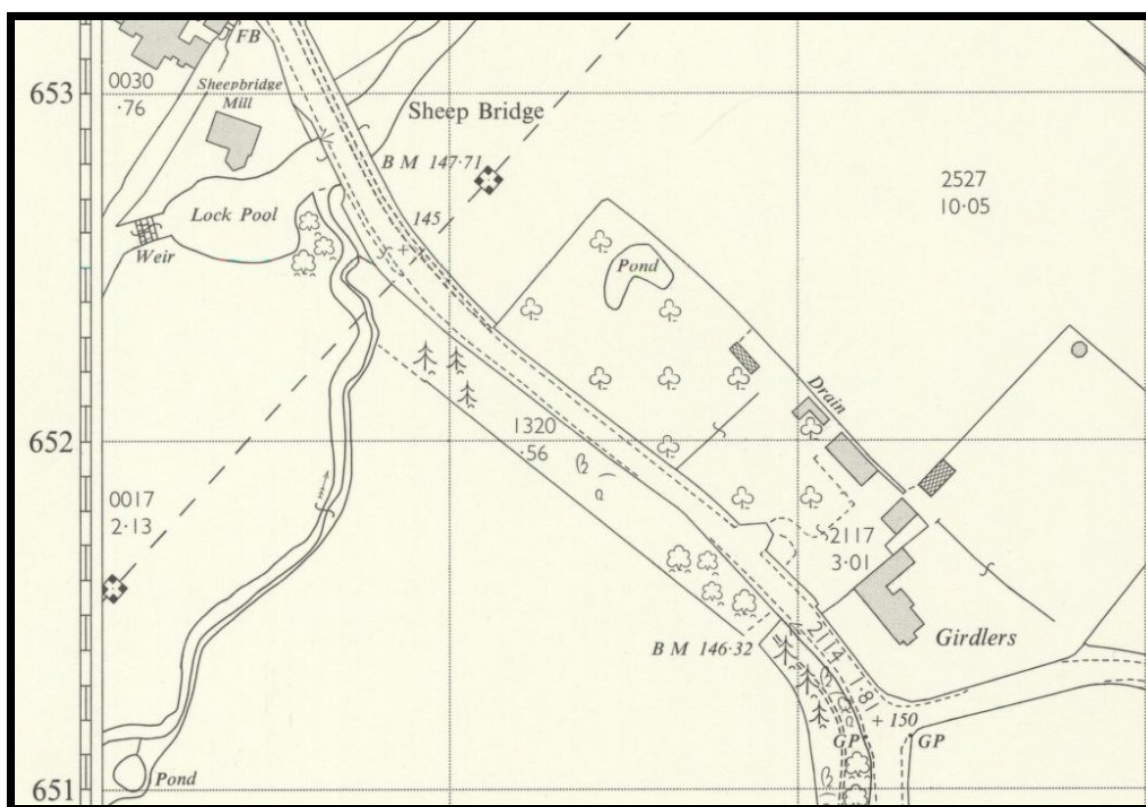
*Extract of 1968 1:2,500 OS map*

The site is located at Ordnance Survey National Grid Reference 472201, 165202 and the River Loddon lies to the north west. Examination of the available OS historical mapping reveals structures on the site in 1968, with a drain present on the northern boundary and a pond to the west. A relevant extract is presented below.

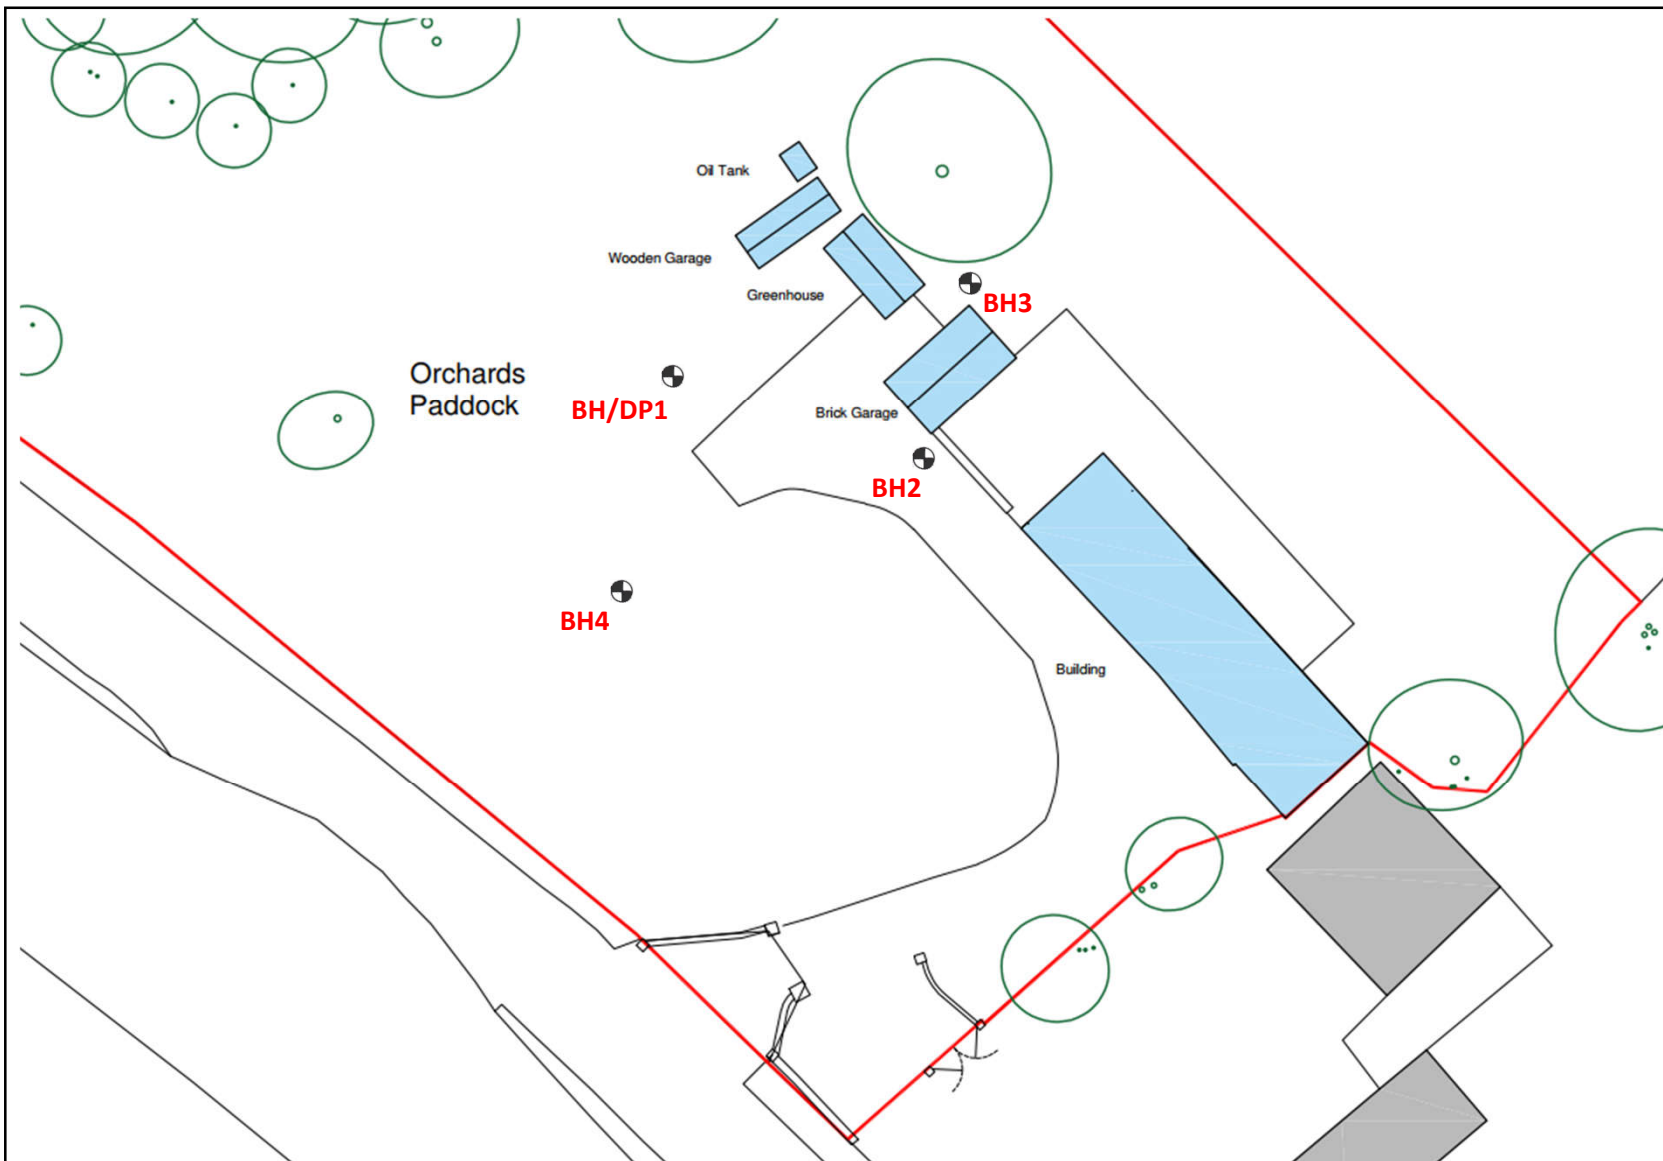
**FIGURE 1**

The boreholes and probe were constructed on 20<sup>th</sup> March 2026 at locations as shown on the site plan, drawing no. 26/13364/1, which is presented as Figure 1. The exploratory positions were located in order to establish the prevailing ground conditions beneath the proposed extension and garage.

**SITE LAYOUT PLAN**

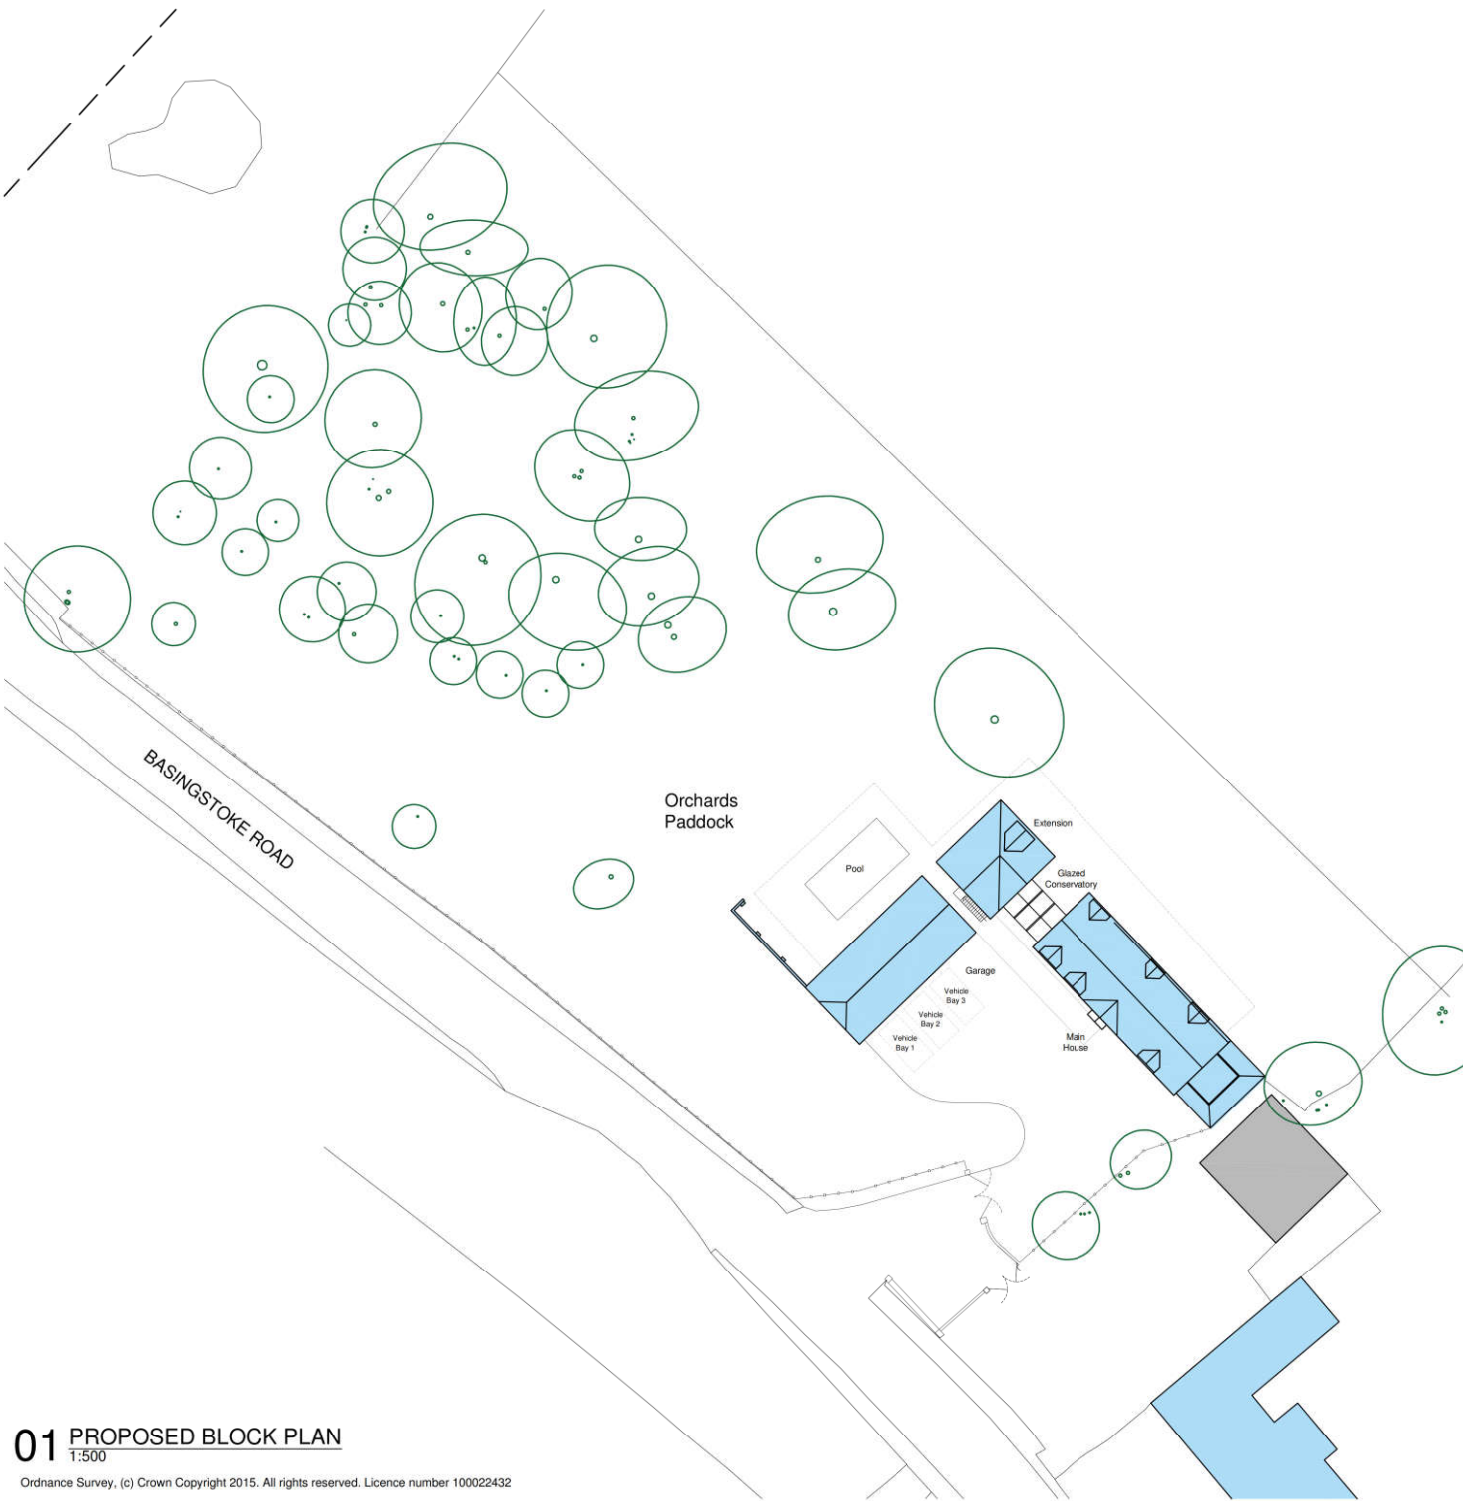
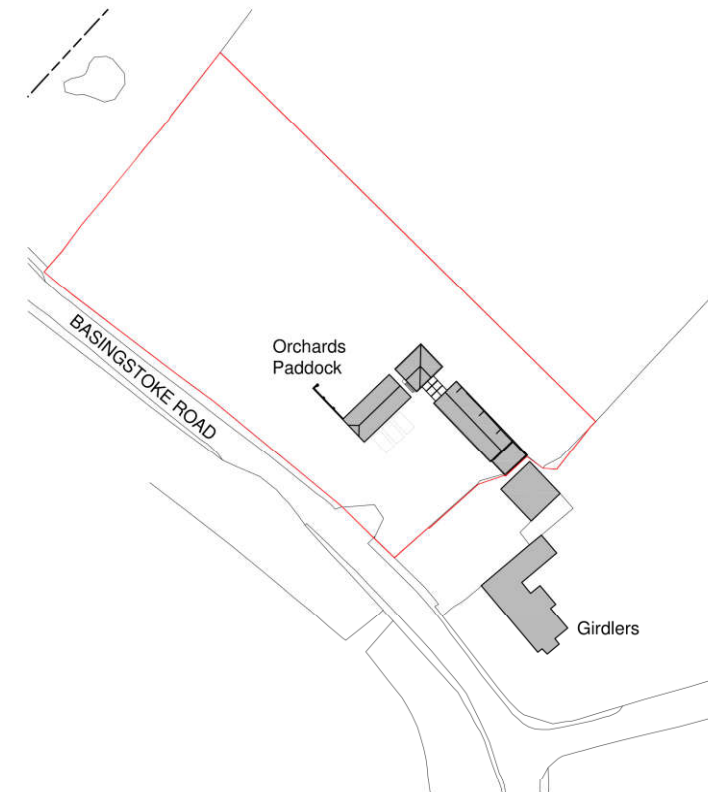
**FIGURE 2**

The client proposes to construct an extension with glazed conservatory link, a detached garage and pool at the site under consideration. The proposed layout is shown in Figure 2. At the time of the preparation of this report the anticipated structural loads were not known.

**PROPOSED LAYOUT PLAN**

**01 PROPOSED BLOCK PLAN**  
1:500

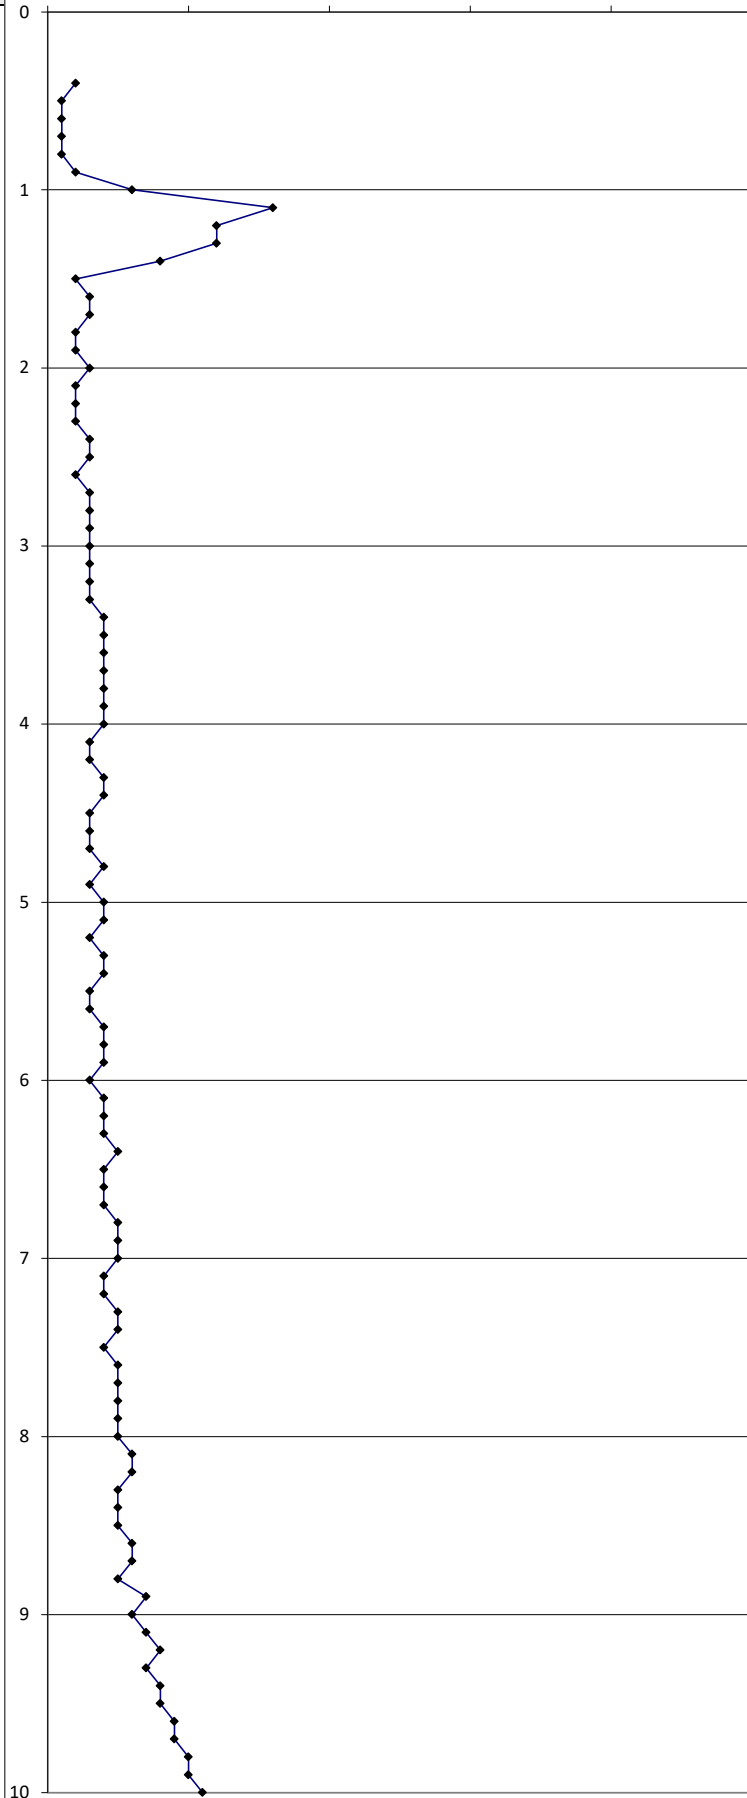
the time of the fieldworks. At location 1 continuous dynamic probing was completed using a lightweight rig utilising DPH specification equipment. The results are presented in graphical format, as a penetration resistance-depth relationship, with the number of blows required to drive the probe 100mm.

Dynamic probing was performed adjacent to borehole 1. Initially low blow counts were recorded from the base of the hand excavated starter pit to 1.00m, where increased resistances to penetration of between 6 and 16 blows/100mm were recorded within the granular soils. These results infer a medium dense in situ condition for a granular soil. The blow counts reduce below 1.40m, ranging from 2 blows/100mm to 4 blows/100mm to 6.50m, steadily increasing to between 5 to 11 blows/100mm within the cohesive soils. The probing was concluded at the target depth of 10.00m.

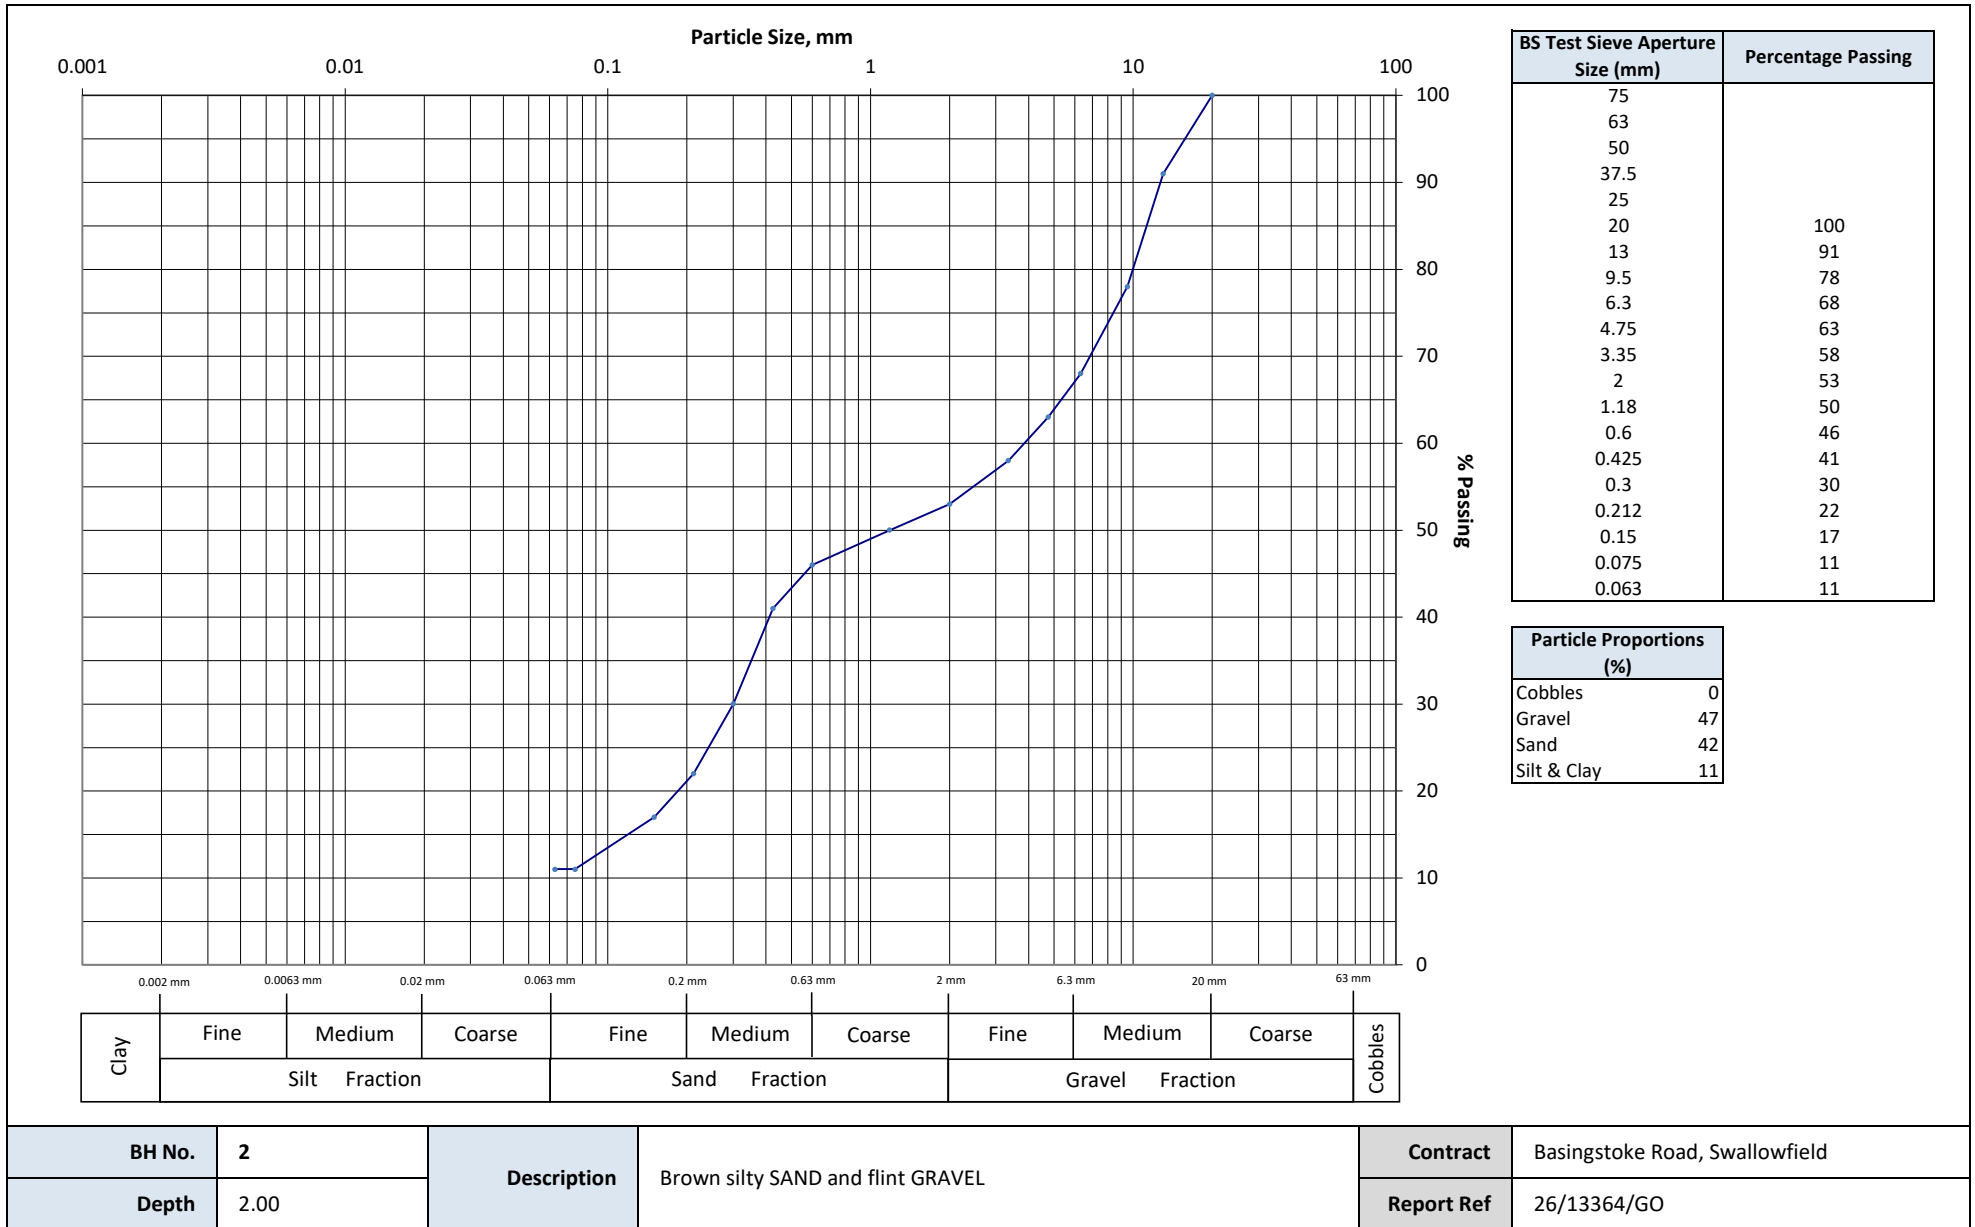
# PARTICLE SIZE DISTRIBUTION

BS EN ISO 17892 : Part 4 : Clause 5.2 Wet Sieving Method

Two samples of the granular soils encountered at this site have been subjected to sieve analysis in order to determine the soils' particle size distribution. The results of this work are presented in the form of grading curves.

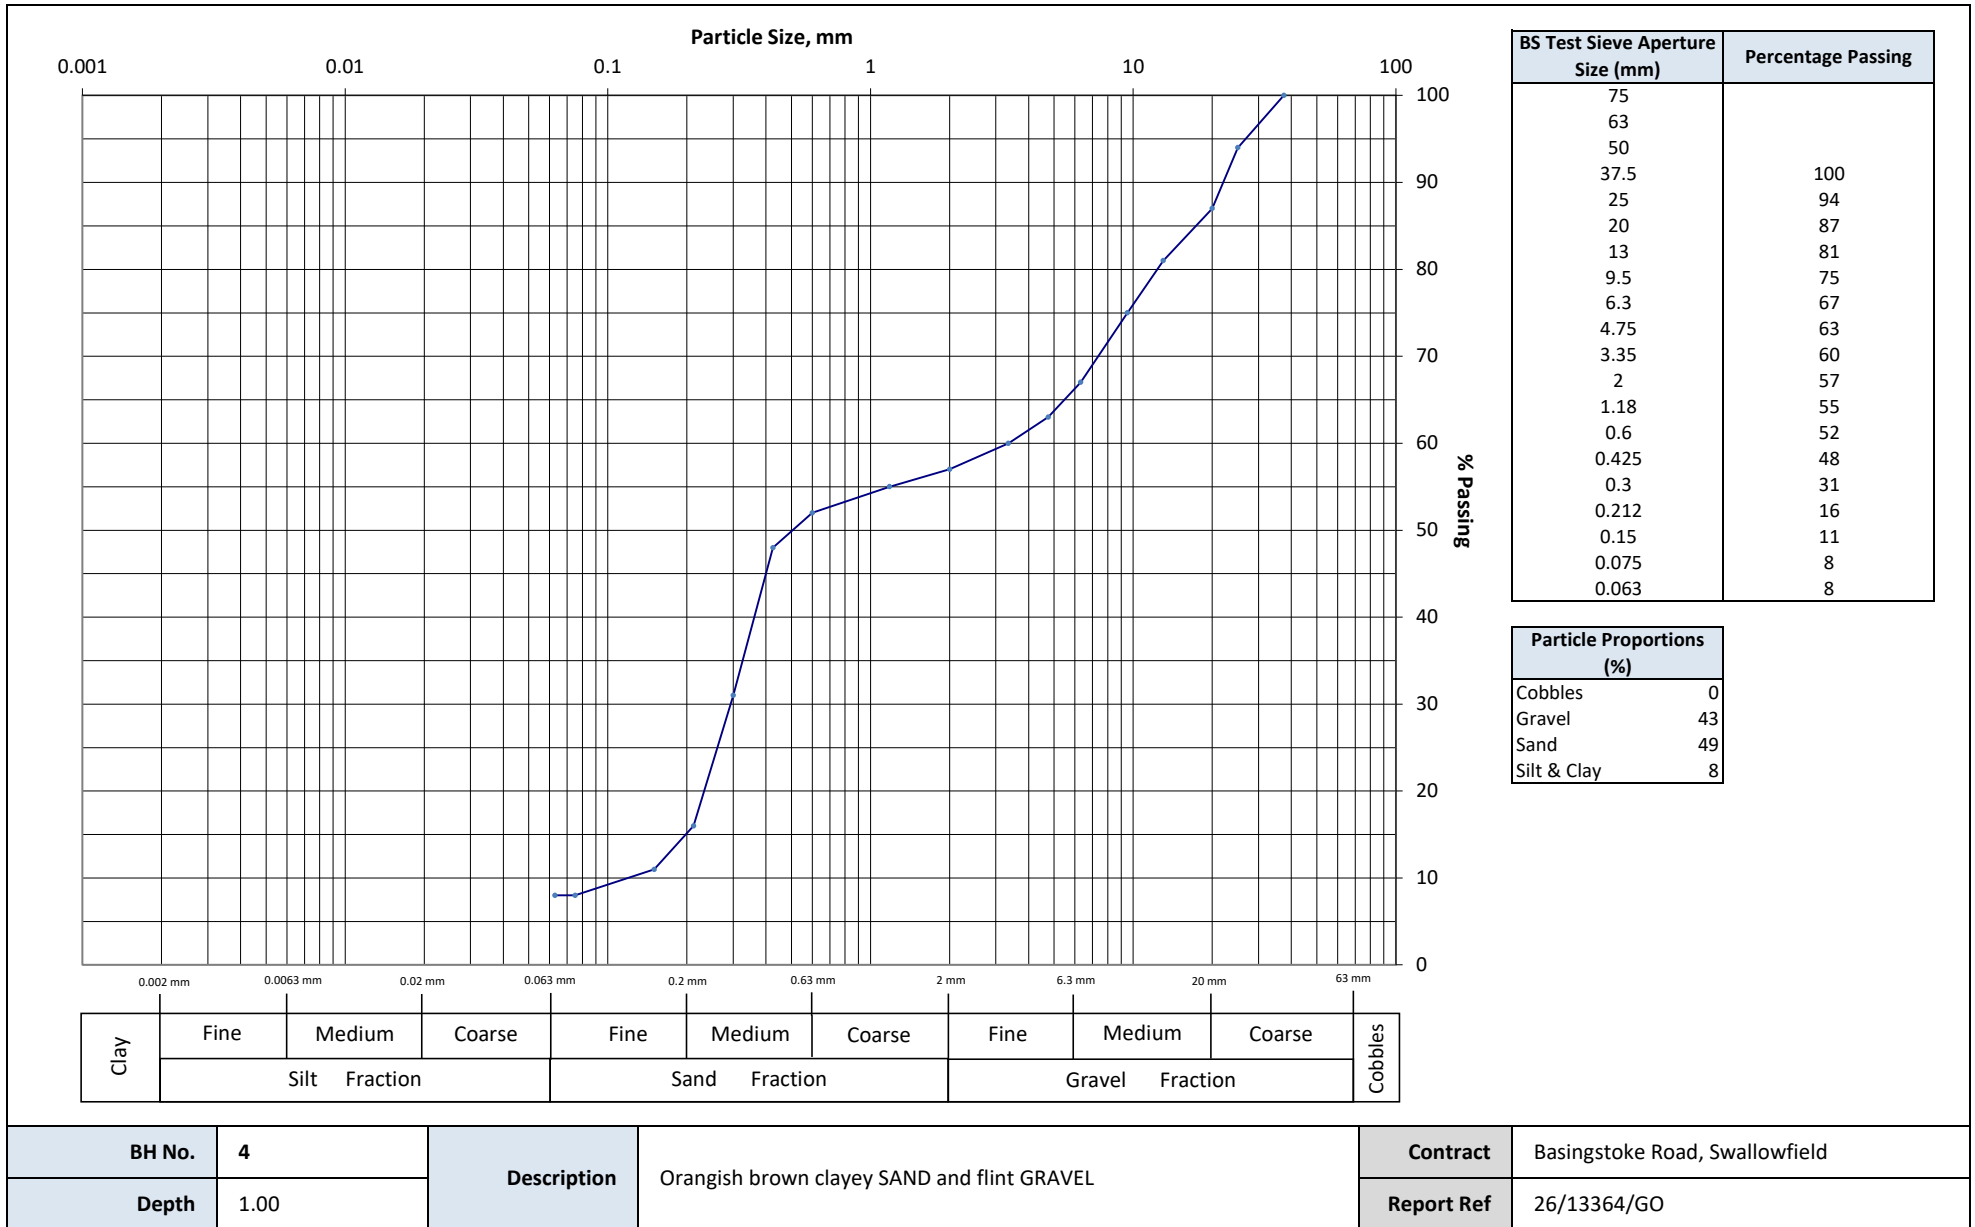
# PARTICLE SIZE DISTRIBUTION

BS EN ISO 17892 : Part 4 : Clause 5.2 Wet Sieving Method
