# Arboricultural Report

Including a tree survey, impact assessment and method statement  
for a replacement dwelling at

121 Nashgrove Lane, Finchampstead,  
Berkshire, RG40 4HG

Reference: MW.2412.NLF.AIA  
Client: Mr & Mrs Gallagher  
Date: 29 July 2025  
Revision: B issued: 2026.02.19

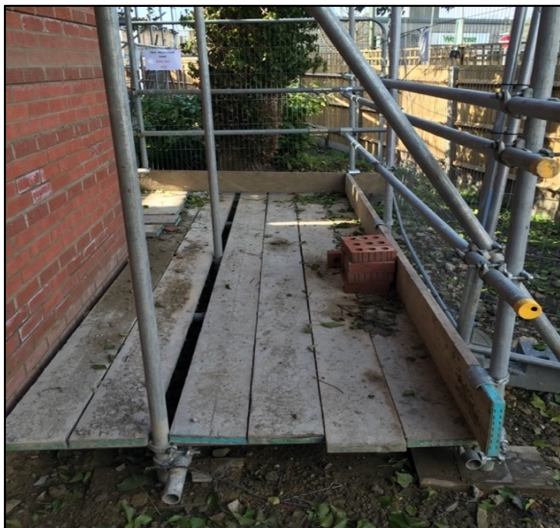
GP1: Tree protection barriers and scaffold ground protection

- 5.21. If required to facilitate access within the CEZ (or as shown on the appended tree protection plan), ground protection is to be installed. If not already included on the tree protection plan, it must be approved in writing by the local planning authority before implementation. The ground protection must be capable of supporting the expected loads and avoiding rutting, compaction and damage to the soil: as advised in section 6.2.3 of the British Standard.

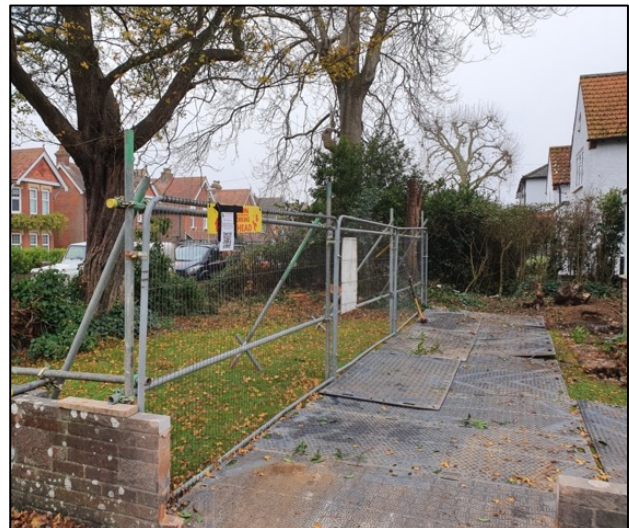
GP2: Tree protection barriers & trackmat ground protection

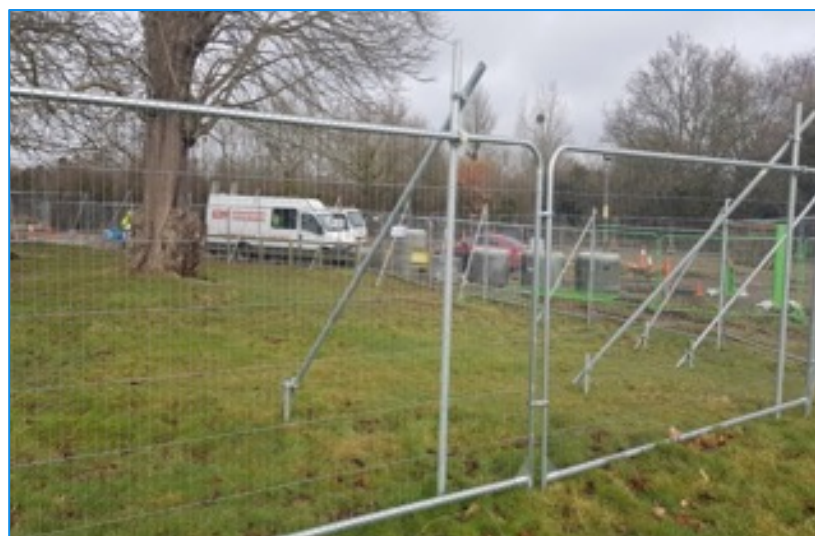
TPF 2: Alternative fencing option: scaffold uprights with backstay

- 4.16. As the proposed construction work is comparatively 'low impact', the default British Standard tree protection specification seems somewhat onerous. Therefore, it is my opinion that an adequate level of protection can be provided with a lesser specification.
- 4.17. Alternative specifications can be found in [Appendix i](#). TPF 2 or TPF 3 are proposed.

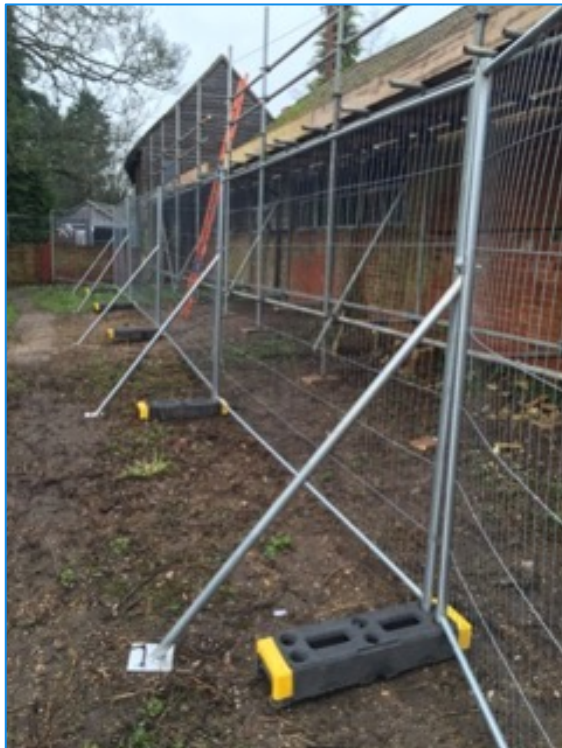
TPF 3: Alternative fencing option: on boots with backstay

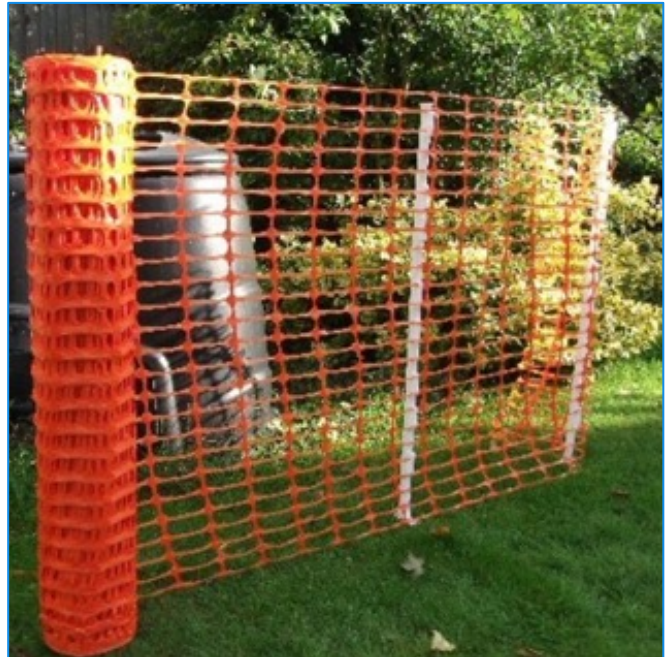
TPF 4: Plastic barrier for low intensity areas of construction

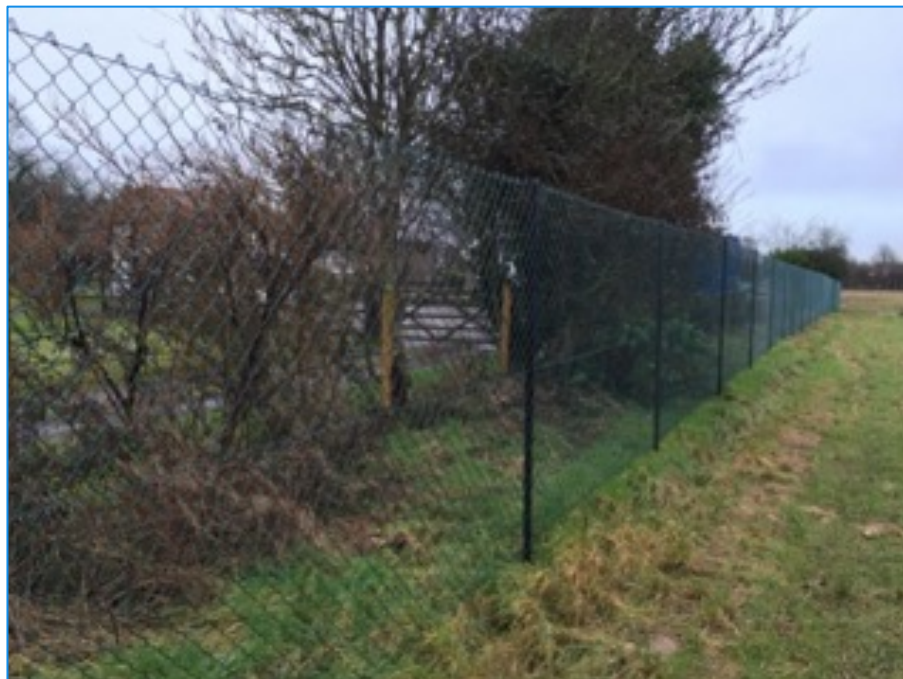
TPF 5: Chain-link for low intensity areas on large projects

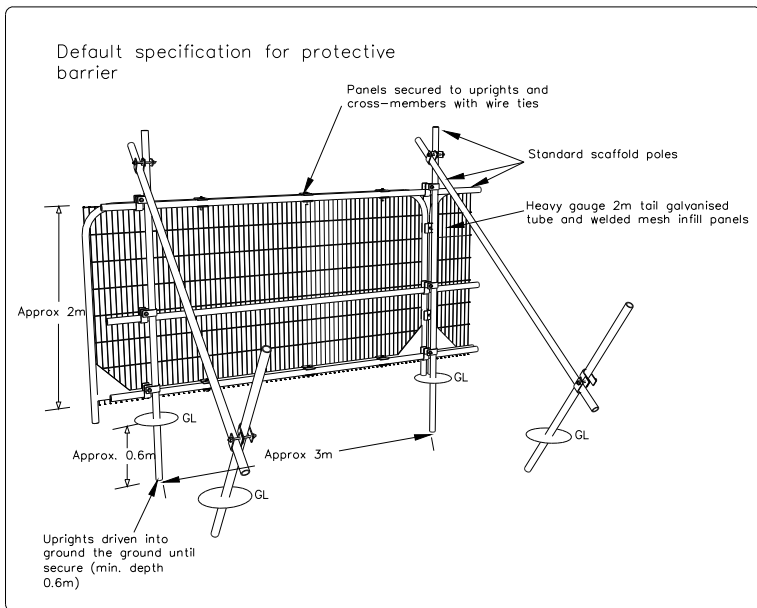
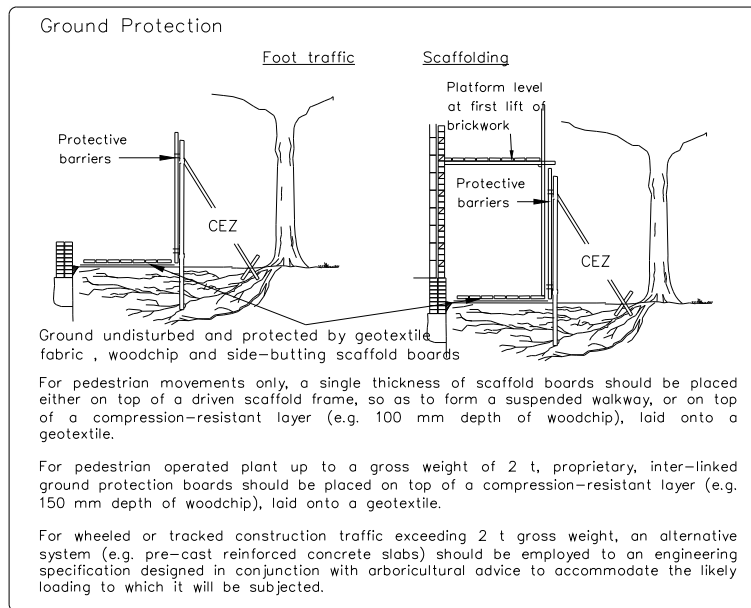
## Protection Plan

This Tree Survey has been undertaken within the recommendations of British Standard BS5837:2012 and current arboricultural best practice. The reference numbers of surveyed trees and groups of trees are shown. Stem locations within groups may be estimated, and indicative of canopy dimensions. The tree survey was carried out from ground level only, with the aid of binoculars as necessary, following the Visual Tree Assessment (VTA) method. Where trees are located on neighbouring land an estimated appraisal has been made of their quality and dimensions. Where stems or branches are observed by Ivy or other materials a full assessment of those parts will not be possible. Height dimensions are estimated and are given in metres. Trunkstem diameters are measured in mm at 1.5 metres above ground level, unless otherwise stated. Where this is not possible, then Figure C1 of the British Standard is followed. Tree canopies are graphically represented on the plan. They, where markedly asymmetrical, were measured by estimated by sighting in four directions using a laser measure. Symmetrical canopies are measured in one direction only with dimensions in the remaining directions assumed to be similar. For the canopies of groups of trees the maximum radius for each compass point is measured. More complicated groups will have further notes taken and an accurate representation will be shown on the plan.

- 5.6. A tree protection plan showing the types of tree protection and their locations is appended. It includes the tree survey data, existing site features and the approved construction. The plan must be read in conjunction with this method statement.
