**ARBORICULTURAL REPORT**  
**at**  
**West Wood**  
**Lower Wokingham Road**  
**Crowthorne**  
**Berkshire**  
**RG45 6BY**

**Client:**  
360Globalnet  
On behalf of Direct Line

**JCA** Limited  
Arboricultural & Ecological Consultants

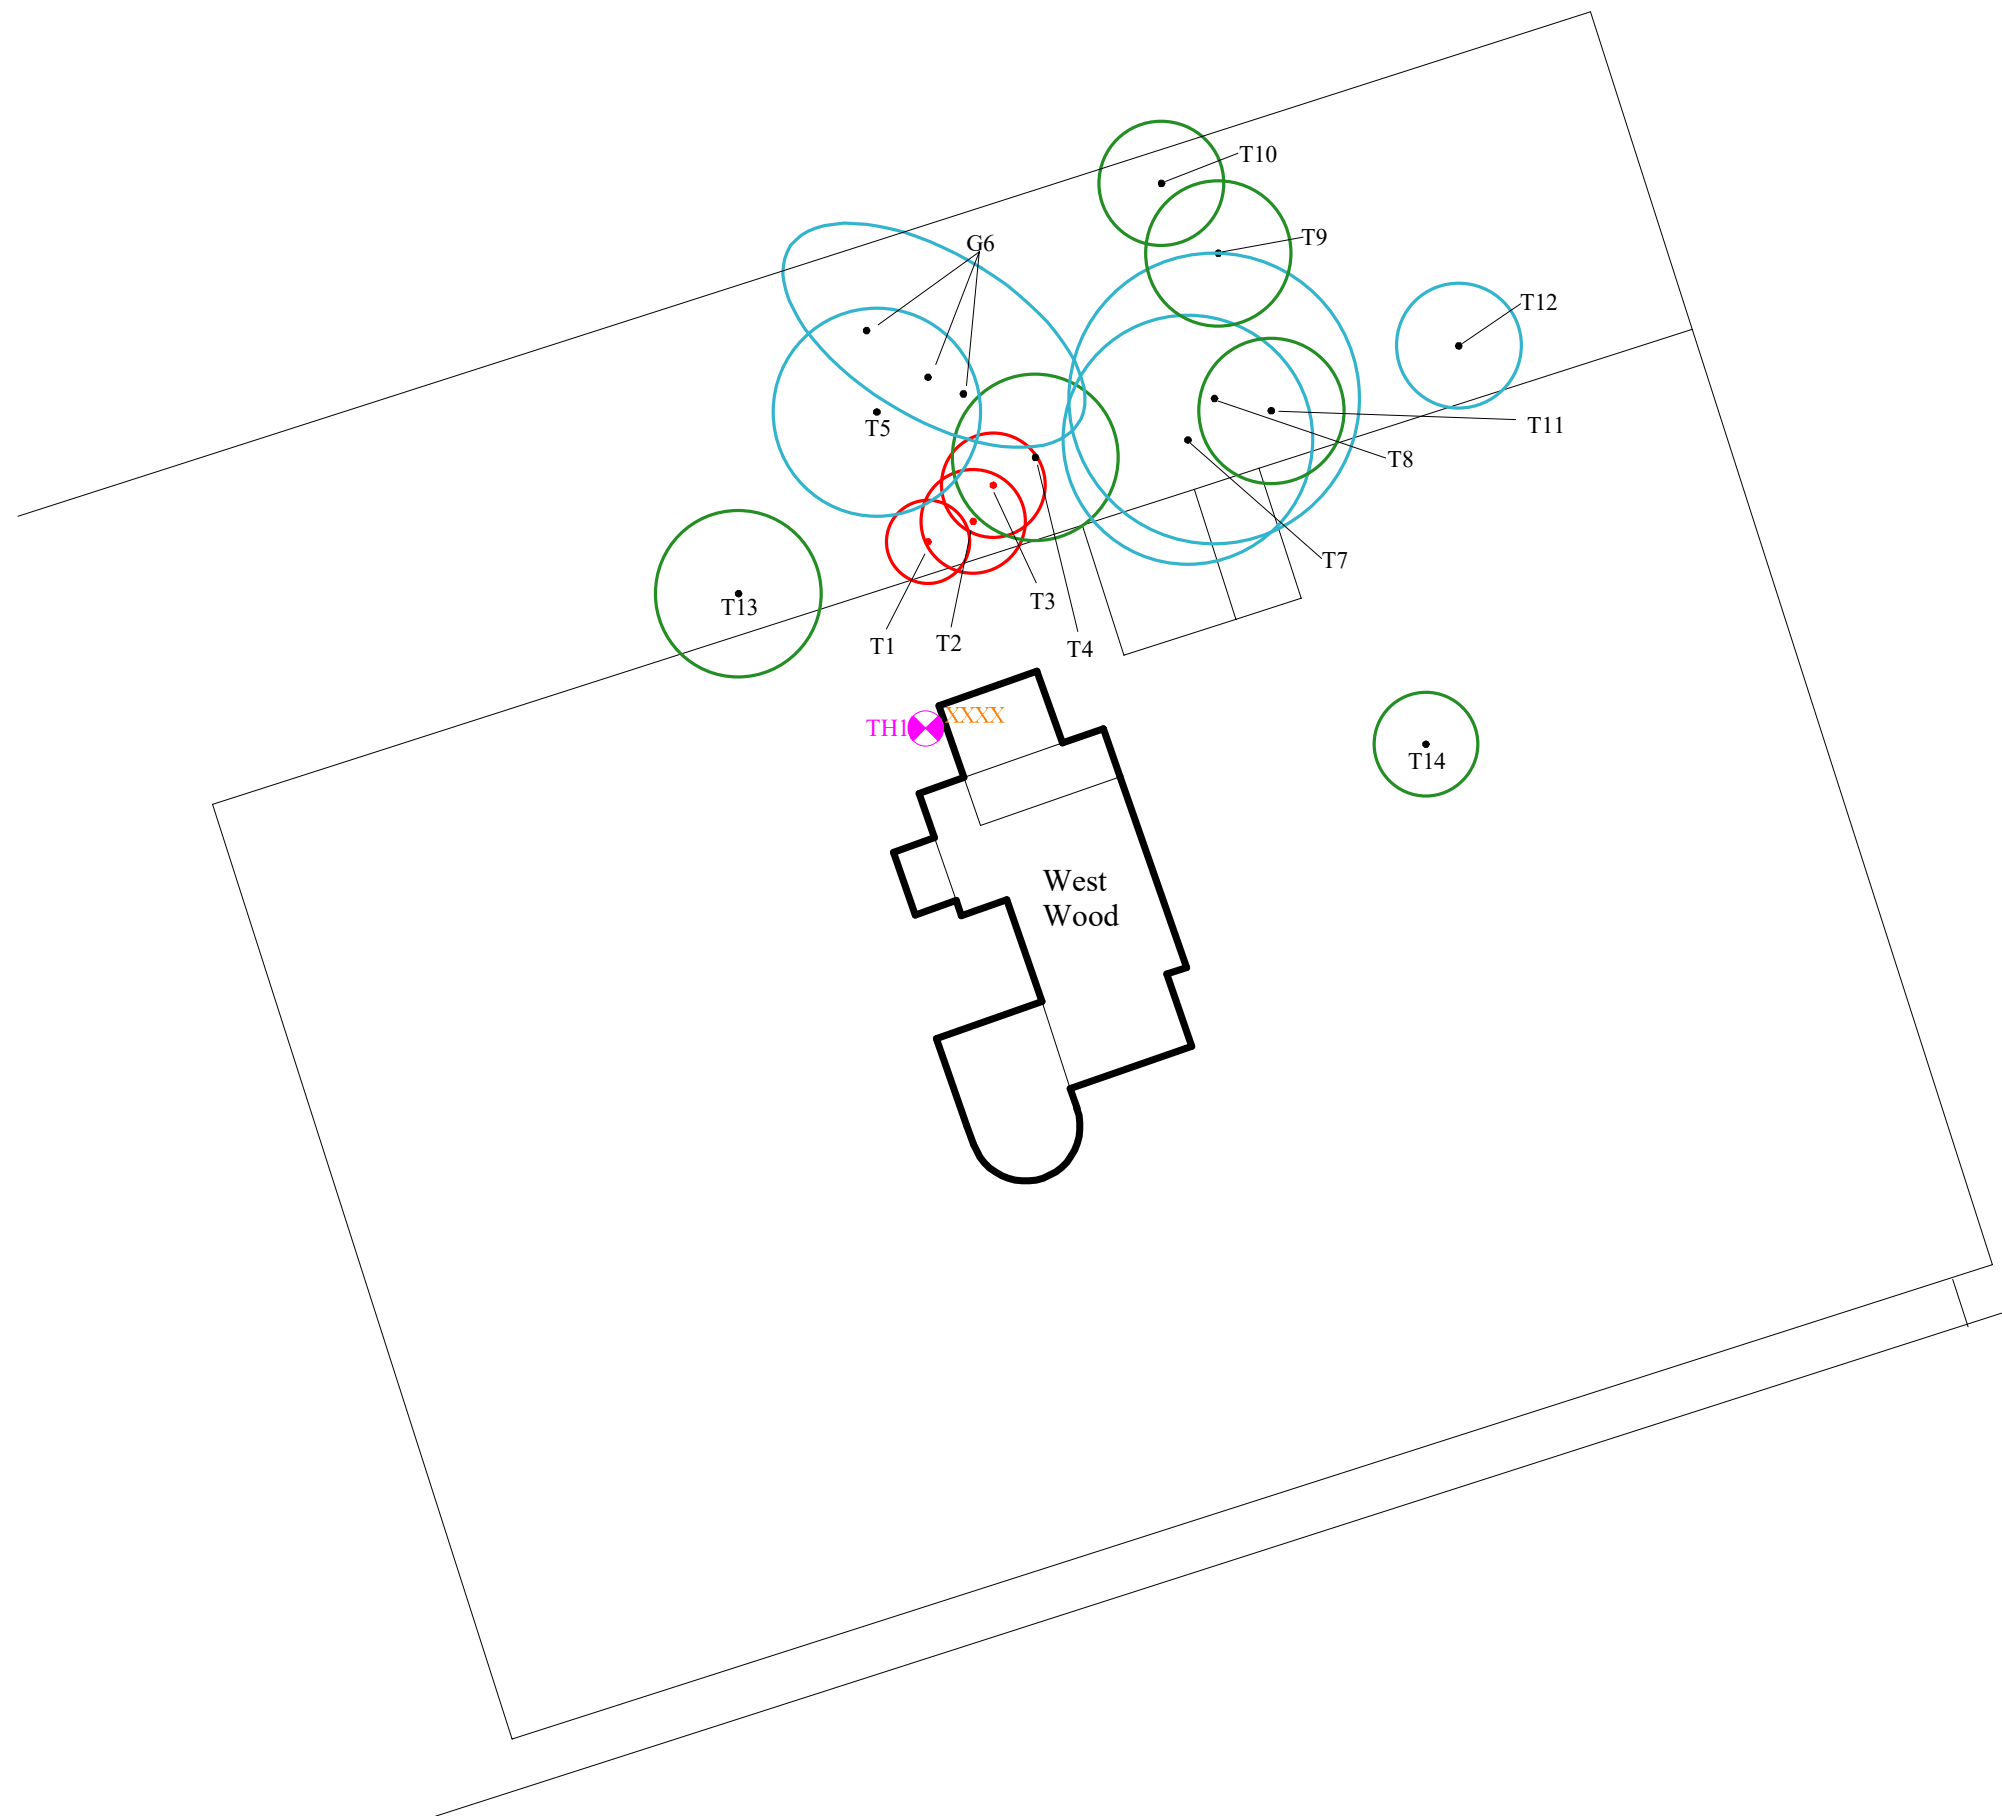
### Appendix 2: Site Plan

- 3.2.1 Please refer to the site plan at **Appendix 2** for an indication of the trial pit/borehole location.
- 3.2.2 **Trial pit/borehole 1** revealed an 800mm thick concrete foundation at a maximum depth of 1600mm below ground level.

- 5.1 Descriptions of the surveyed vegetation and all recommended work are detailed in the tables at **Appendix 1**.
- 5.2 Please refer to the site plan at **Appendix 2** for the locations of the vegetation surveyed and all the relevant site features.

- 6.3 We consider the vegetation identified as **T1, T2** and **T3** to be collectively contributing to the damage observed at the subject property. We have therefore recommended that **T1, T2** and **T3** be removed and that the stumps be treated to prevent regrowth.

- 6.4 We consider the vegetation identified as **T5, G6, T7, T8** and **T12** to be of possible future concern to the subject property, if left unmanaged. We have therefore recommended that **T5, G6, T7, T8** and **T12** be maintained at their current height and spread over the forthcoming years. This work is only recommended as a precaution and is not considered a priority to resolve the damage observed at the subject property.
