# Park Lane, Charvil, RG10 9TS

P25-0896  
ISSUE: 2

Flood Risk Assessment & Drainage Strategy Report

| <b>Client</b> | Bellway Homes Limited (Thames Valley) |

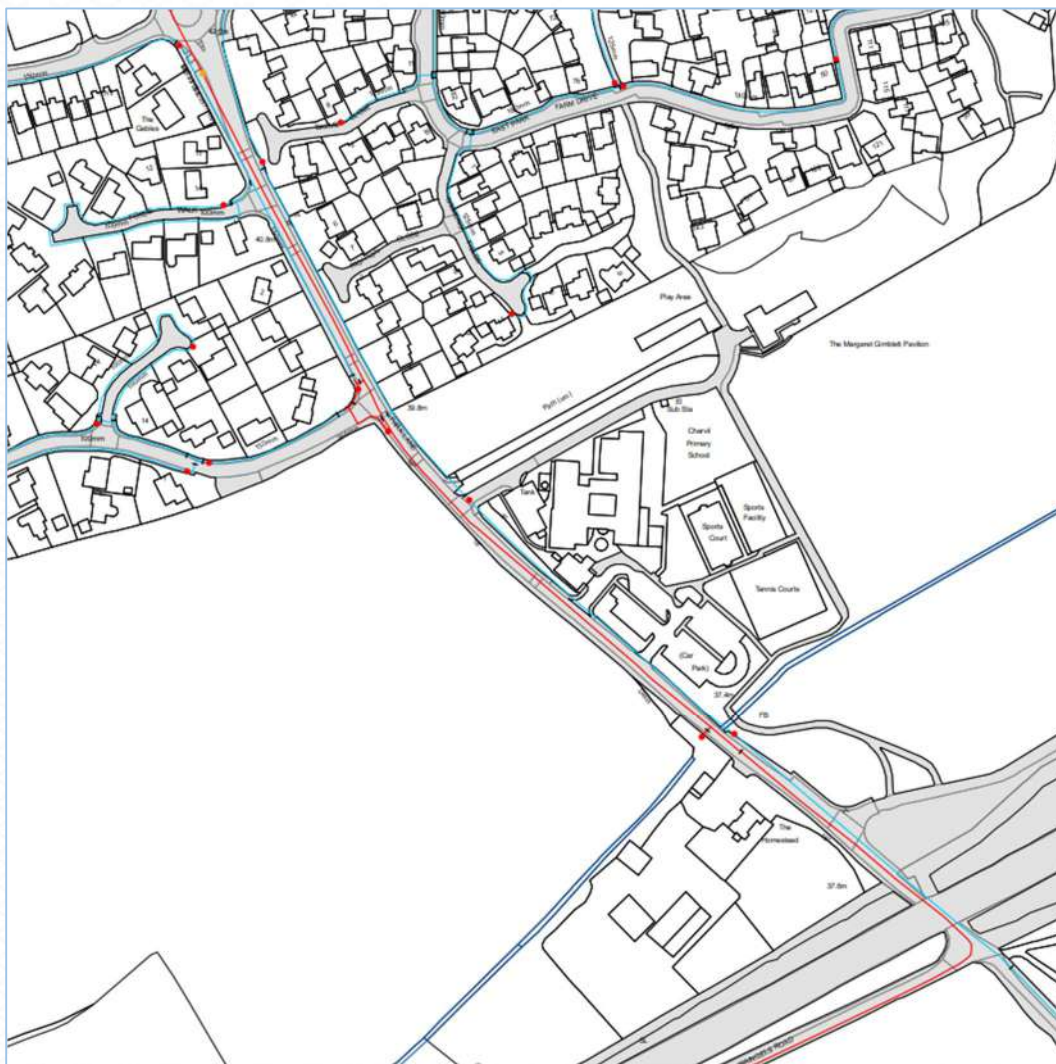
Figure 2.2: Thames Water Sewer Records

2.5.2. Thames Water is the incumbent sewerage utility provider for the area. A review of the Thames Water's Records confirms that there is a surface water sewer running west to east along The Hawthorns to the north of the site and north to south down Park Lane to the east of the site. There is a foul water sewer that runs parallel to the surface water sewer along The Hawthorns. Not shown on the Thames Water plan is a surface water and foul water sewer that has been installed running south to north along Canberra Lake Way that has recently been built as part of an adjacent development. *Figure 2.2* below shows an extract of Thames Water's sewer records for the site.

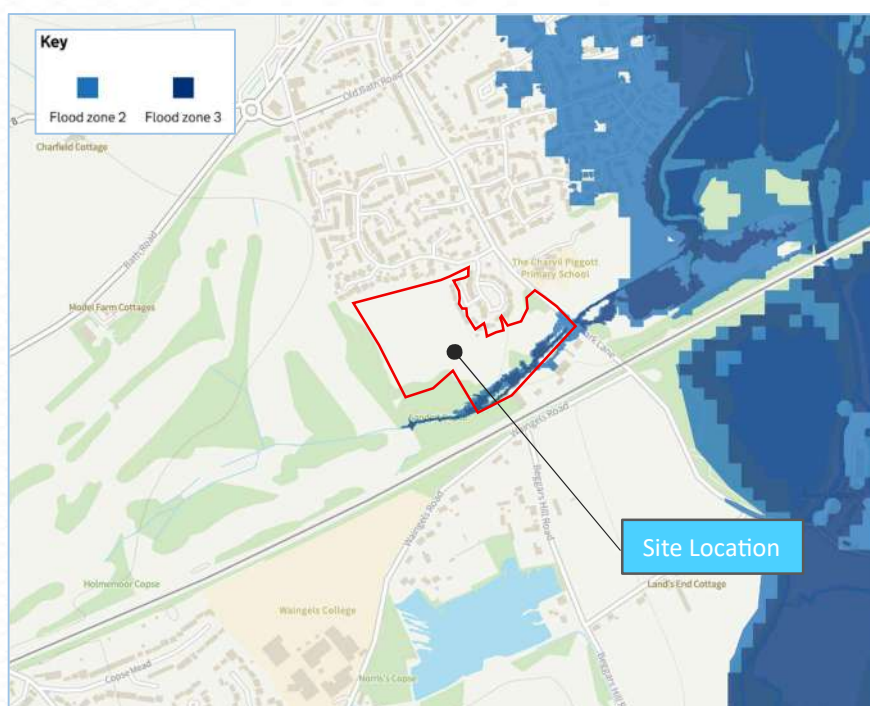
Figure 5.1: EA Flood Zone Map

5.2.2. The EA's Flood Map for Planning is the initial dataset used for identifying the location and extent of fluvial and tidal flooding. Figure 5.1 – 5.4 below shows the flood map, which identifies that whilst the site is predominately located within Flood Zone 1 with areas to the south shown as Flood Zones 2 & 3. Flood Zone 1 would be representative of land at low probability of fluvial flooding, with less than 1 in 1,000 annual probability of river flooding (<0.1%).

5.2.3. Based on the review of mapping relating to fluvial flooding from information sources outlined above, the site overall is assessed to be at very low risk from fluvial flooding with the sections to the south shown to be at medium to high.

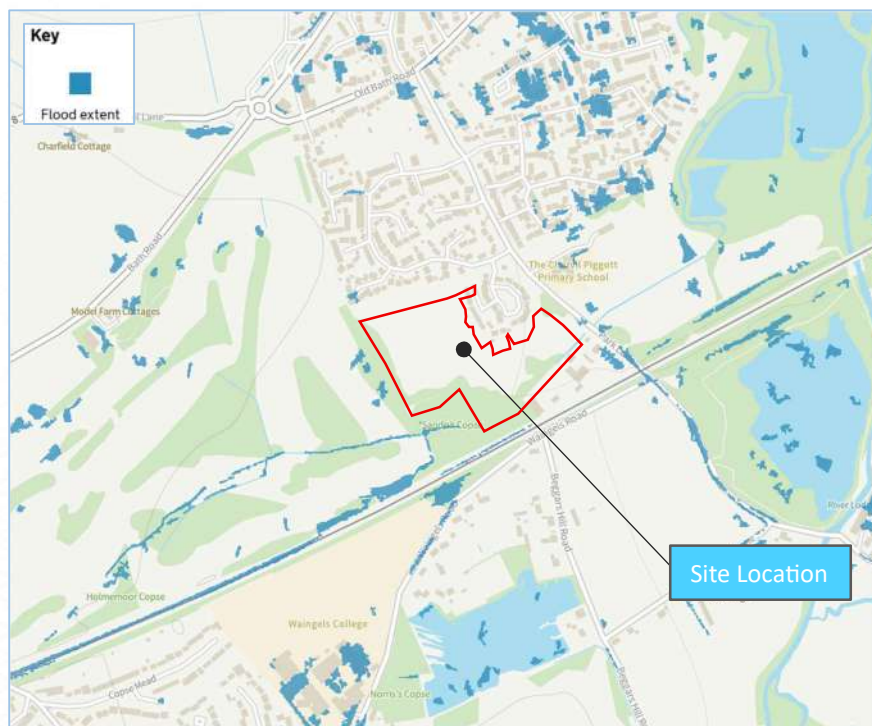
Figure 5.2: EA Risk of Surface Water Flooding Map

5.3.3. The surface water flood risk map from the EA’s website is shown in Figure 5.2 below. Within the surface water flood mapping, you can view flood extents for the 1 in 30, 1 in 100, and 1 in 1000-year return periods; the below mapping displays the worst-case flood extents of 1 in 1000 year. The mapping shows there to be no areas of the site that are at risk of surface water flooding.

5.3.4. Based on the review of mapping relating to surface water flooding from information sources outlined above, the site is not assessed to be at risk from surface water flooding.

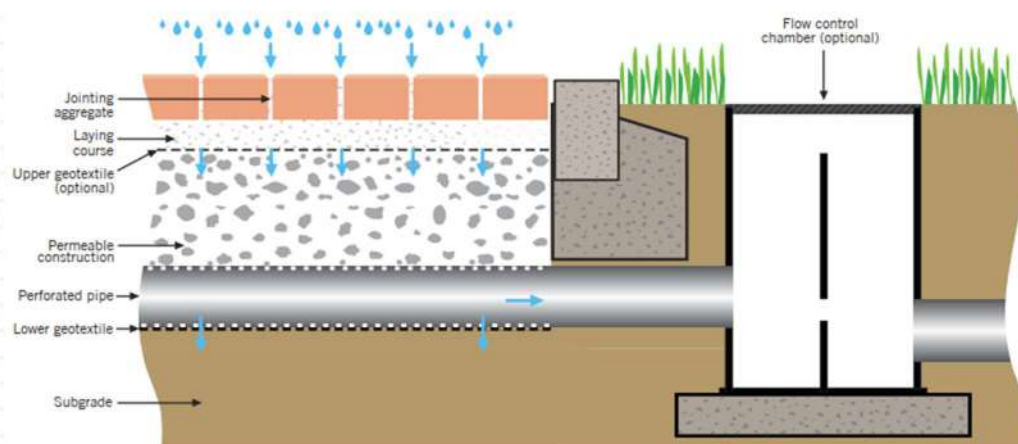
Figure 7.8: Typical partial infiltration permeable paving detail (Interpave)

- Permeable paving as shown in *Figure 7.8* below would be used for the interception and treatment of surface water runoff from parking areas. Permeable paving would allow surface water runoff to filter through a block paved surface into a filter zone of sub-base beneath the bedding layer. As a result of soakage testing and differences in permeability of soils across the site, flows would be collected via a perforated pipe connecting to the proposed below ground network however the system would not be lined with any impermeable membrane to promote infiltration.

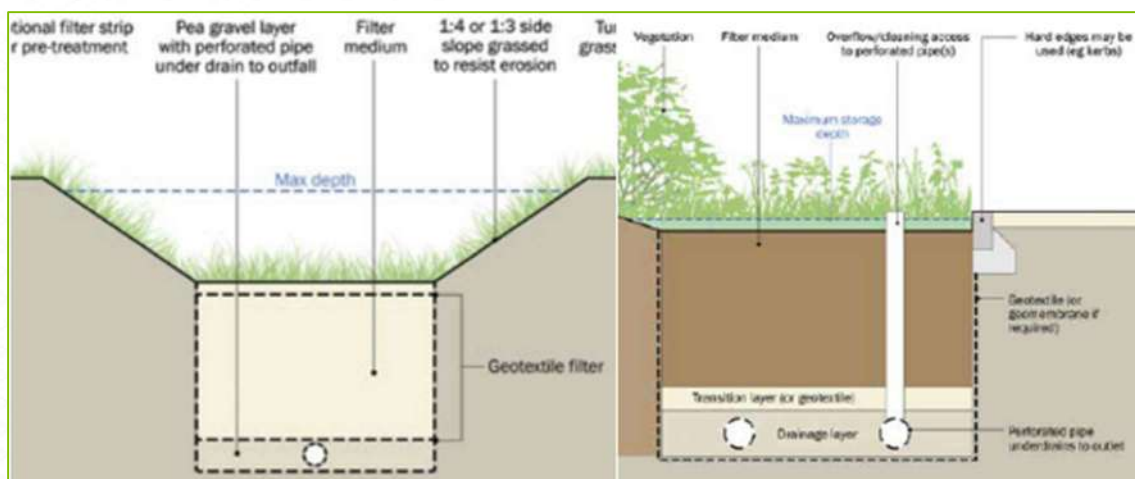
Figure 7.9: Typical swale and bioretention swale details (SuDS Manual)

- A combination of swales and rain gardens would be used alongside the road network and paved areas for interception, treatment and conveyance of road runoff. *Figure 7.9* below shows typical examples of swales and bioretention swales and dry swales. The swales would be designed as shallow features 250mm deep and receive runoff directly from the adjacent roads. The swales would incorporate a road gully situated 25mm above the surface to provide resilience against silt entering the system and promote infiltration. The gully in turn would be connected to the below ground surface water network.
- Rain gardens would operate on a similar basis receiving flows directly from the adjacent roads through which the water would permeate through the engineered porous medium and collected via a perforated pipe connecting to the below ground system.

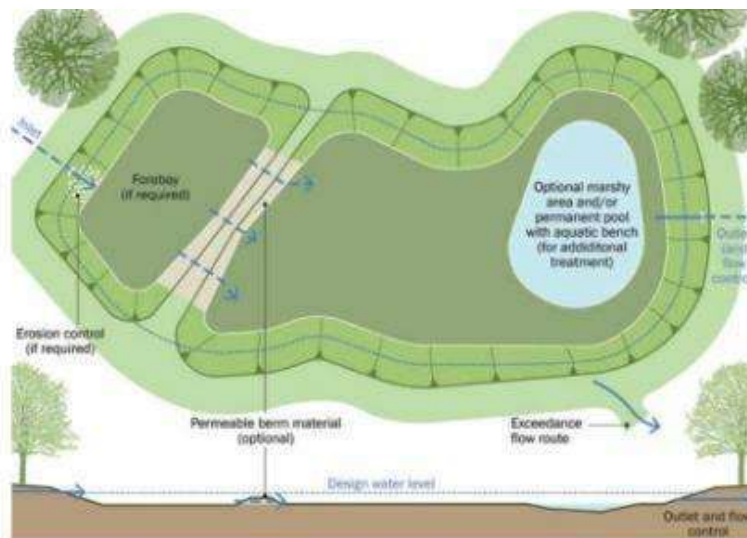
Figure 7.10: Typical examples of detention basin principles (SuDS Manual)

- As a result of the elevated groundwater levels, the basins would be lined with an impermeable liner to prevent ingress of groundwater and ensure capacity is not reduced.

- The attenuation basin to the southeast has been designed with low flow channels to direct flows to a deepened section with a permanent pool. The basin features a range of slopes comprising of 1 in 4 to the development side and a shallow section to with access through shallow 1 in 6 side slopes. *Figure 7.10* below shows typical example of a detention basin.

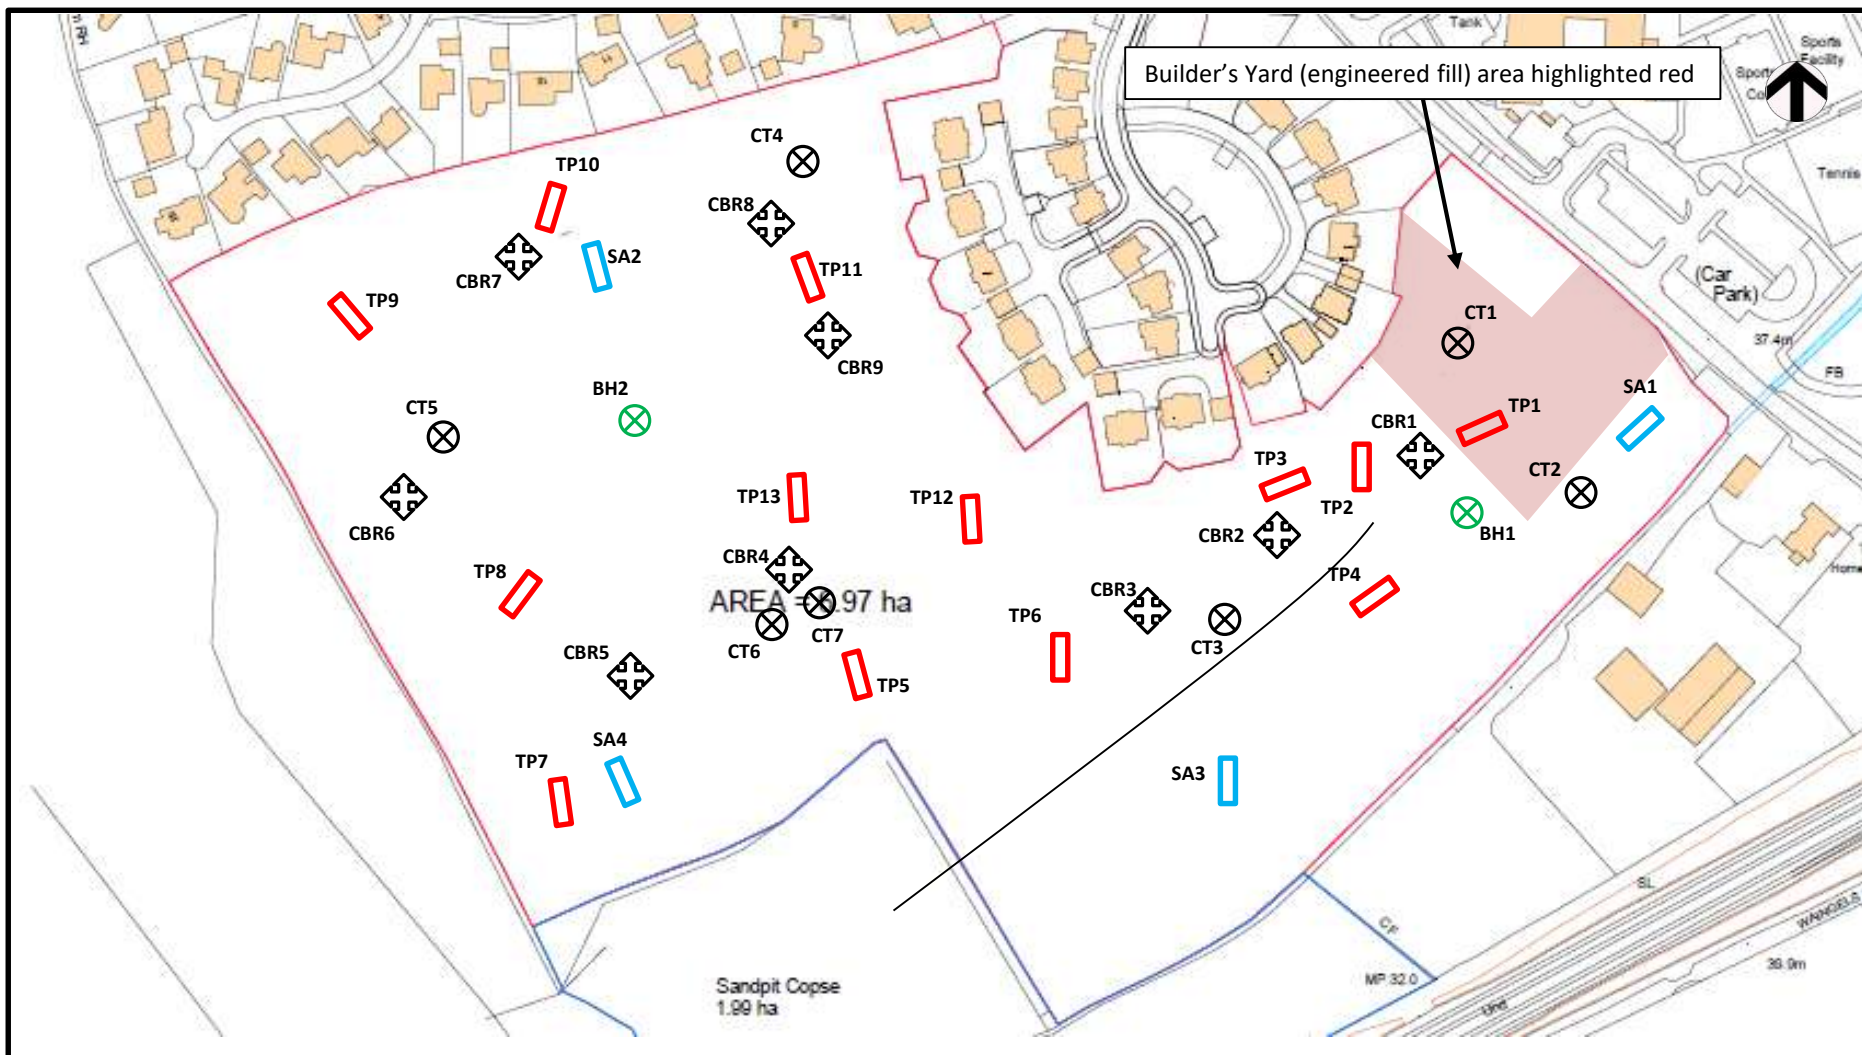
| <b>Key</b><br>Trial Pit<br>Continuous Tube Borehole<br>Soakaway Pit<br>CBR Test<br>Cable Percussive BH | Exploratory Hole Location Plan | SITE:- Park Lane, Charvil | Drawn EM | |

2.4.2. A Site Investigation was undertaken by Geo-Integrity ref: 25-07-12 which provides further details of the underlying ground conditions. The results of the investigation works are included in *Appendix B* which identifies the test locations with soils encountered, areas of contamination and soakage tests locations / rates.

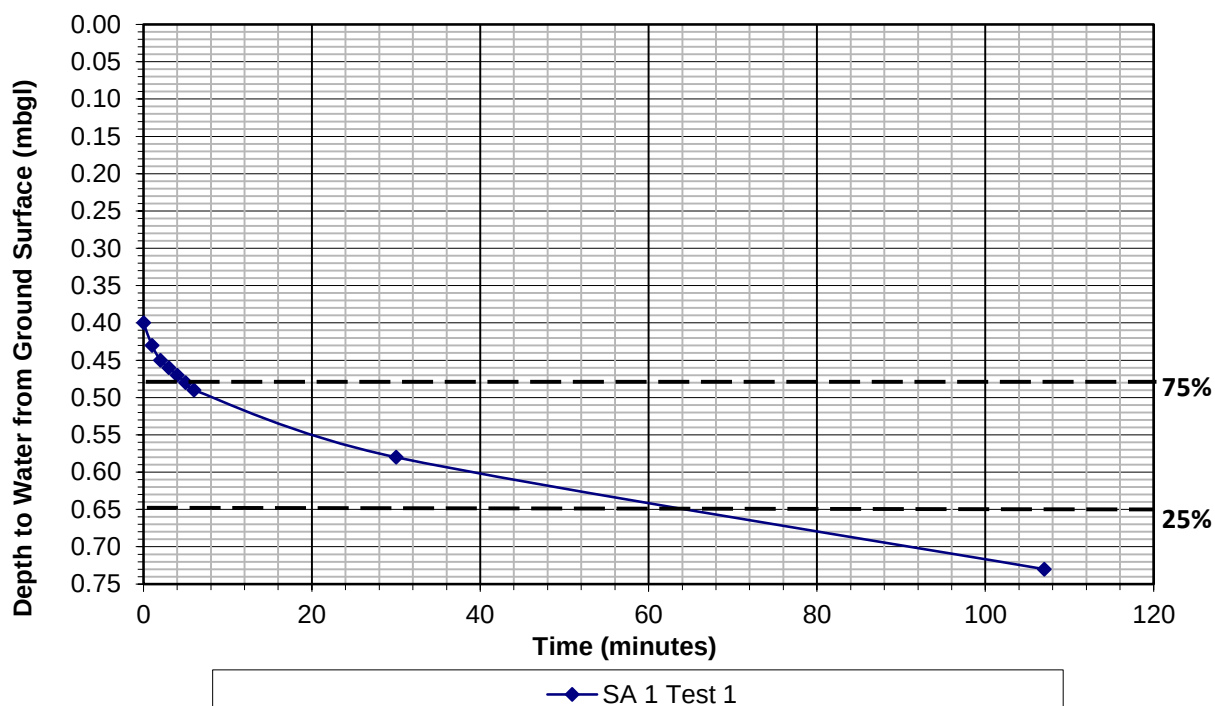
**Soil Infiltration Rate:  $2.44 \times 10^{-5}$  m/s**

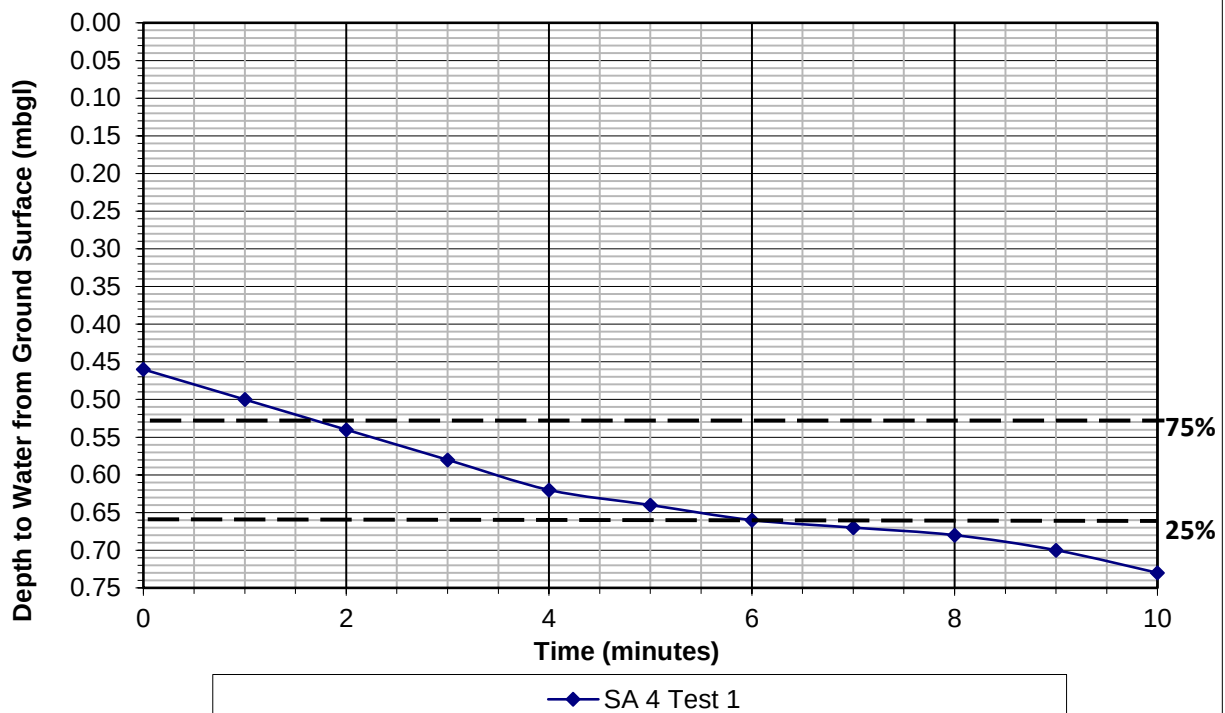
Soil Infiltration Rate:  $3.03 \times 10^{-4}$  m/s

| System | Assessment | Suitability |
|---|---|---|
| <b>Discharge to ground by infiltration.</b> | In Section 2, it was noted that soakage tests to BRE 365 were undertaken across the site. The recorded rates ranged between $\times 10^{-4}$ in the west and $\times 10^{-6}$ in the east. Whilst the infiltration rates permit the use of infiltration, winter groundwater monitoring confirmed elevated levels across the site between 0.33-0.62mbgl. In accordance with WBC standards, 1m from the base of infiltration systems is required to the highest recorded level could not be achieved and therefore discharge to ground is not considered feasible. The site investigation also identified the risk of pollution features known to be prevalent in the area limiting the potential use of infiltration to the be solely relied on and recommending a minimum of 10m from any foundations for structures, roads and railways. | ✗ |

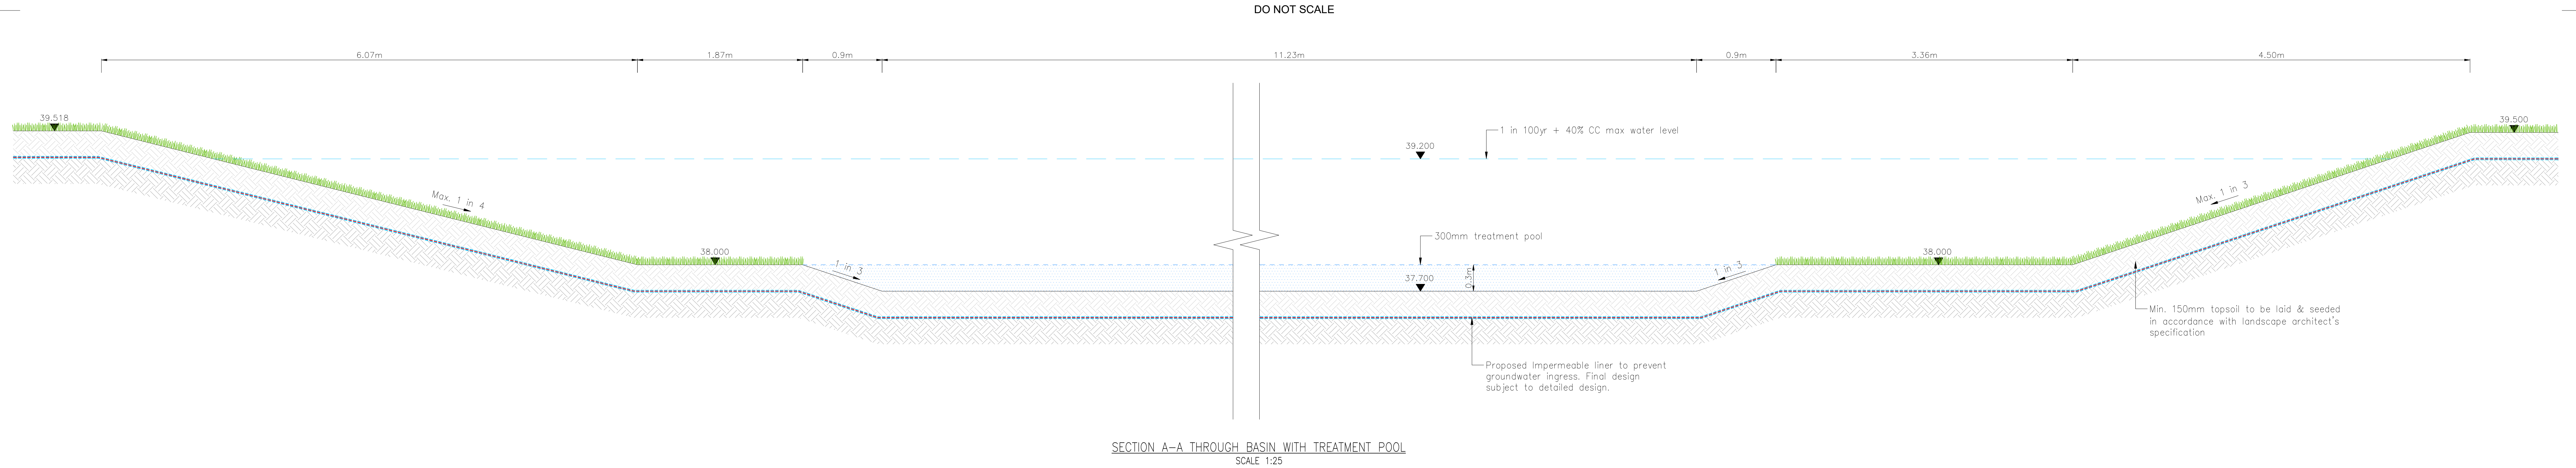
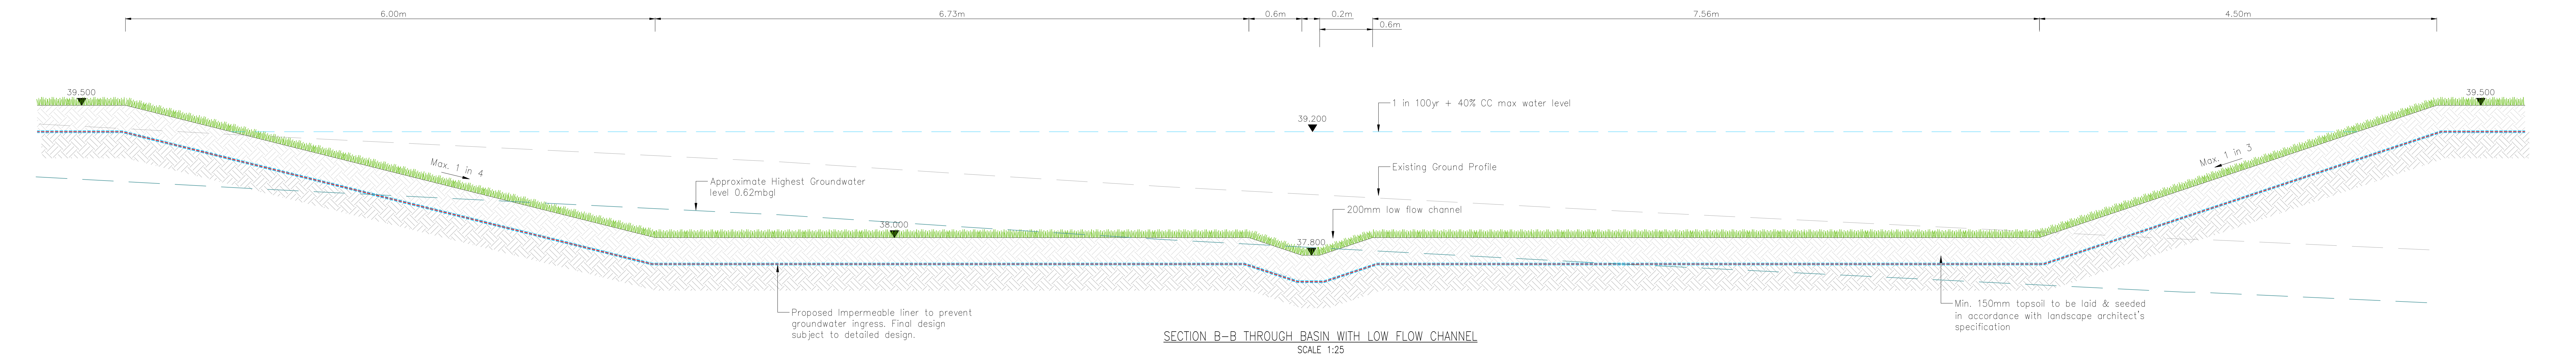
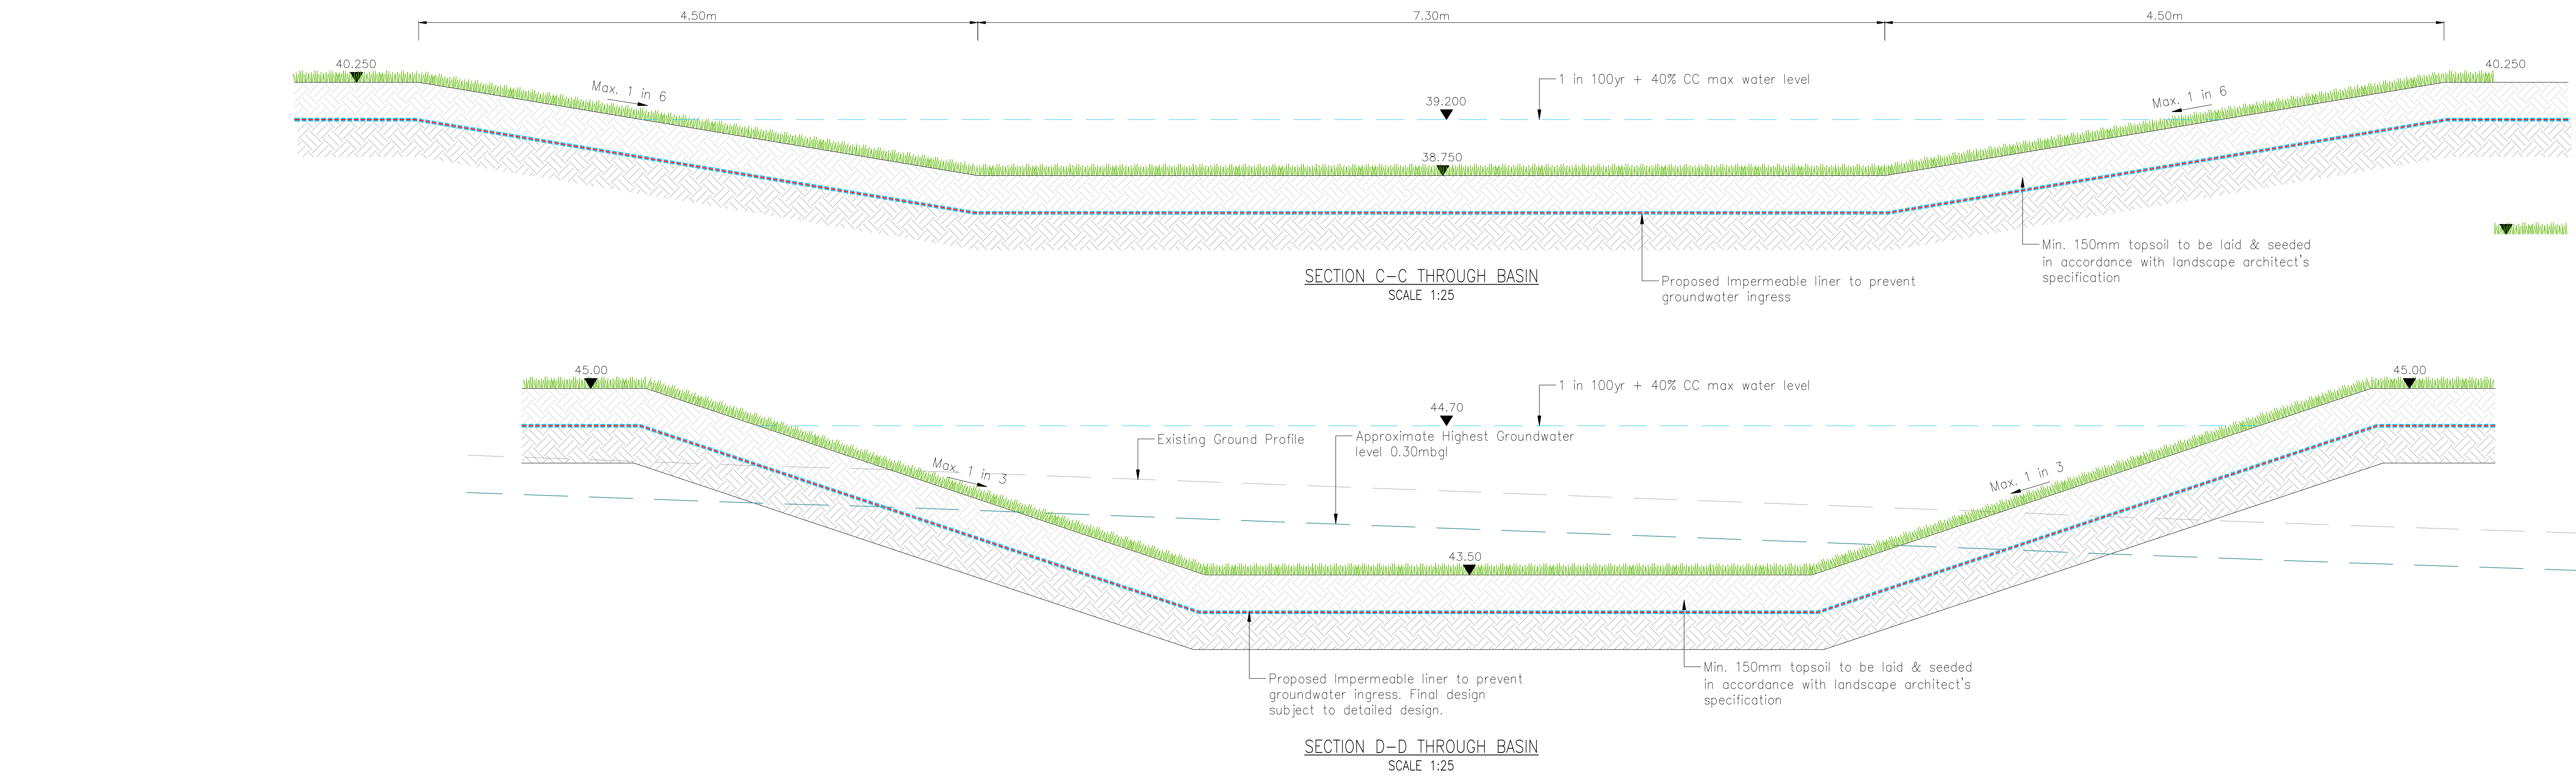
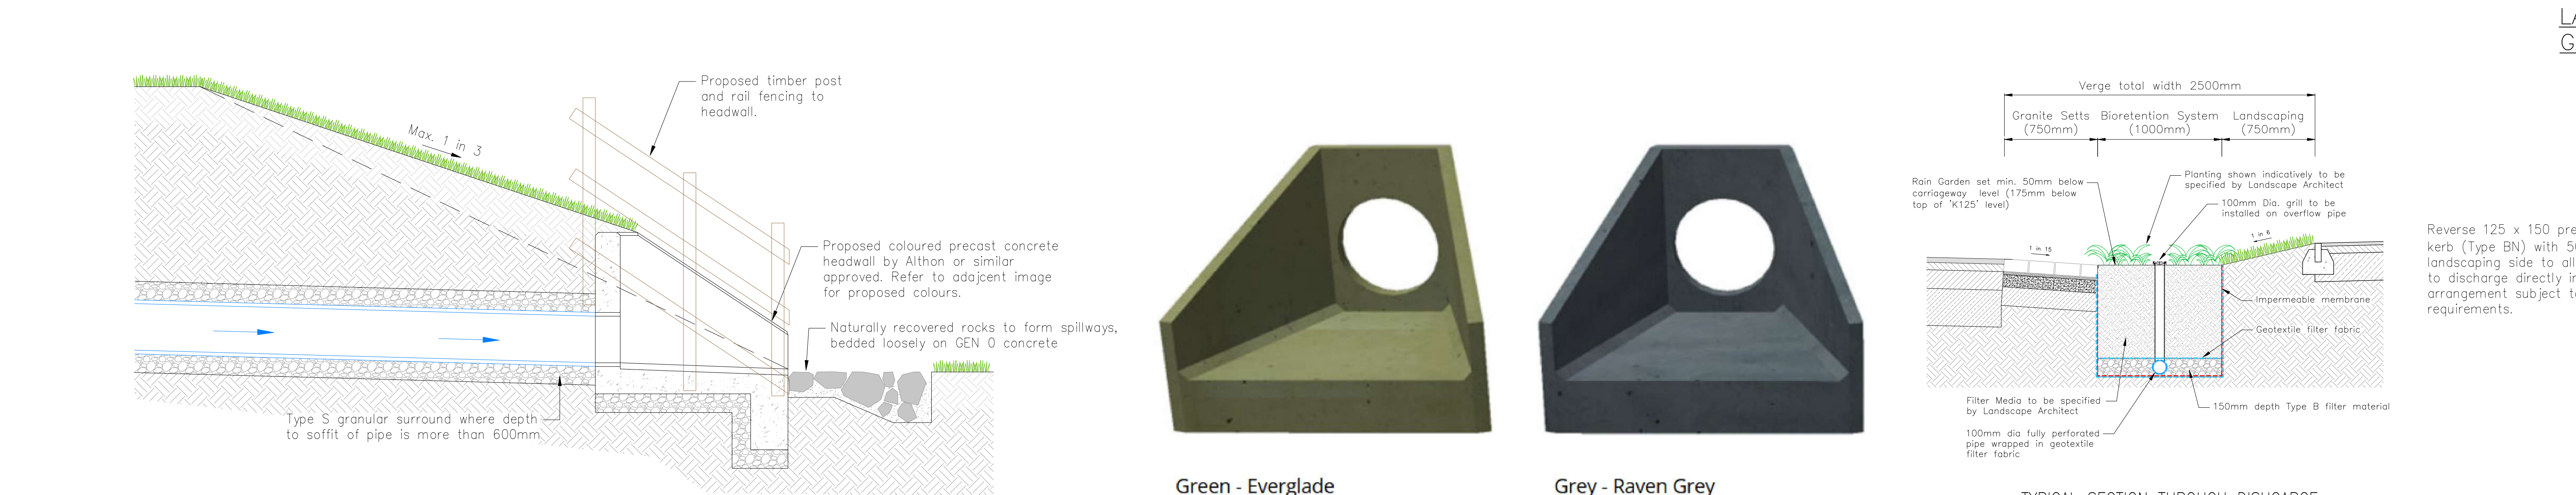
### SuDS Construction Details

LLDPE Impermeable Membrane by Stormwater Management LTD or similar approved

NOTE  
Membranes to be installed in accordance with manufacturers recommendations
