**BS5837:2012 TREE SURVEY AND  
ARBORICULTURAL IMPACT ASSESSMENT:  
40 Parkway, Crowthorne, RG45 6EW**

Our reference: GHA/DS/160888:25

Location: 40 Parkway, Crowthorne, RG45 6EW  
Our reference: GHA/DS/168880:25  
Client: L Anderson  
Dated: 30<sup>th</sup> September 2025  
Prepared by: Glen Harding MICFor, MSc (Forestry), MArborA  
Date of Inspection: 24<sup>th</sup> September 2025

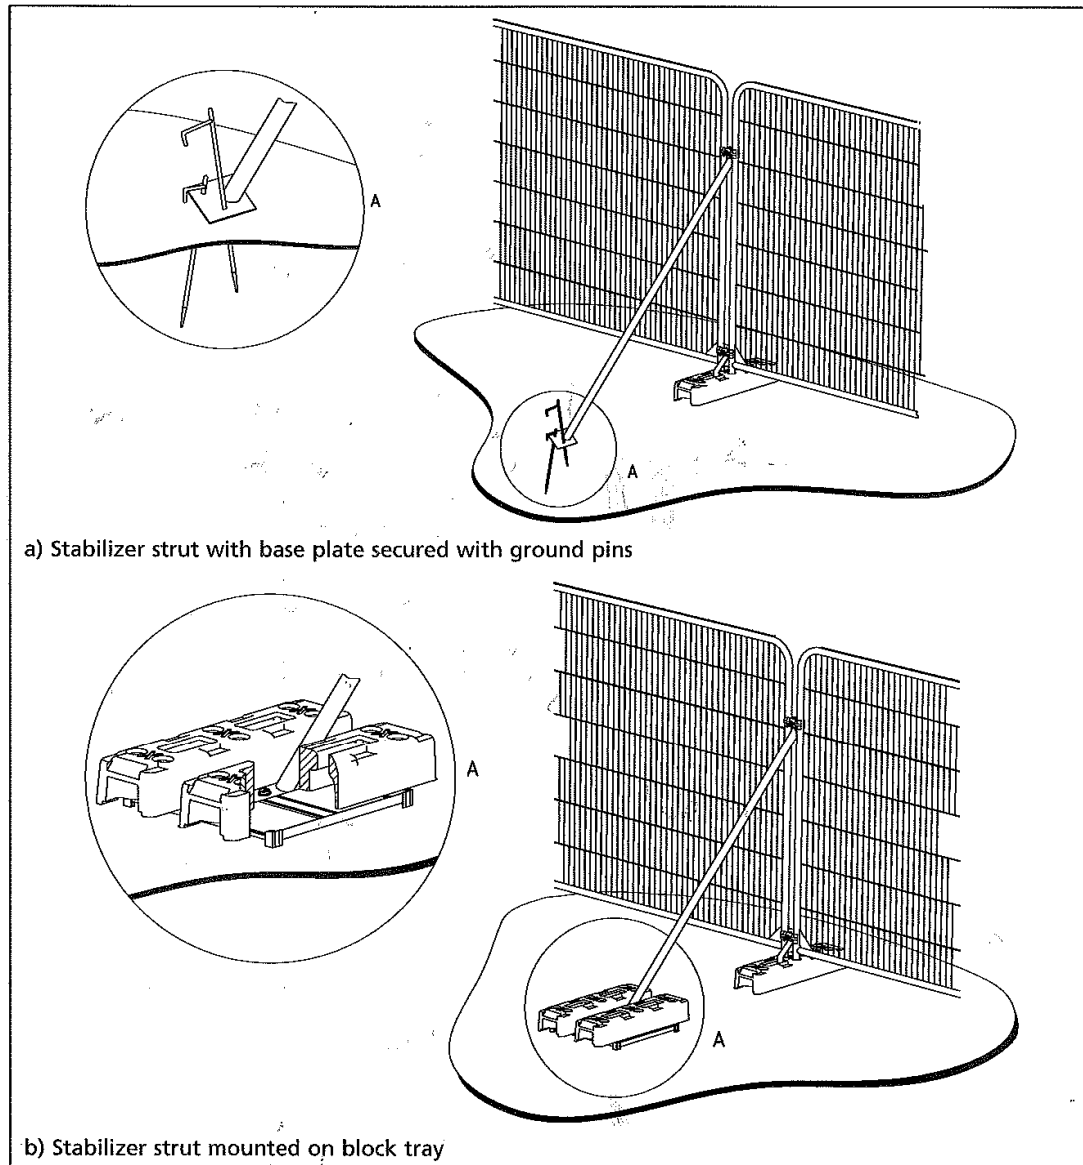
**Appendix C**  
**TREE FENCING DETAIL**

Figure 3 Examples of above-ground stabilizing systems

It is essential for the future health of the trees to be retained on site, that all development activity is undertaken outside the root protection zone of these trees. The position of the fence **MUST** be marked out with biodegradable marker paint on site and agreed with appropriate representatives from the LPA and contractor. The fencing **MUST** be erected **prior** to any works in the vicinity of the trees and removed only when all development activity is complete. The protective fencing **MUST** be as that shown in BS 5837 (see Appendix C). The herras panels **MUST** be joined together using a minimum of two anti-tamper couplers which **MUST** be installed so they can only be removed from the inside of the fence. The panels **MUST** supported by stabilizer struts, which **MUST** be installed on the inside and secured to the ground using pins or appropriate weights.
