| The Old Cottage, Sonning RG4 6UH |
| Proposed First Floor Ceiling Beam Repair |
| Existing & Proposed First Floor RCP Plans |

| 1362-HR-A-TP-XX-0122 | 00 | |

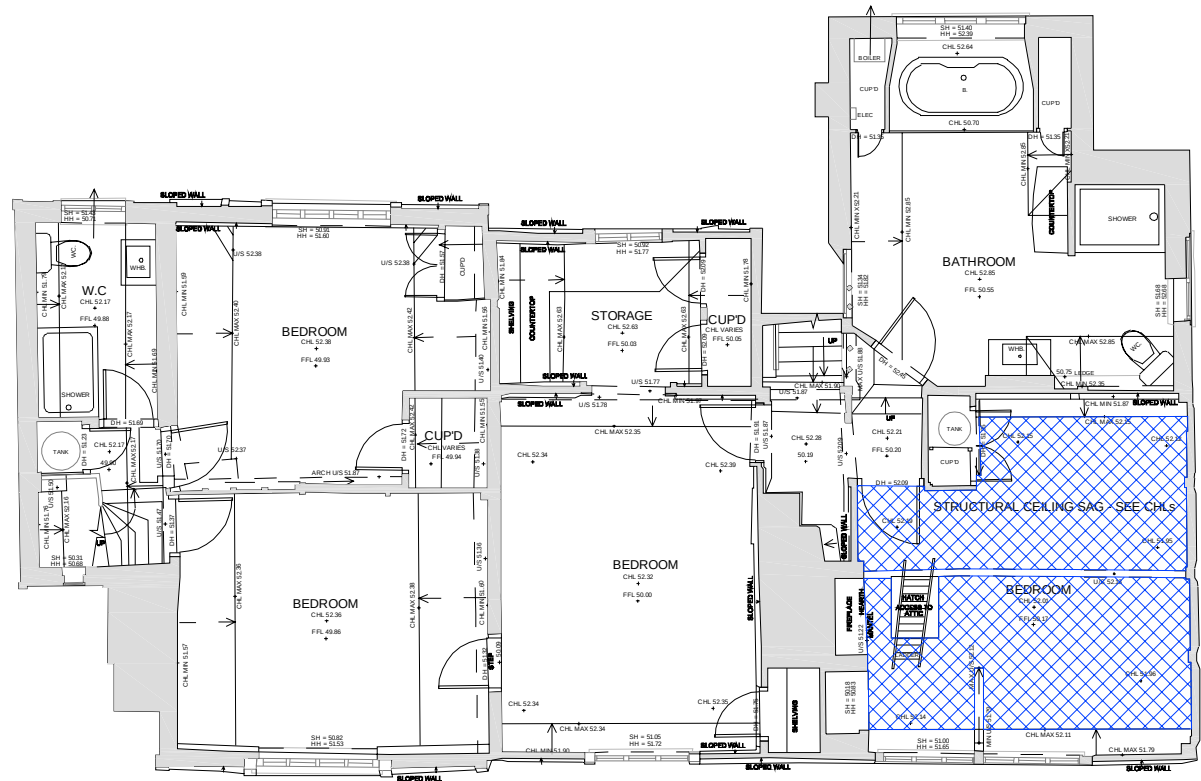
2 PROPOSED FIRST FLOOR REFLECTED CEILING PLAN

Existing ceiling hatch (appx. 600 x 800mm) - to be used to access the ceiling void to carry out the proposed repairs

- KEY
- Existing fabric
  - Ceiling repair area: damaged laths to be replaced with riven laths; modern plaster finishes to be removed where possible to reduce weight on existing laths.  
15 mm scratch coat haired lime mortar,  
10 mm float coat unhaired lime mortar,  
3 mm top coat of heritage lime plaster (based on Mike Wye products, or similar).
