## HERITAGE STATEMENT. Date: 28.03.2025

### 11 HEADLEY ROAD, WOODLEY, BERKSHIRE. RG5 4JB

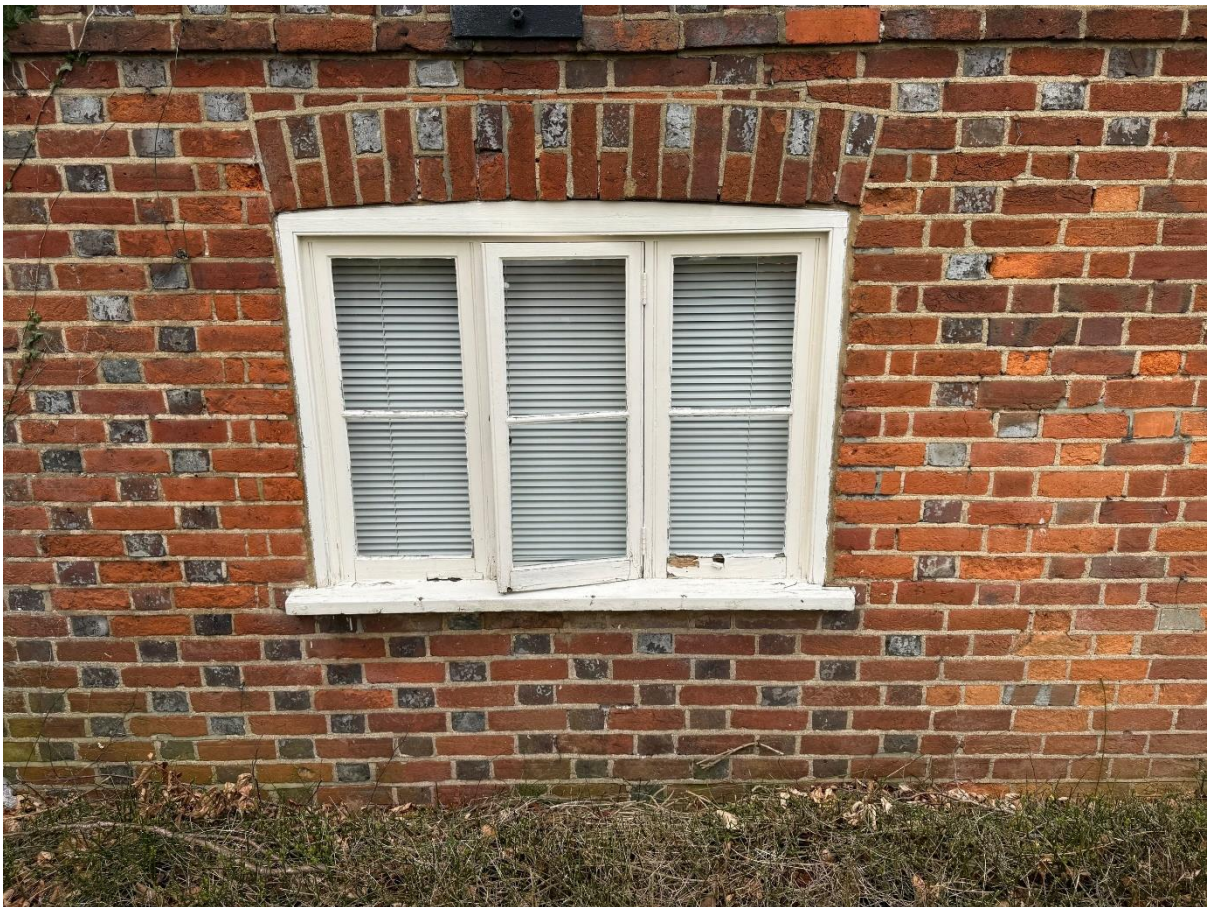
6. Five windows facing south (front elevation) are in a very poor state of repair and beyond economic or feasible repair. These windows are numbered A to E on the accompanying drawing.
7. Like wise the porch is decayed beyond economic or feasible repair, although the roof can be salvaged.
8. It is intended to carefully remove the four original front windows (A to D) and replace them with like for like single glazed soft wood windows detailed to match the existing 100%, including the beading detail to the opening light frame uprights. Windows C and D will have a matching spandrel infill panel to the head. The windows will be painted white.

**Window D showing typical decay to cill, casement bottom rails, swollen shut casements etc. All windows (A to D) are similar.**
