## Heriots, Wokingham Road, Hurst

Application Ref. 242961

### Condition 2 - Cladding Removal Method Statement

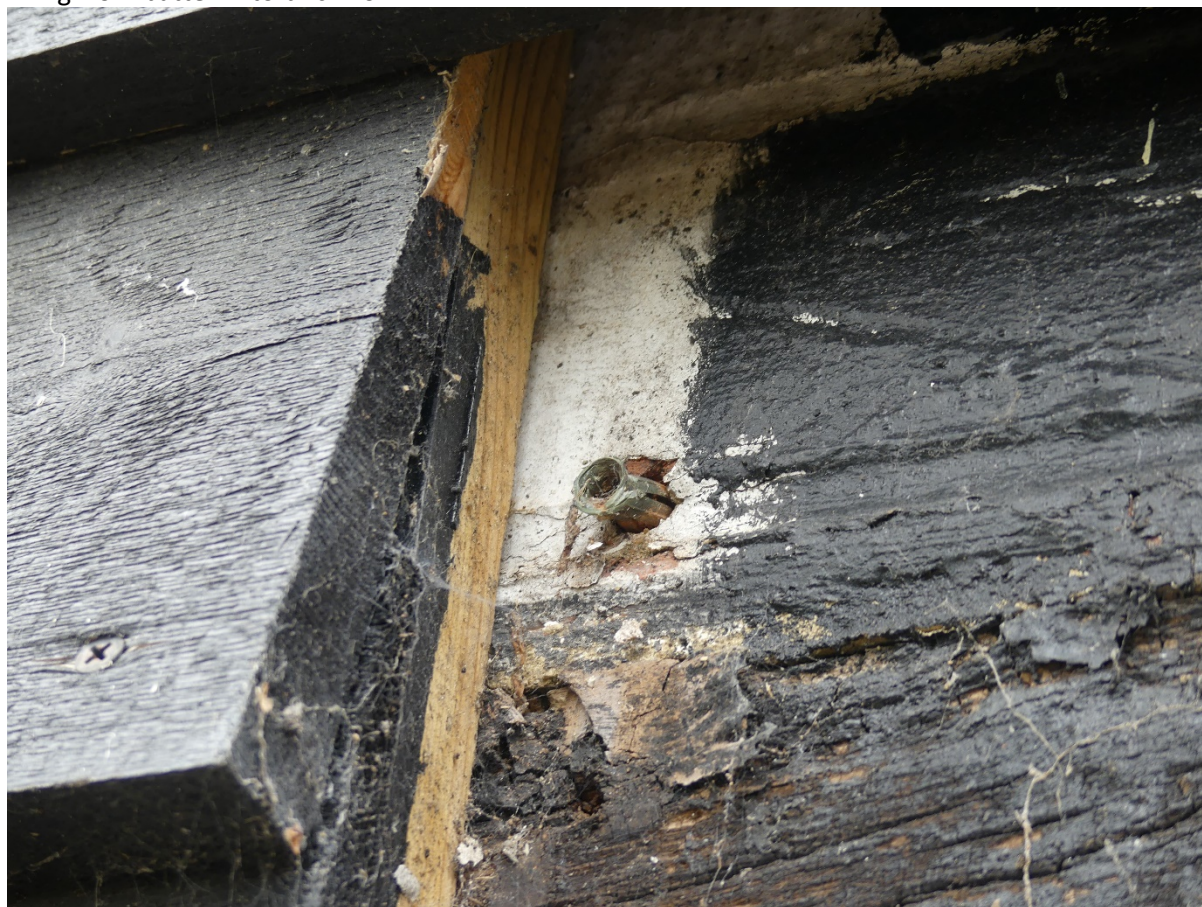
Upon further investigation, we note that the existing horizontal black stained weather boarding has been screw fixed to 44 x 25mm vertical softwood timber battens, which in turn were fixed to the existing walls via wall plugs and screws. Note that the walls have been painted in a white masonry paint.

Image below shows the cross head screw fixing the weatherboarding to the battens, and a rawlplug fixing from batten into brickwork.

This simple method of fixing enables a simple method of removal as follows:

- 1 Unscrew weatherboarding planks using Philips screw driver (or battery screwdriver)
- 2 Carefully unscrew battens from wall and gently remove plugs from wall by hand using pliers, taking care to minimise any facework damage to bricks.

Upon removal of all of the plugs, use a lime putty mortar to repair holes in brickwork, and any holes within the bed joints.

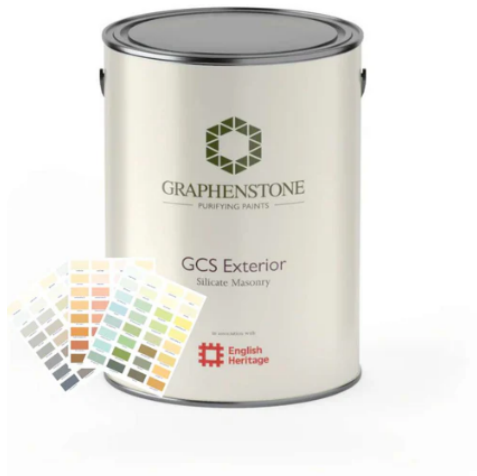
## Exterior Wall Paint, Lime Silicate, Colours – Heritage Graphenstone GCS Exterior

Universal exterior lime based natural paint for lime render, brick, old paints, brick, mortar, concrete and many others. Ideal for walls with multiple surface types or tricky substrates.

Graphenstone GCS Exterior is perfect for restoration works, especially on older or historic buildings that need to be able to breathe. Made from a perfect mix of lime, silicate and other natural mineral bases and offers a gorgeous matt finish.

Upon restoration of the holes, any loose/flaking existing white masonry paint is to be removed with a light brush, to accept a new white 'breathable heritage paint', from Graphenstone range, see below.

This paint enables the wall to breathe, preventing damp and mould growth, to enable internal finishes to remain in good decorative condition for longer.
