# MEMORANDUM

| <b>Address:</b> | URS Building, Whiteknights Campus, Earley, RG6 6BW. | | |
| <b>Proposal:</b> | <p>261891: Application for submission of details to comply with the following condition of planning consent 252389 dated 14/7/2026. Conditions 10 (Materials) and Condition 16 (Biodiversity).</p> <p>261892 - Application for submission of details to comply with the following condition of planning approval 252302 dated 14.07.2026. Condition 10 relates to materials of external stair cores.</p> | | |

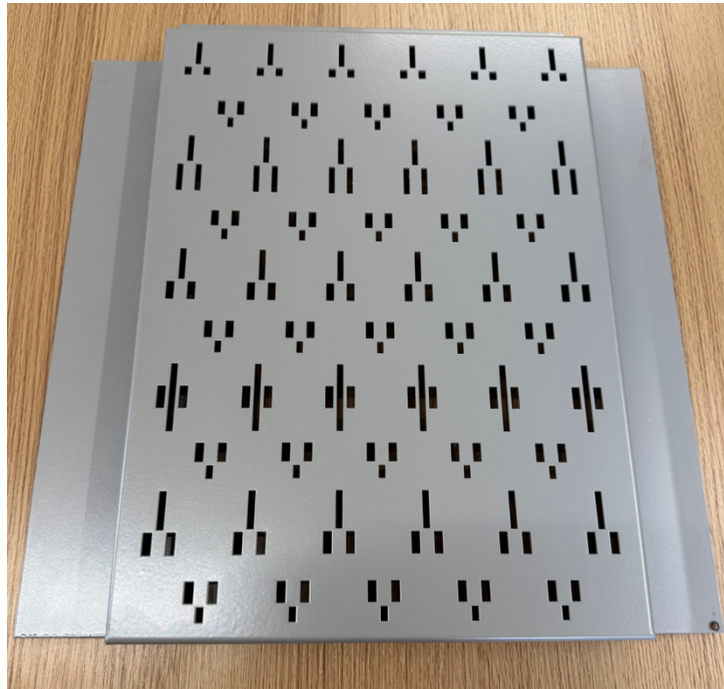
Submitted photo of cladding material sample

In terms of the physical sample the aluminium cladding with decorative perforation pattern to be used on the new stair and lift towers confirms the intended silver-grey coloured powdered coated finish to the cladding along with the size and configuration of the perforations to the cladding.

Whilst there is no provided scaling is shown in the photograph of the sample panel on a desk-top that would establish the relative size of the perforations in the panelling, which from the faux timber graining of the desk-top would appear to suggest these perforations to be relatively small (estimated to be around 5mm wide, with the longer elements being some 30mm long) and as such seemingly be quite small in size. Furthermore, the accompanying submitted drawing WW033-2360383-ACG-A-SKE260603-003 Rev.3: Proposed Stair Core, shows the arrangement of the perforations and their regularity to change over the length/height of the towers, with

the sample panel being thought to be representative of those cladding panels with the densest concentration of perforations to them. Also as shown on the drawing the perforations to the cladding would appear to be larger than that of the sample.

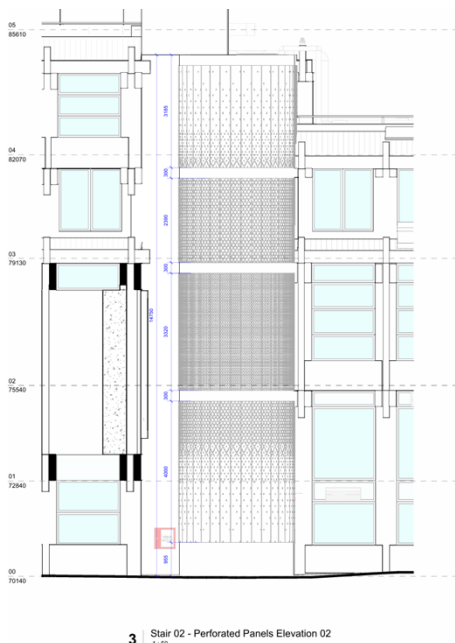
3 | Stair 02 - Perforated Panels Elevation 02  
1:50

Extract of drawing WW033-2360383-ACG-A-SKE260603-003 Rev.3: Proposed Stair Core
