Land West of Park Lane  
Charvil

# **Arboricultural Method Assessment**

| <b>Project:</b> | Land West of Park Lane, Charvil |
| <b>File Reference:</b> | 12671_AMS.001 Rev C |

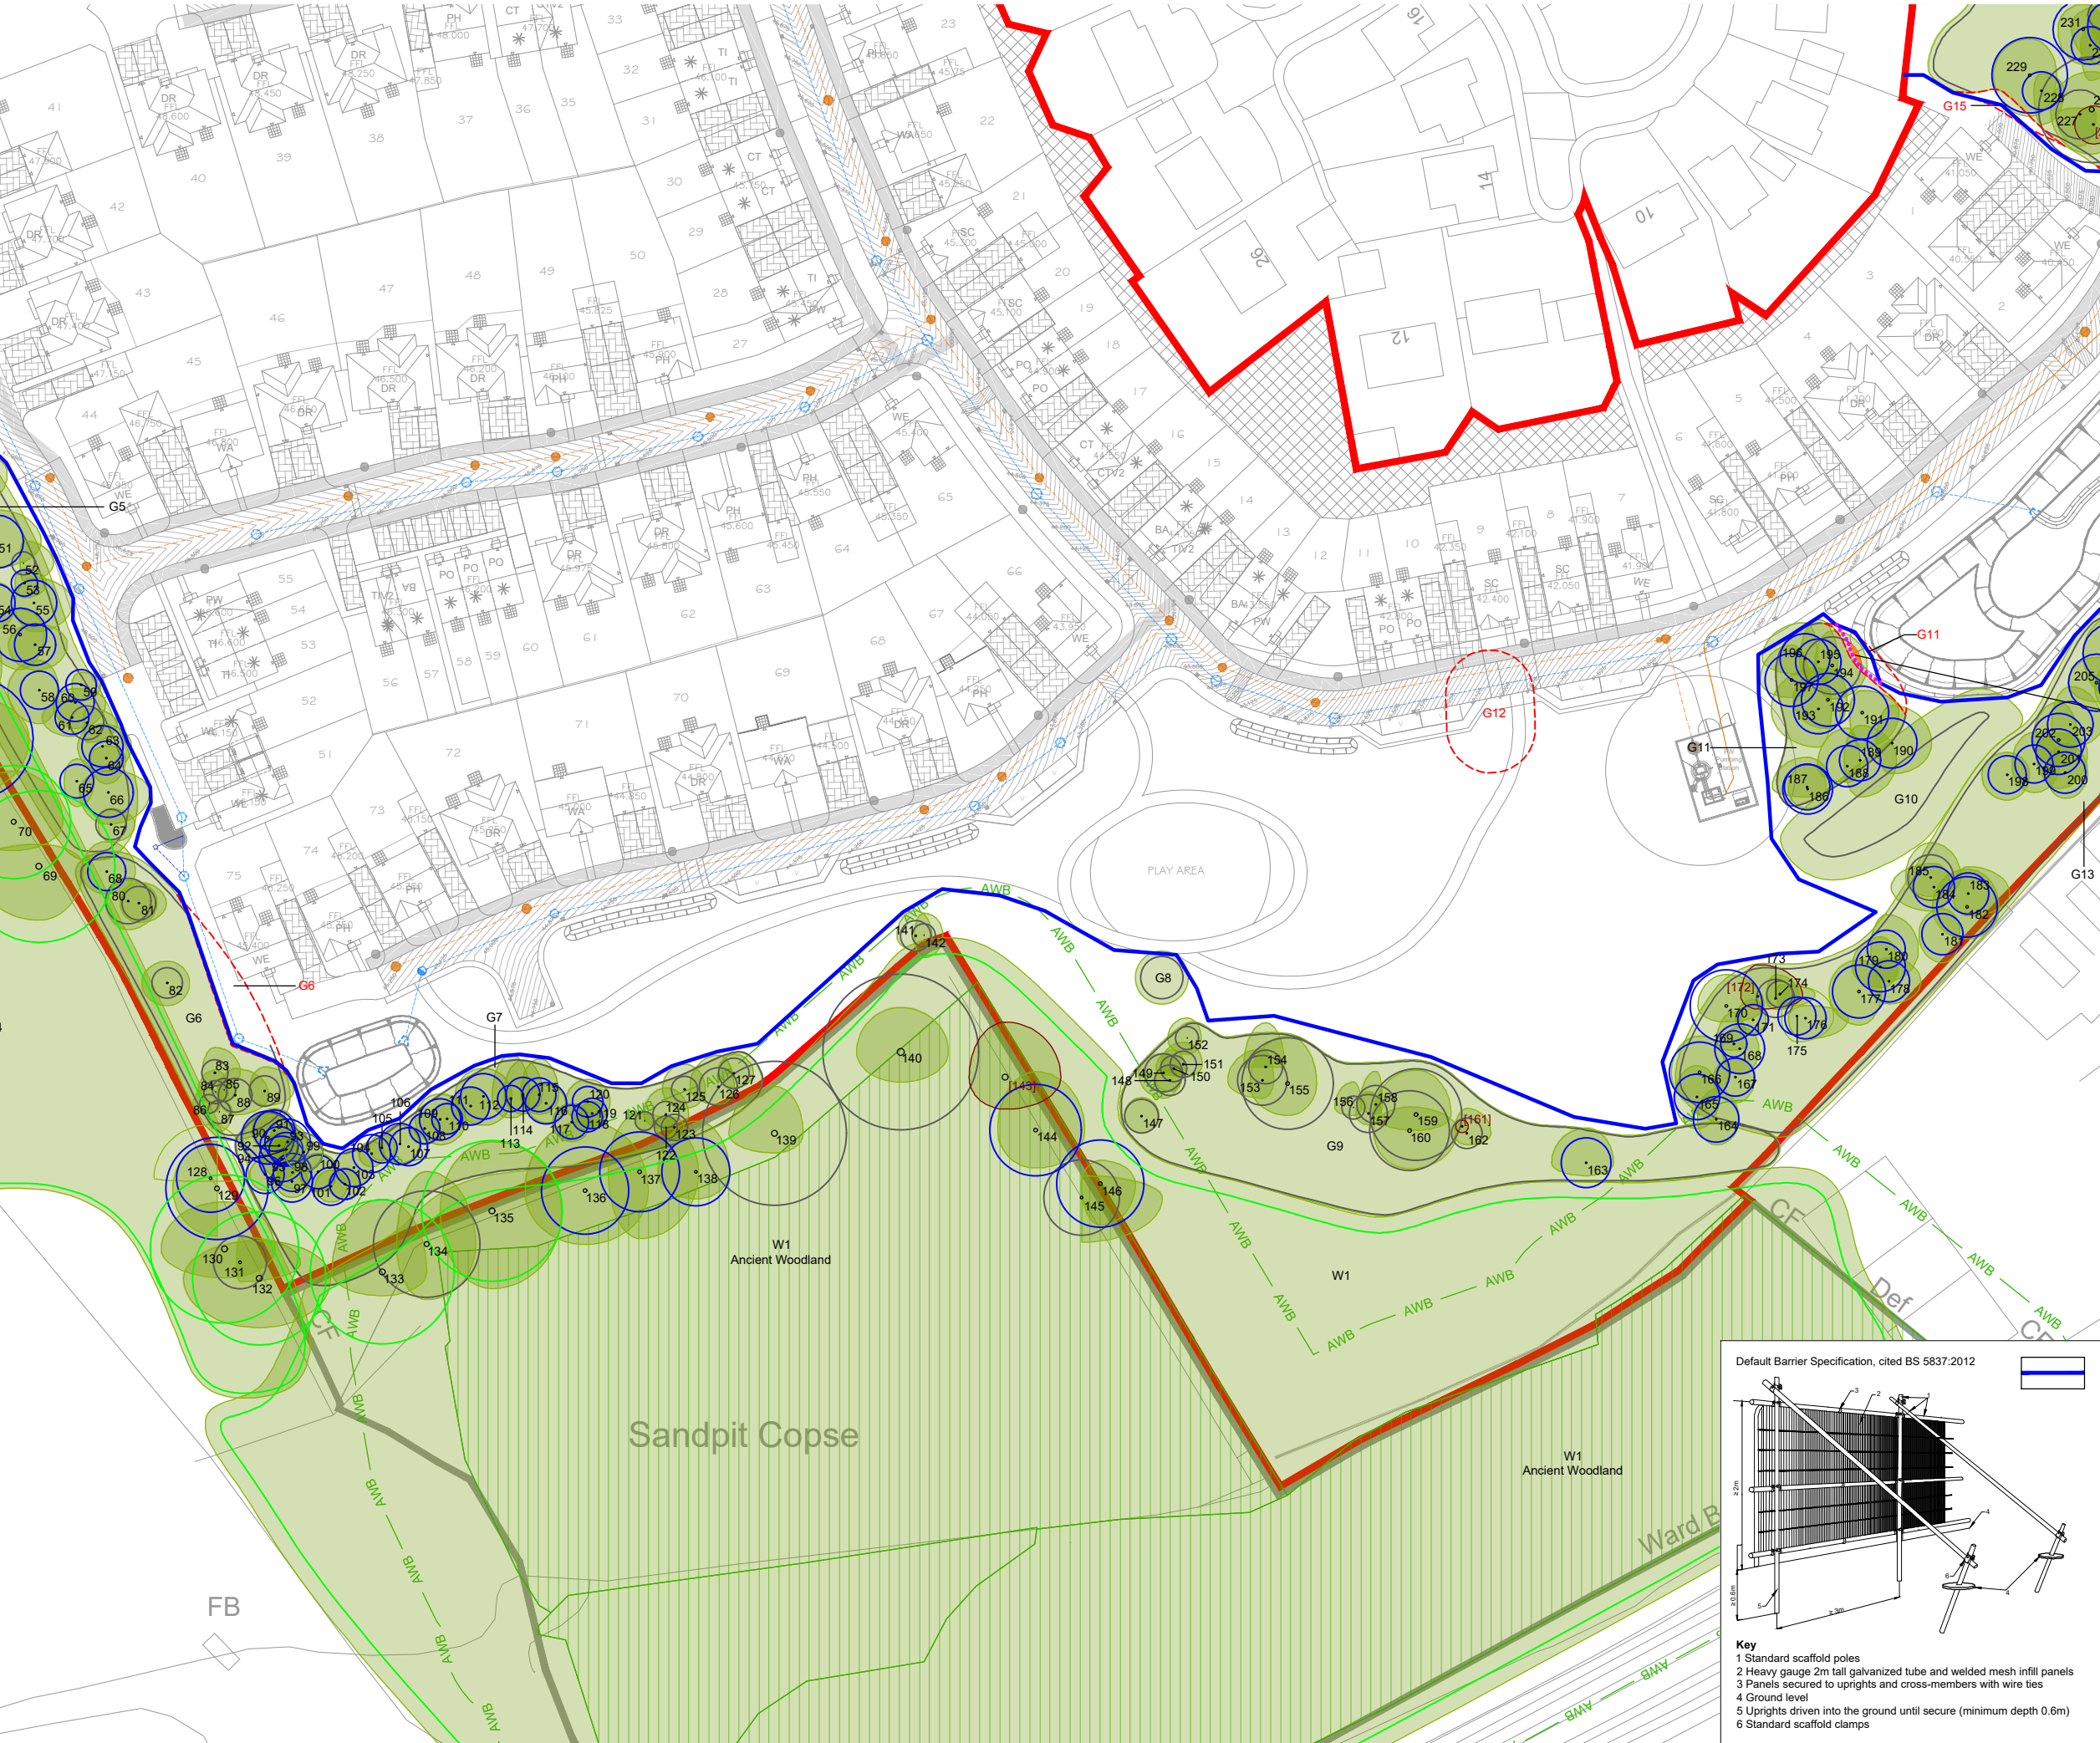
| 12671 TPP 01 Rev C (1/3) | C | |

- KEY:**
- Site Boundary
  - Tree Numbers
  - Tree Canopies
  - Category 'U' Trees
  - Category 'A' RPA
  - Category 'B' RPA
  - Category 'C' RPA
  - Ancient Woodland
  - Ancient Woodland 15m Buffer
  - Tree Preservation Order
  - Trees to be Removed
  - Tree Protection Barrier
  - Tree Protection Barrier (2nd Position)
  - Supervised Excavation

Note: Trees 4, 8, 12, 31-33, 68-75, 126-140, 143-146, 181, 210-212, 234 have been plotted using measurements on-site in conjunction with aerial imagery. Their boundaries were not recorded on the topographical survey of the site (drawing ref: 10544 Park Lane Charvil.dwg).  
Note: The RPA footprints for Trees 1, 2, 31, 32, 210, 216, 221, 222, 226, 237 have been displaced to allow for the effect of the adopted highway and existing building foundations. The surface area of the RPA has not been reduced.

- 2.4.1 Tree protection barriers are required to safeguard retained trees from damage during construction works. Protective barriers must be installed before works commence as illustrated on the Tree Protection Plan provided at appendix A. The location for protective barriers has been informed by retained trees' canopy extents and root protection areas (RPA) and are shown within appendix A with a dark blue line.
- 2.4.2 The Site Manager will be responsible for arranging attendance of the Project Arboriculturist, for the purpose of setting out barriers, and for their monitoring during the development; issues will be resolved on site and reported to the Council's Arboricultural Officer by the Project Arboriculturist.

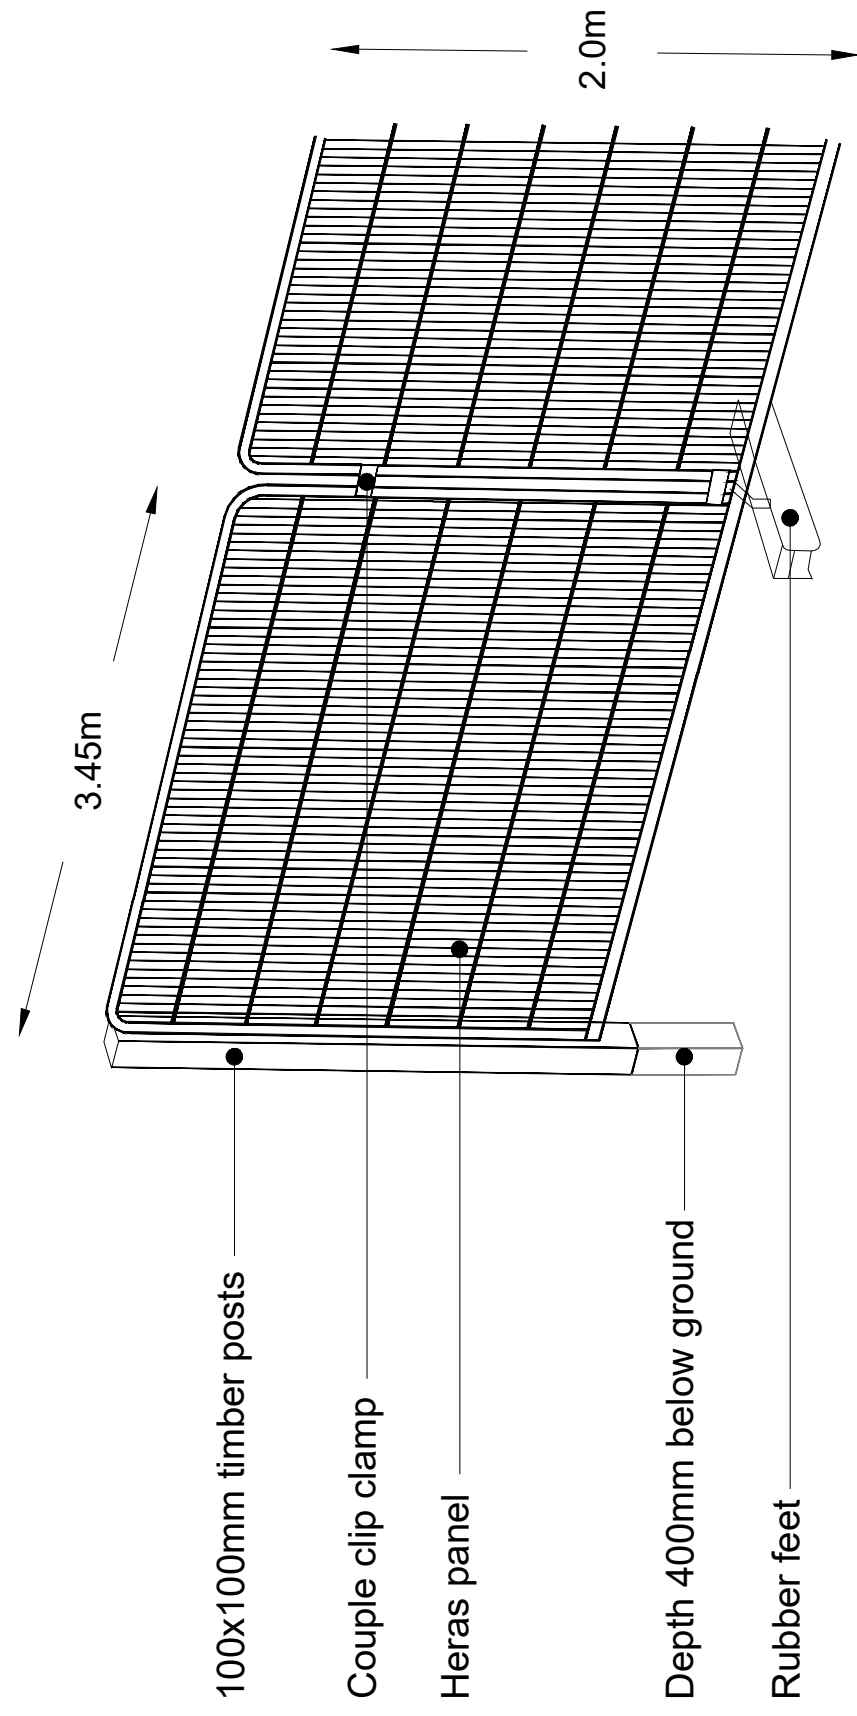
## Tree Protection Barrier Specification

Heras panels supported with pinned rubber feet and driven 100x100mm timber posts on every second panel.
