## Emergence Survey Report – Bats

| <b>Site Location</b> | 3 Foxcote, Finchampstead, WOKINGHAM, RG40 3PG |
| <b>Document reference</b> | CE4579-01<br><br><i>This document should be read in conjunction with the Preliminary Roost Assessment for bats completed on the 2<sup>nd</sup> July 2025, document reference: CE4579</i> |

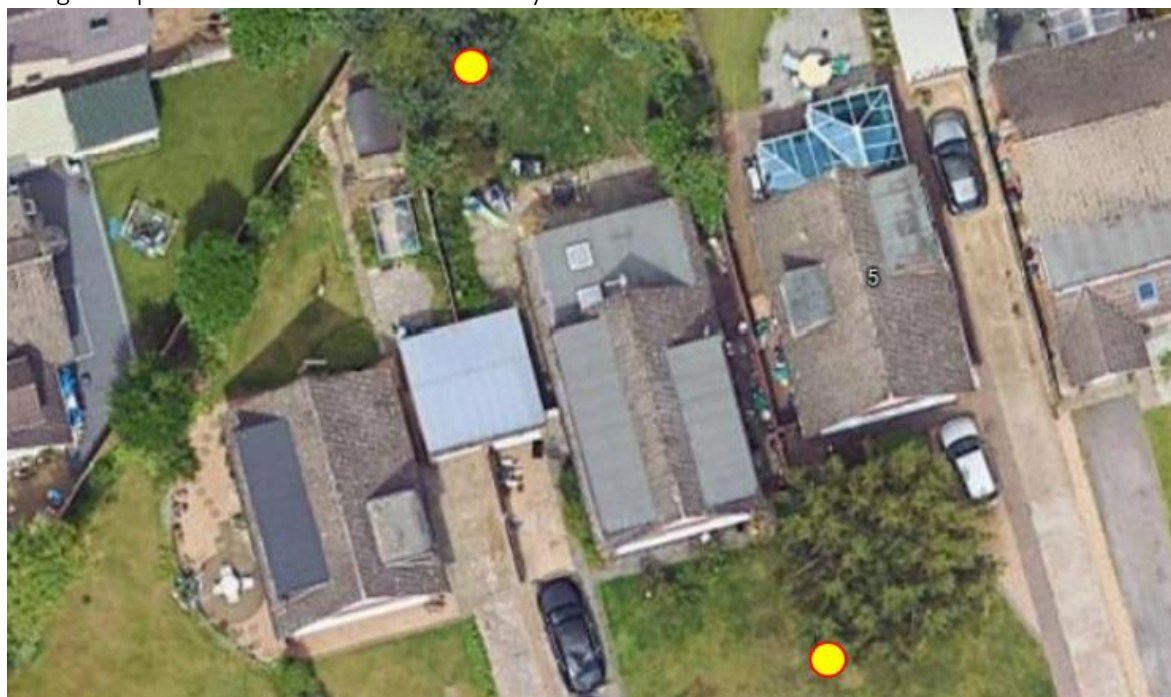
Google Map View to show locations of surveyors.

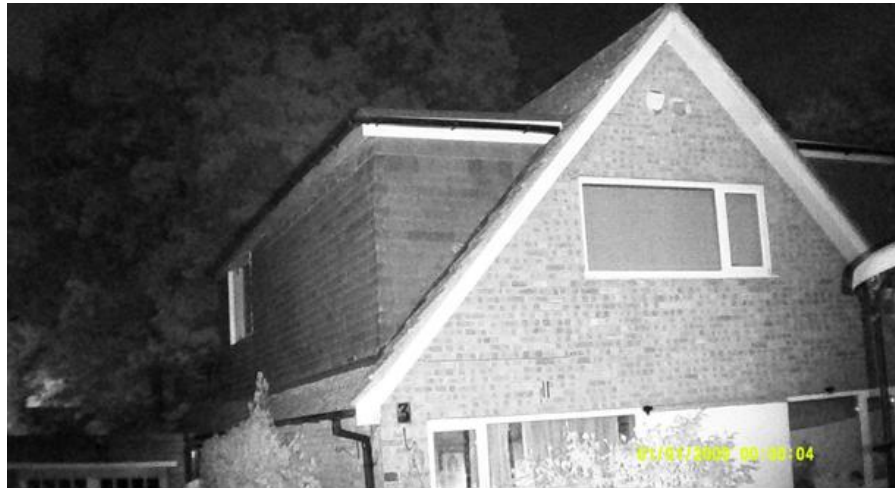
Front elevation view

No roosting activity recorded during survey times notes.

IR Images taken from each surveyor point during the survey

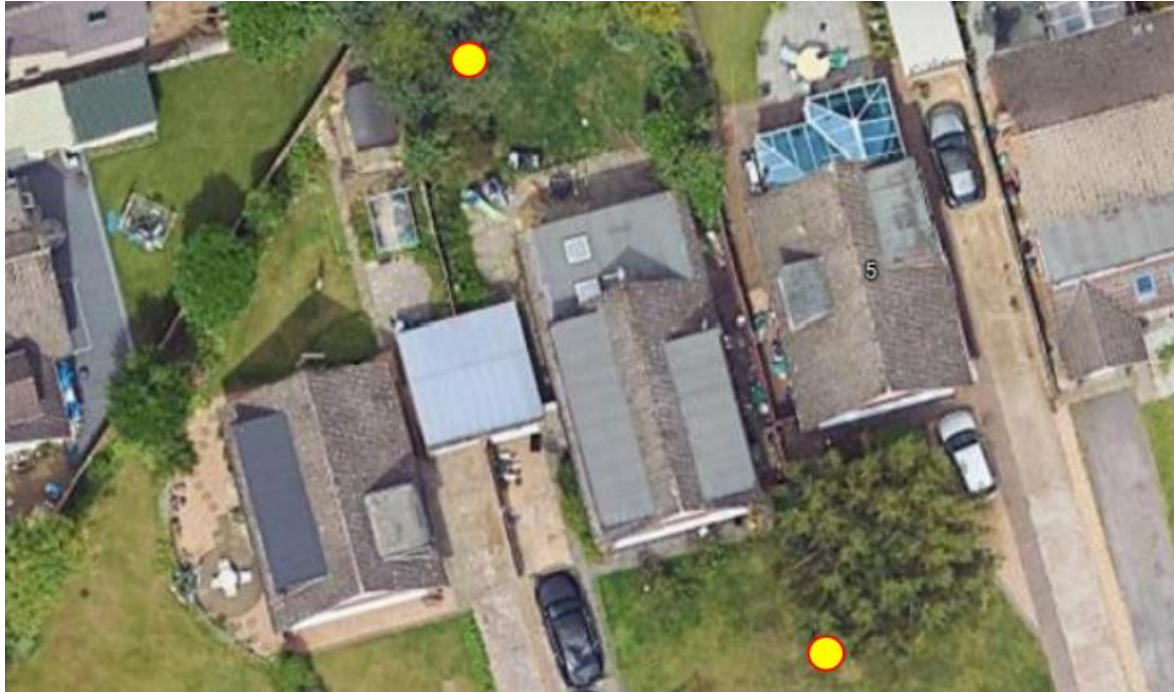
Google Map View to show locations of surveyors.

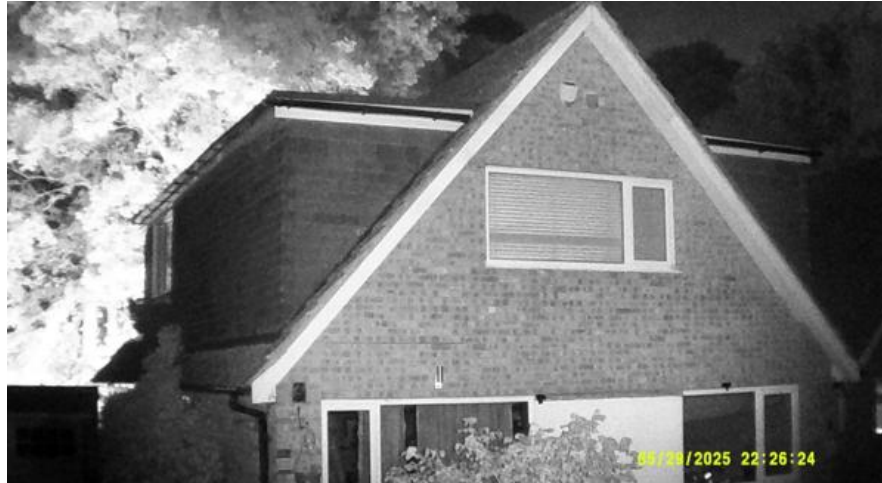
Front elevation view

No roosting activity recorded during survey times notes.

IR Images  
taken from  
each surveyor  
point during  
the survey
