## TREE SURVEY (BS 5837:2012)

CLIENT - Bernadette Cowling  
PROJECT - Powerscourt  
DOC. REF - P2590-TS01 V1  
PLANNING REF - n/a  
CREATION DATE - 19/12/2022

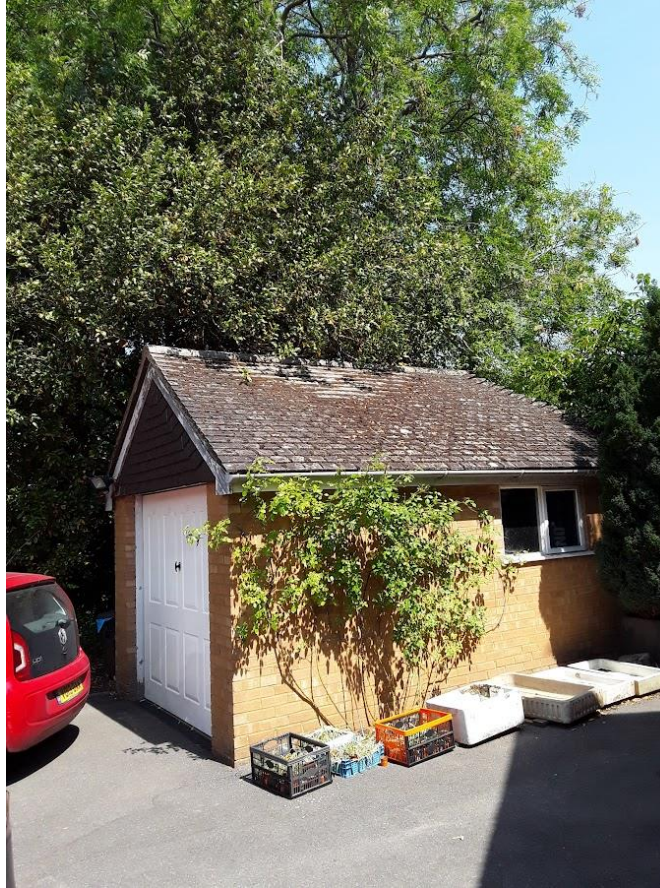
*Figure 1 – Looking northwards at the existing garage to be demolished.*

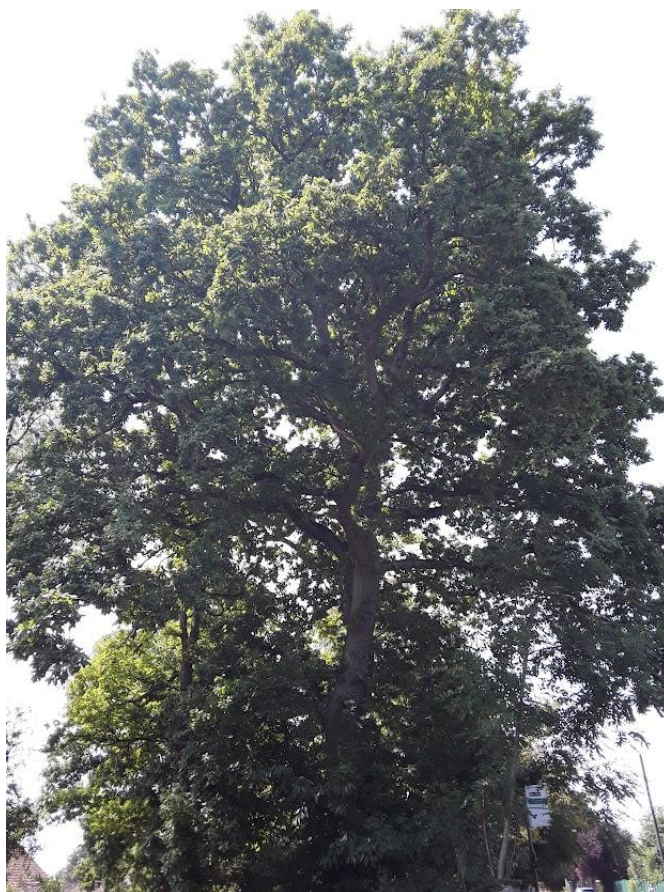
*Figure 2 – Looking westwards at T1.*

| Ref. | Tag | Species | Height (m) | Crown (N/E/S/W) | Crown Clearance (m) | DBH (mm) | Life Stage | Structural | Vitality | Additional Notes | General Management Recommendations | Priority | DRAFT Development Related Tree Works | Tolerance | RPA Radius (m) | RPA Area (m²) | Cat. |
|---|---|---|---|---|---|---|---|---|---|---|---|---|---|---|---|---|---|
| T1 | | Quercus robur (English oak) | 18.5 | 9 / 11 / 8 / 7.5 | 2 | 950 | Mature | Good | Good | Minor deadwood within crown - negligible risk posed. | | | | Moderate - Good | 11.4 | 408.3 | A2 |

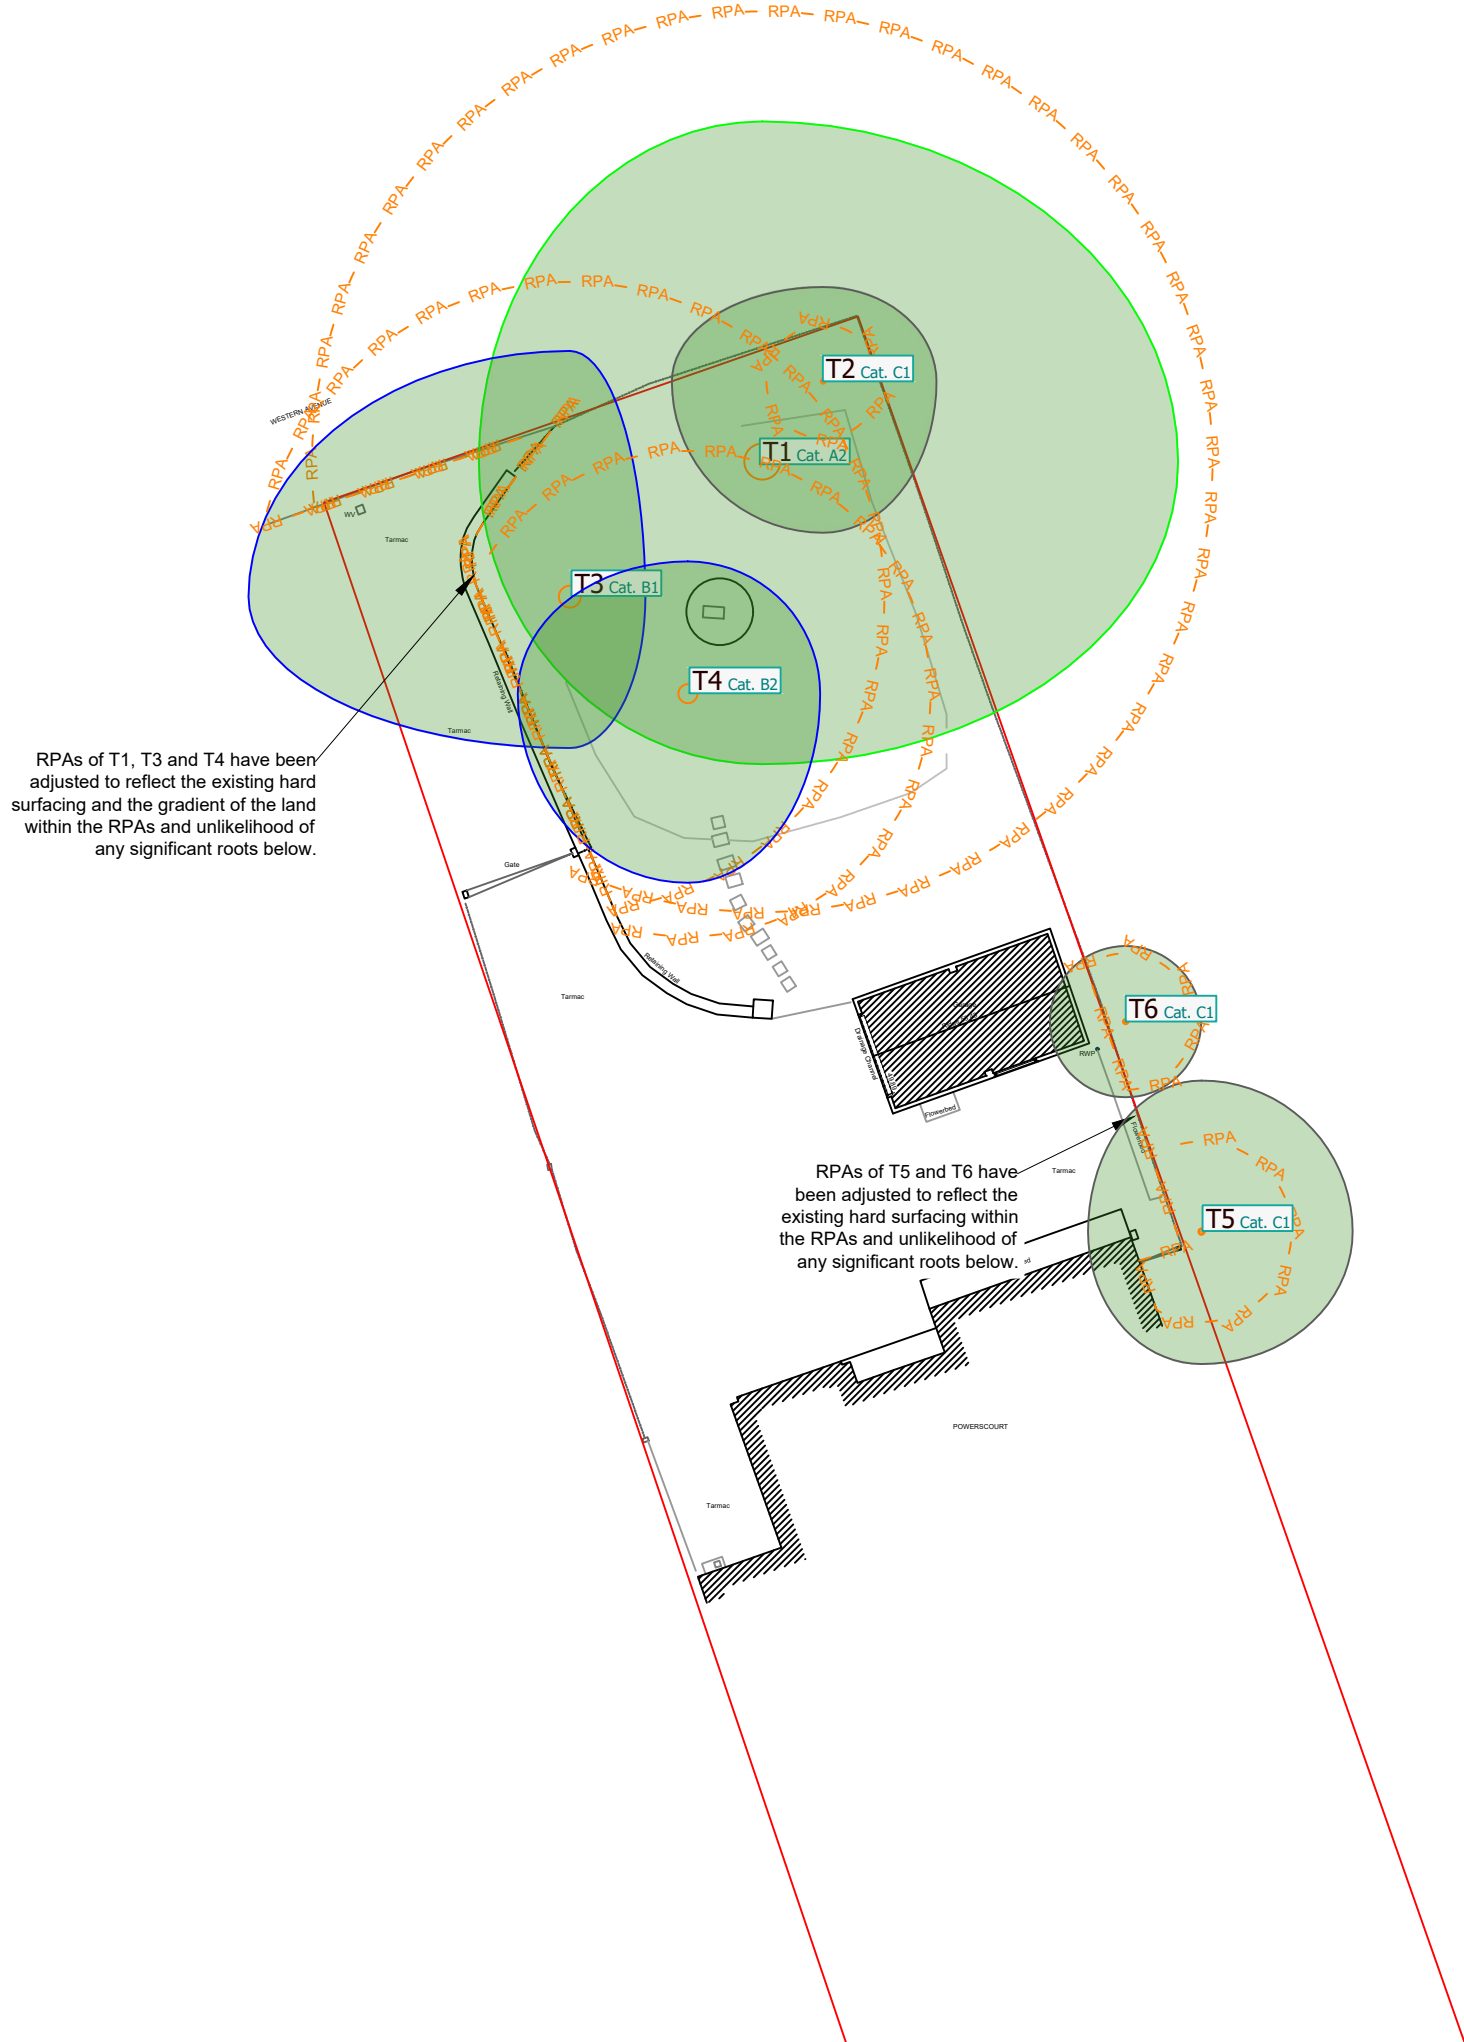
| Drawing: | | Arboricultural Site Plan (Existing) | |

The method used for categorising the trees can be seen in Appendix 1 of the Tree Survey/Arboricultural Impact Assessment. The categorisation method used is an improved variation of the method suggested in BS 5837:2012.

In order to avoid damage to the roots or rooting environment of retained trees, the Root Protection Areas (RPA's) should be plotted around each of the category A, B and C trees. This is a notional depiction of the minimum rooting area in m2 which should be left undisturbed around each tree. The RPA is calculated using the *British Standard BS 5837:2012 'Trees in relation to design, demolition and construction - Recommendations'*, unless otherwise stated within the survey schedule.

Where there appears to be restrictions to root growth the root protection area is reshaped to more accurately reflect the likely distribution of the roots.
