# Infrastruct CS

# Infiltration Test to BRE365 - SA1 - TEST 1

**7a The Ridgeway, Woodley, Reading, RG5 3QD**

**Ground Investigation**

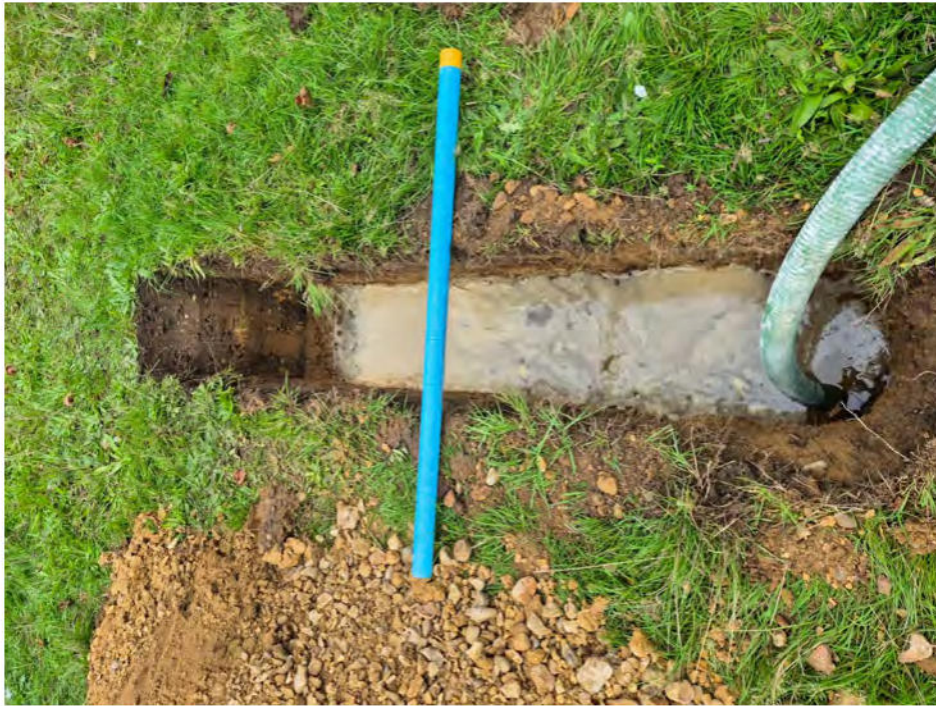
**Photo of the trial pit SA1**

| Exploratory Location (Depth) | Location Details |
|---|---|
| SA1 (1.00m) | Within the southern portion (Rear) of the site to assess the general ground conditions and carry out an infiltration test. |

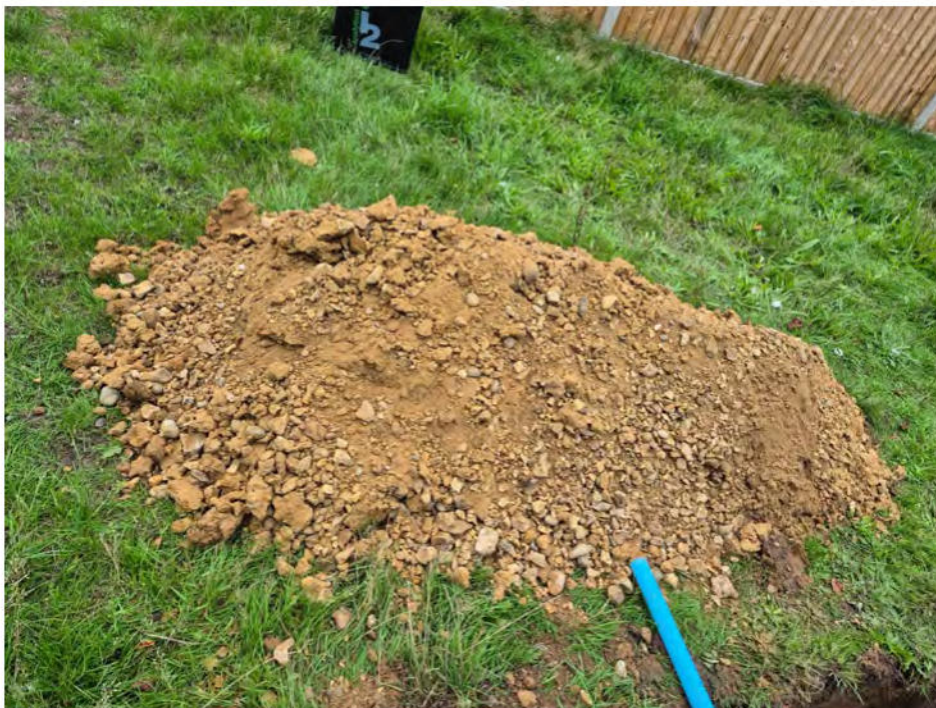
**Photo SA1 Arisings**

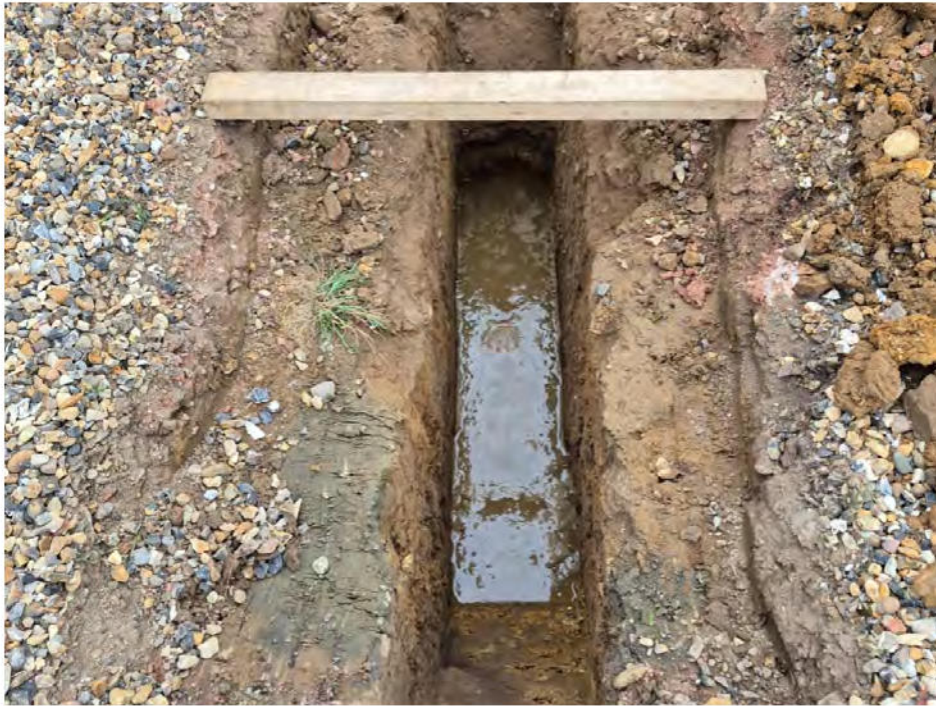
**Photo of the trial pit SA2**

| Exploratory Location (Depth) | Location Details |
|---|---|
| SA2 (1.70m) | Within the northern portion (Front) of the site to assess the general ground conditions and carry out an infiltration test. |

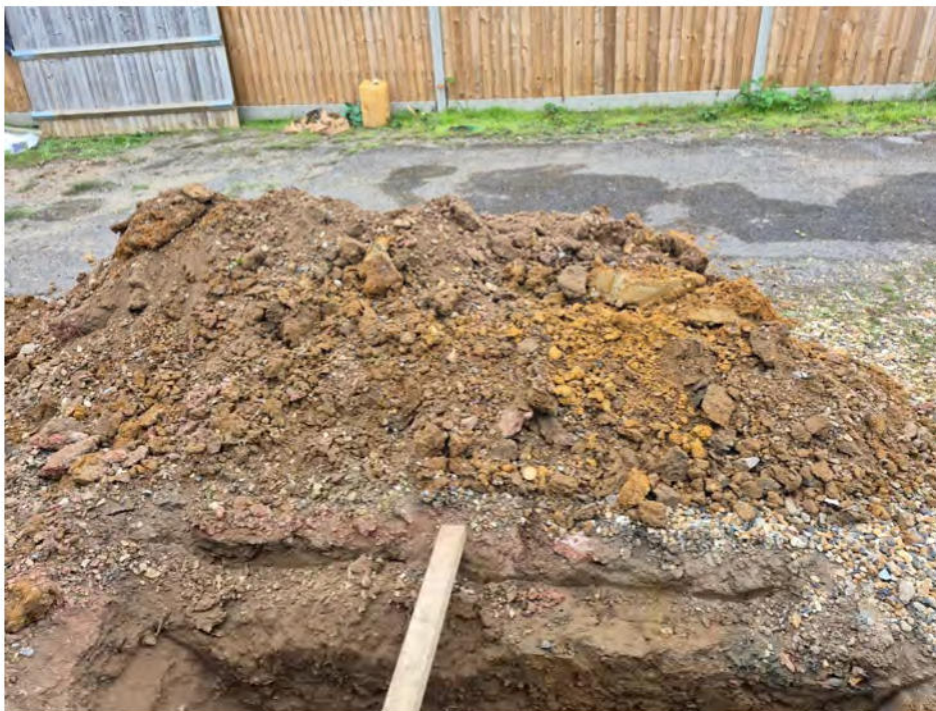
**Photo SA2 Arisings**

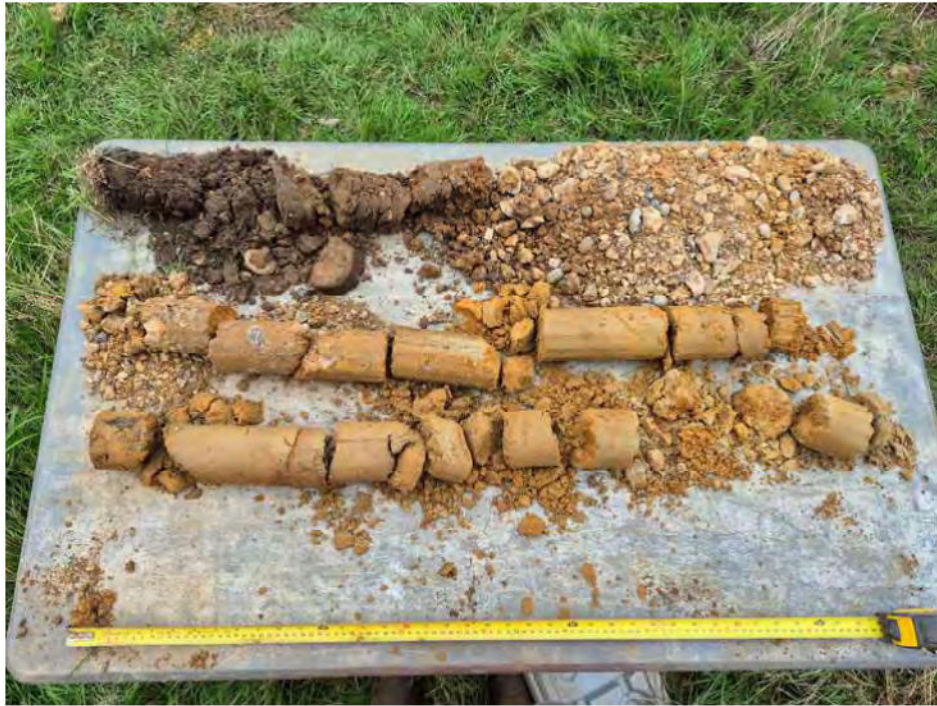
**Photo of WS1**

| Exploratory Location (Depth) | Location Details |
|---|---|
| WS01(3.00m) | Nearby the southeast corner of the proposed dwelling to assess the general ground conditions. |

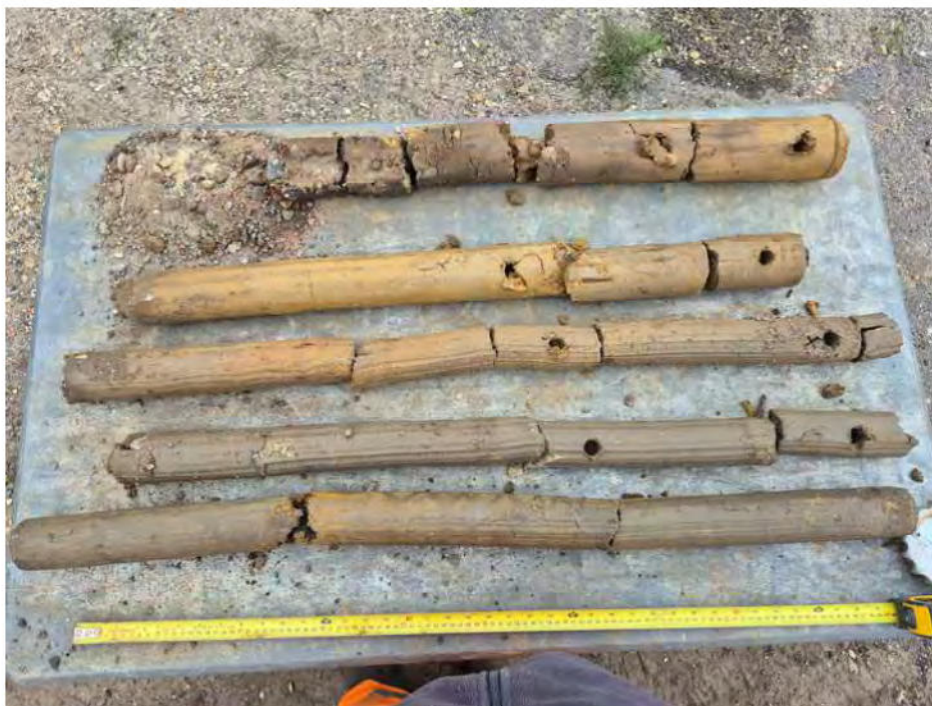
Photo of WS3

| Exploratory Location (Depth) | Location Details |
|---|---|
| WS03(5.00m) | Nearby the northwest corner of the proposed dwelling to assess the general ground conditions. |

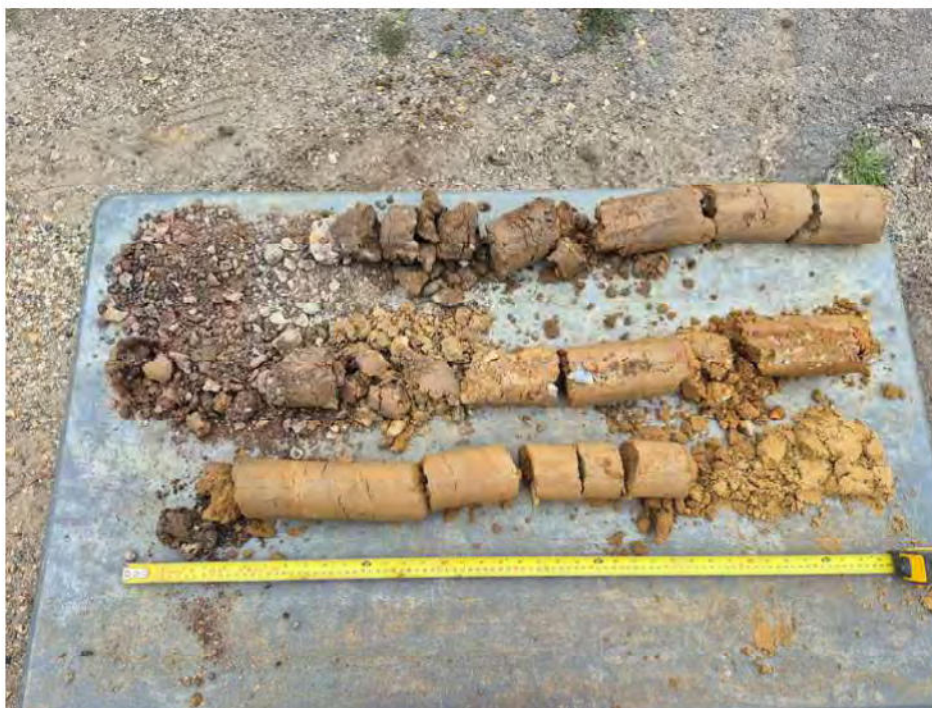
Photo of WS4

| Exploratory Location (Depth) | Location Details |
|---|---|
| WS04(3.00m) | Nearby the northeast corner of the proposed dwelling to assess the general ground conditions. |
