# **Flood Risk Assessment for Observer Park, Arborfield**

for:

Tungsten Dev Co 4 Limited

Reference: 64120-01

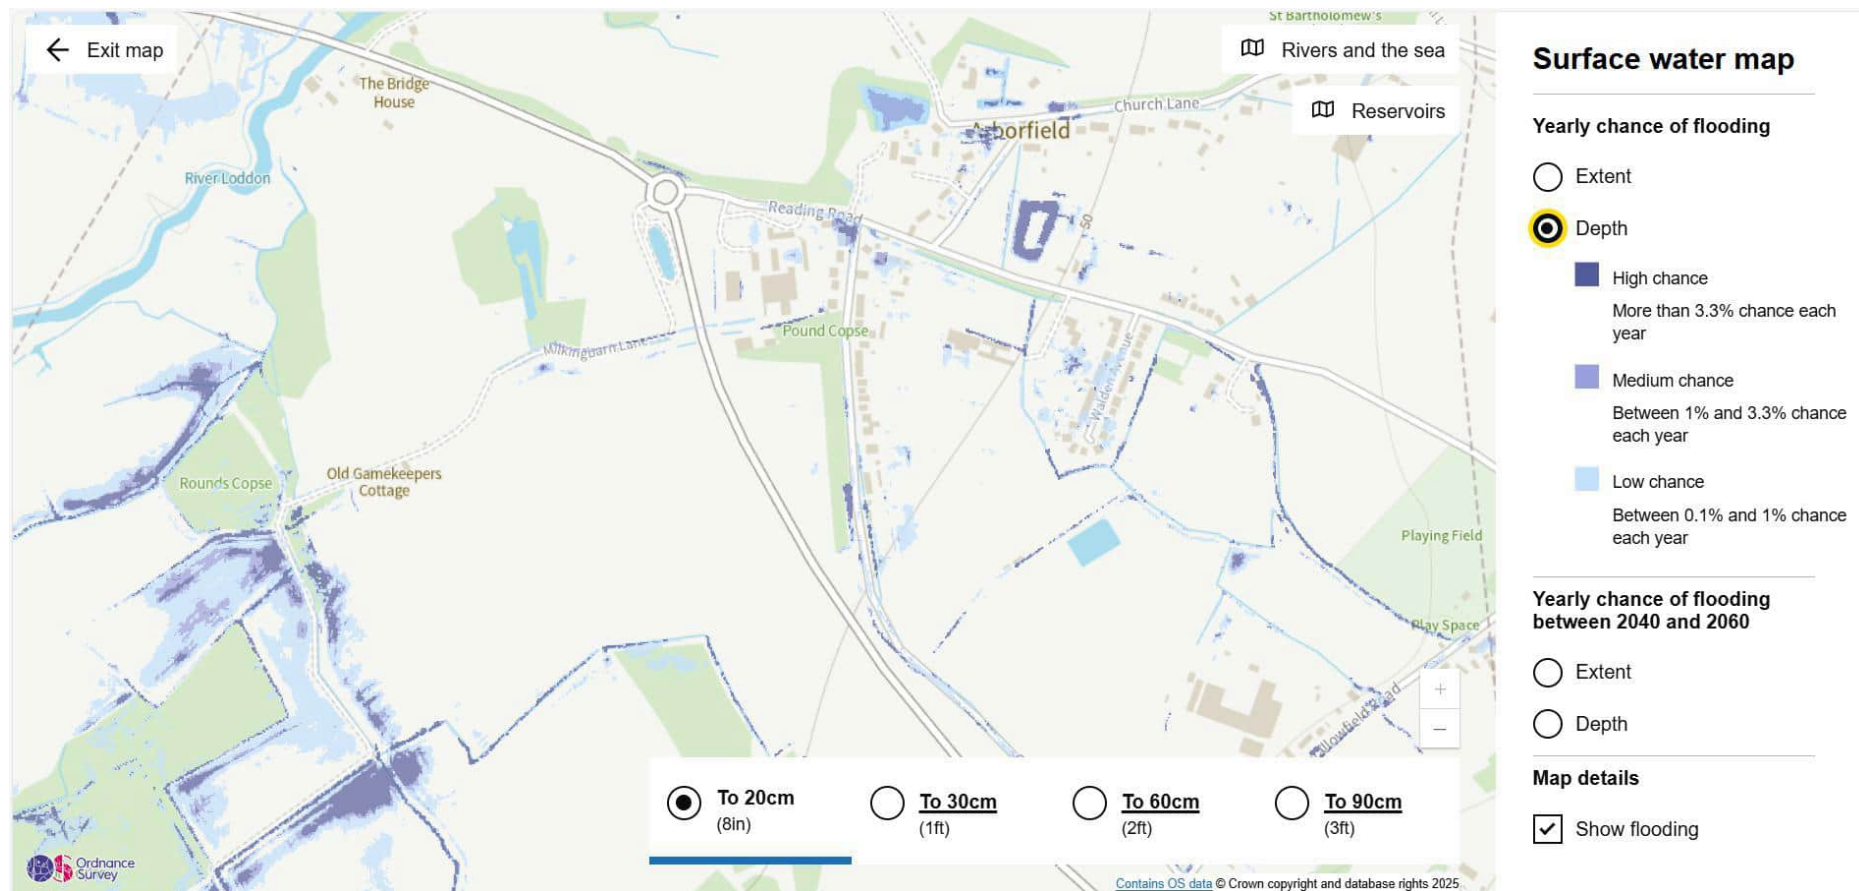
## Surface water map

### Yearly chance of flooding

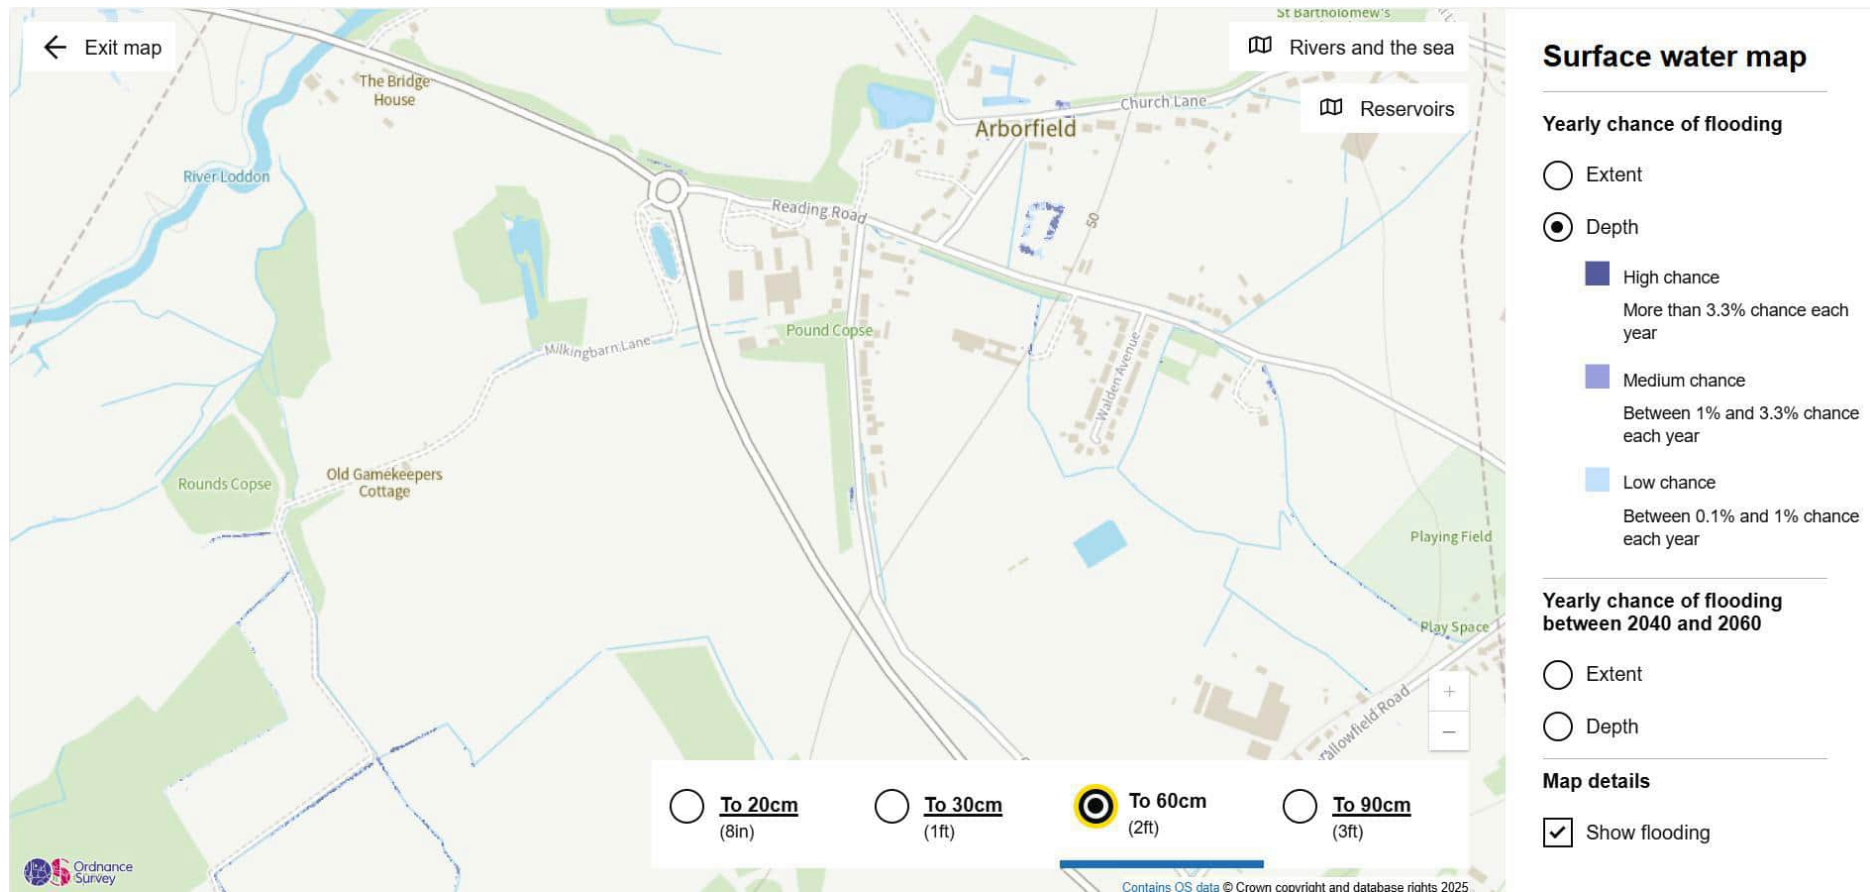
## Surface water map

### Yearly chance of flooding

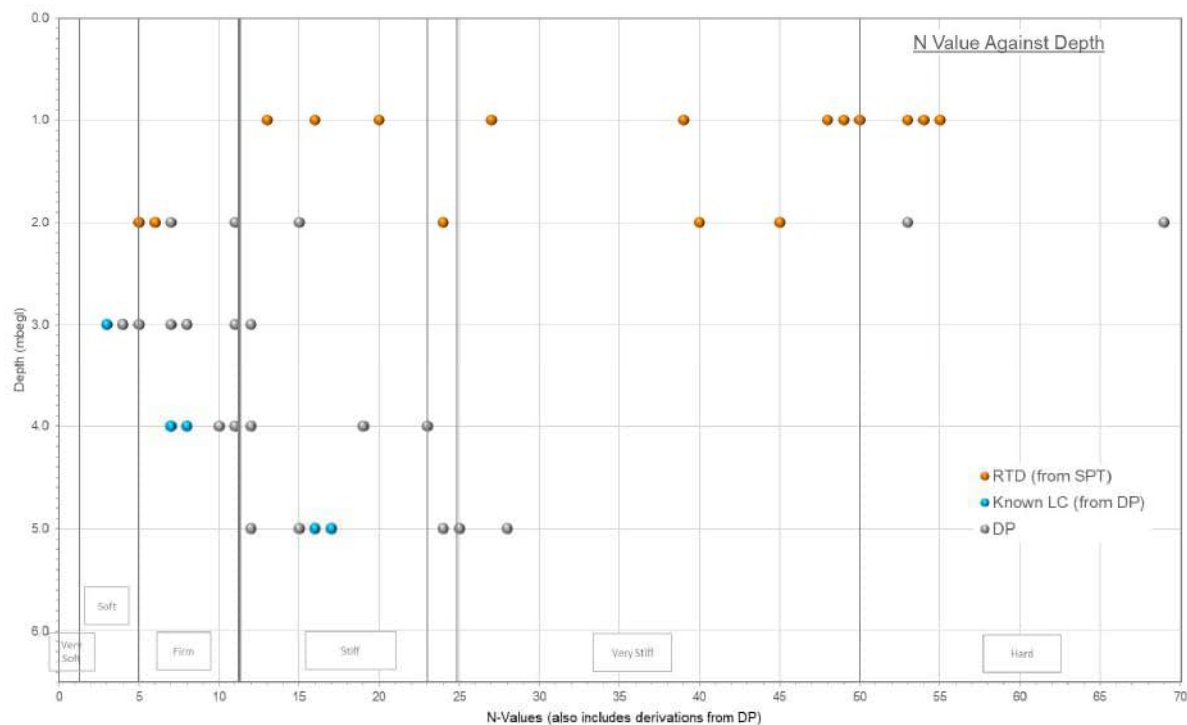
**Figure 1: N Value against Depth**

Also shown in Figure 1 is the low strength of the underlying London Clay (LC). As previously noted, the ground surface was water-logged across much of the Site, which appears to be a common, if not permanent, situation. This saturation has a softening impact on the surface of the clay, which itself acts as an aquiclude (capable of absorbing water slowly but cannot transport it, therefore acts as a confining bed relative to the RTD overburden). This hypothesis is supported by the increase in strength within the LC with depth. Therefore, it would be recommended that some form of ground improvement that is compatible with the level of groundwater/surface water should be considered.

As noted earlier, the saturation of the soils caused collapse within the dynamic sampling holes, therefore dynamic probing (DP) was used to ascertain the interface between RTD and LD and to assess the soil strength at depth. Figure 1 shows a comparable strength drawn from the DP data at equivalent depths to where SPTs would have been undertaken; interpretation of this indicates that most of the DP data was drawn from the LC. The table below is an extract from the DP data from each location where LC was not encountered through dynamic sampling (shaded blue were encountered by dynamic sampling). This shows a likely RTD/LC interface in the majority of locations (represented by the blue line); full DP data is presented with the logs in [Appendix B](#).

From this data, it can be concluded that LC was encountered from between 2.2m and 3.1mbegl; data recovered from WS02, WS04, and WS06 is inclusive as the collapsed material would be very loose, therefore, a clear distinction between that and LC is not apparent. However, it can be assumed that the interface between the two strata would likely fall within the range indicated above. Location WS05 is the further position southward and therefore it would be reasonable to interpret this as likely having the shallowest RTD overburden.

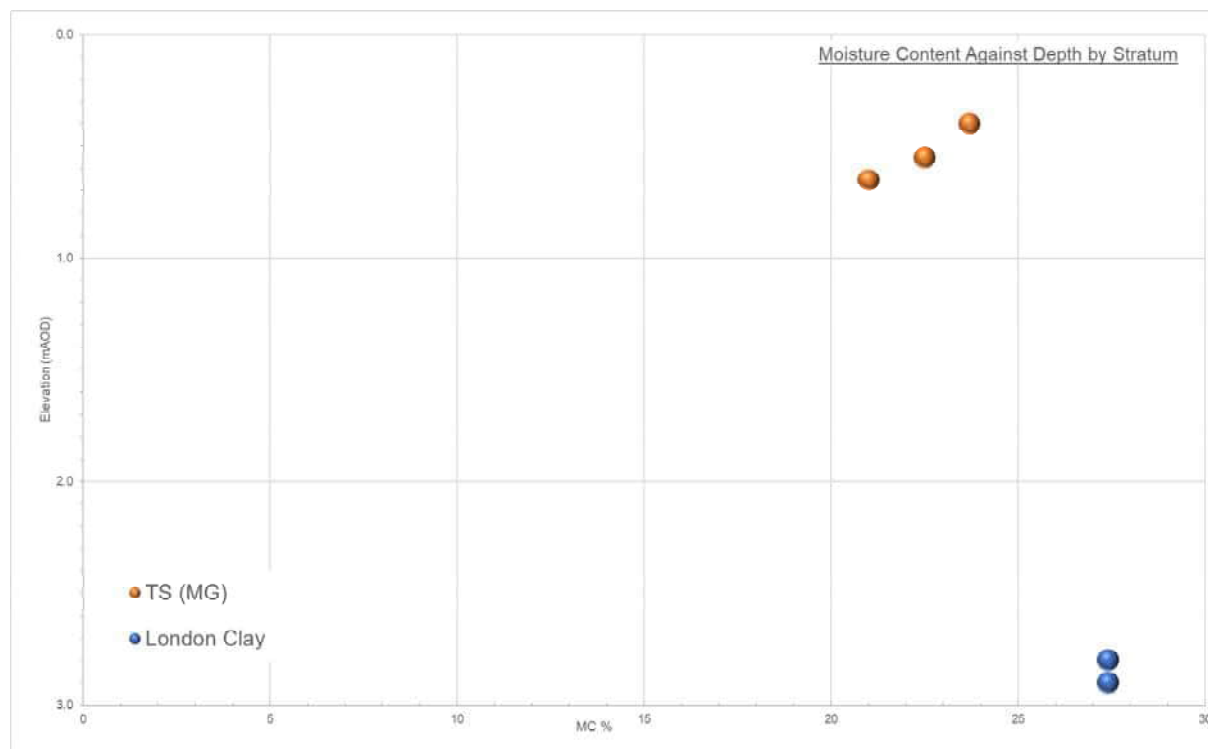
Figure 2: NMC against Depth by Stratum

The moisture content of the samples tested was recorded at between 21% and 23.7% near surface and between 21.4% and 32.9% in the London Clay. **Figure 2** below shows that moisture content is within a relatively narrow band, regardless of stratum or depth; this is reflective of the high saturation state of the soils encountered across the Site.

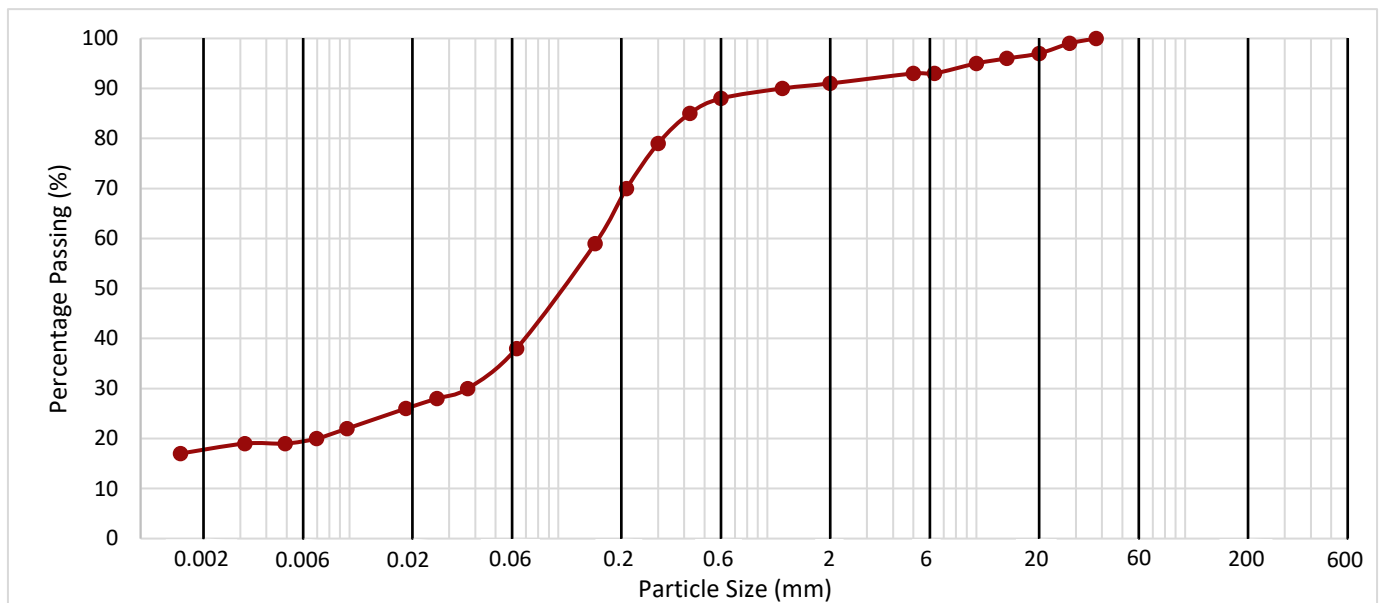
| Borehole / Pit No. | Depth (m) | Sample | | Description | Remarks |
|---|---|---|---|---|---|
| WS01 | 0.30 - 1.00 | U | 1 | Pale olive and locally brown slightly gravelly sandy silty CLAY. Gravel is brown, black and white angular to rounded chert and rare brown and white quartzite and chalk. | |

Method of Test: **Wet Sieve + Hydrometer** Method of Pretreatment: **Not required**

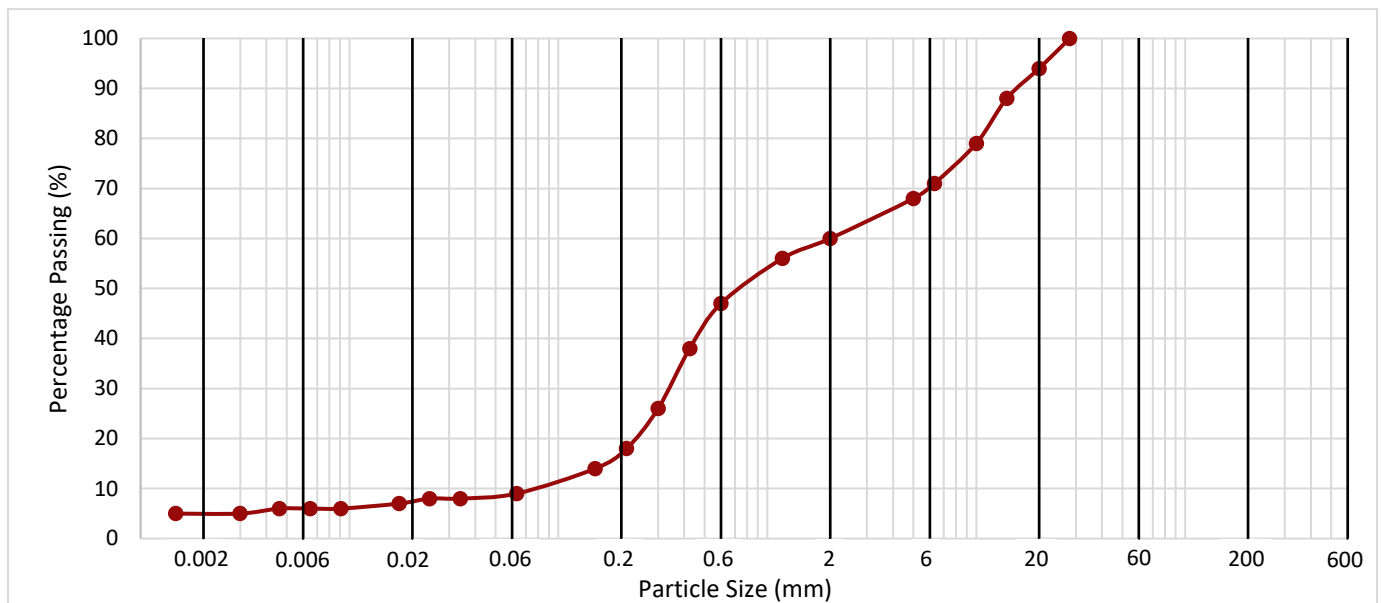
| Borehole / Pit No. | Depth (m) | Sample | | Description | Remarks |
|---|---|---|---|---|---|
| WS05 | 1.00 - 2.00 | U | 2 | Yellowish brown clayey slightly silty very gravelly SAND. Gravel is brown, black and white sub angular to sub rounded chert and rare yellowish brown sandstone. | |

Method of Test: Wet Sieve + Hydrometer Method of Pretreatment: Not required

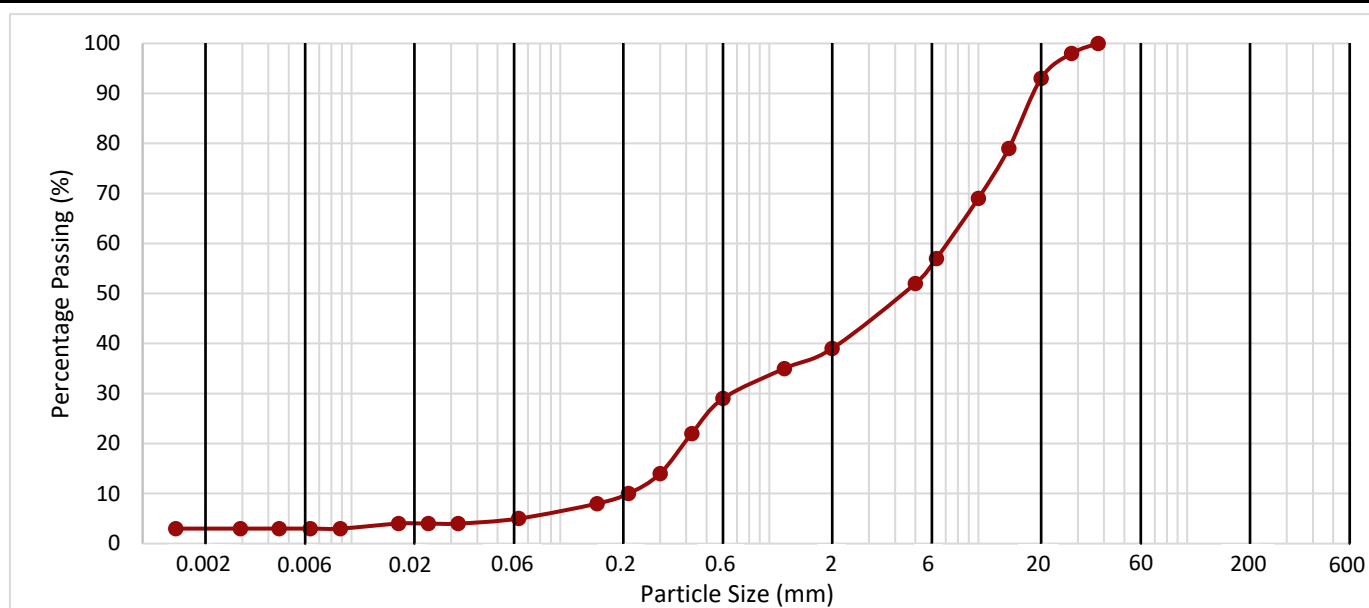
| Borehole / Pit No. | Depth (m) | Sample | | Description | Remarks |
|---|---|---|---|---|---|
| WS07 | 1.00 - 1.50 | U | 2 | Brown, black and white angular to sub rounded chert and rare light brown sandstone slightly clayey slightly silty very sandy GRAVEL. Sand is brownish yellow. | |

Method of Test: Wet Sieve + Hydrometer Method of Pretreatment: Not required

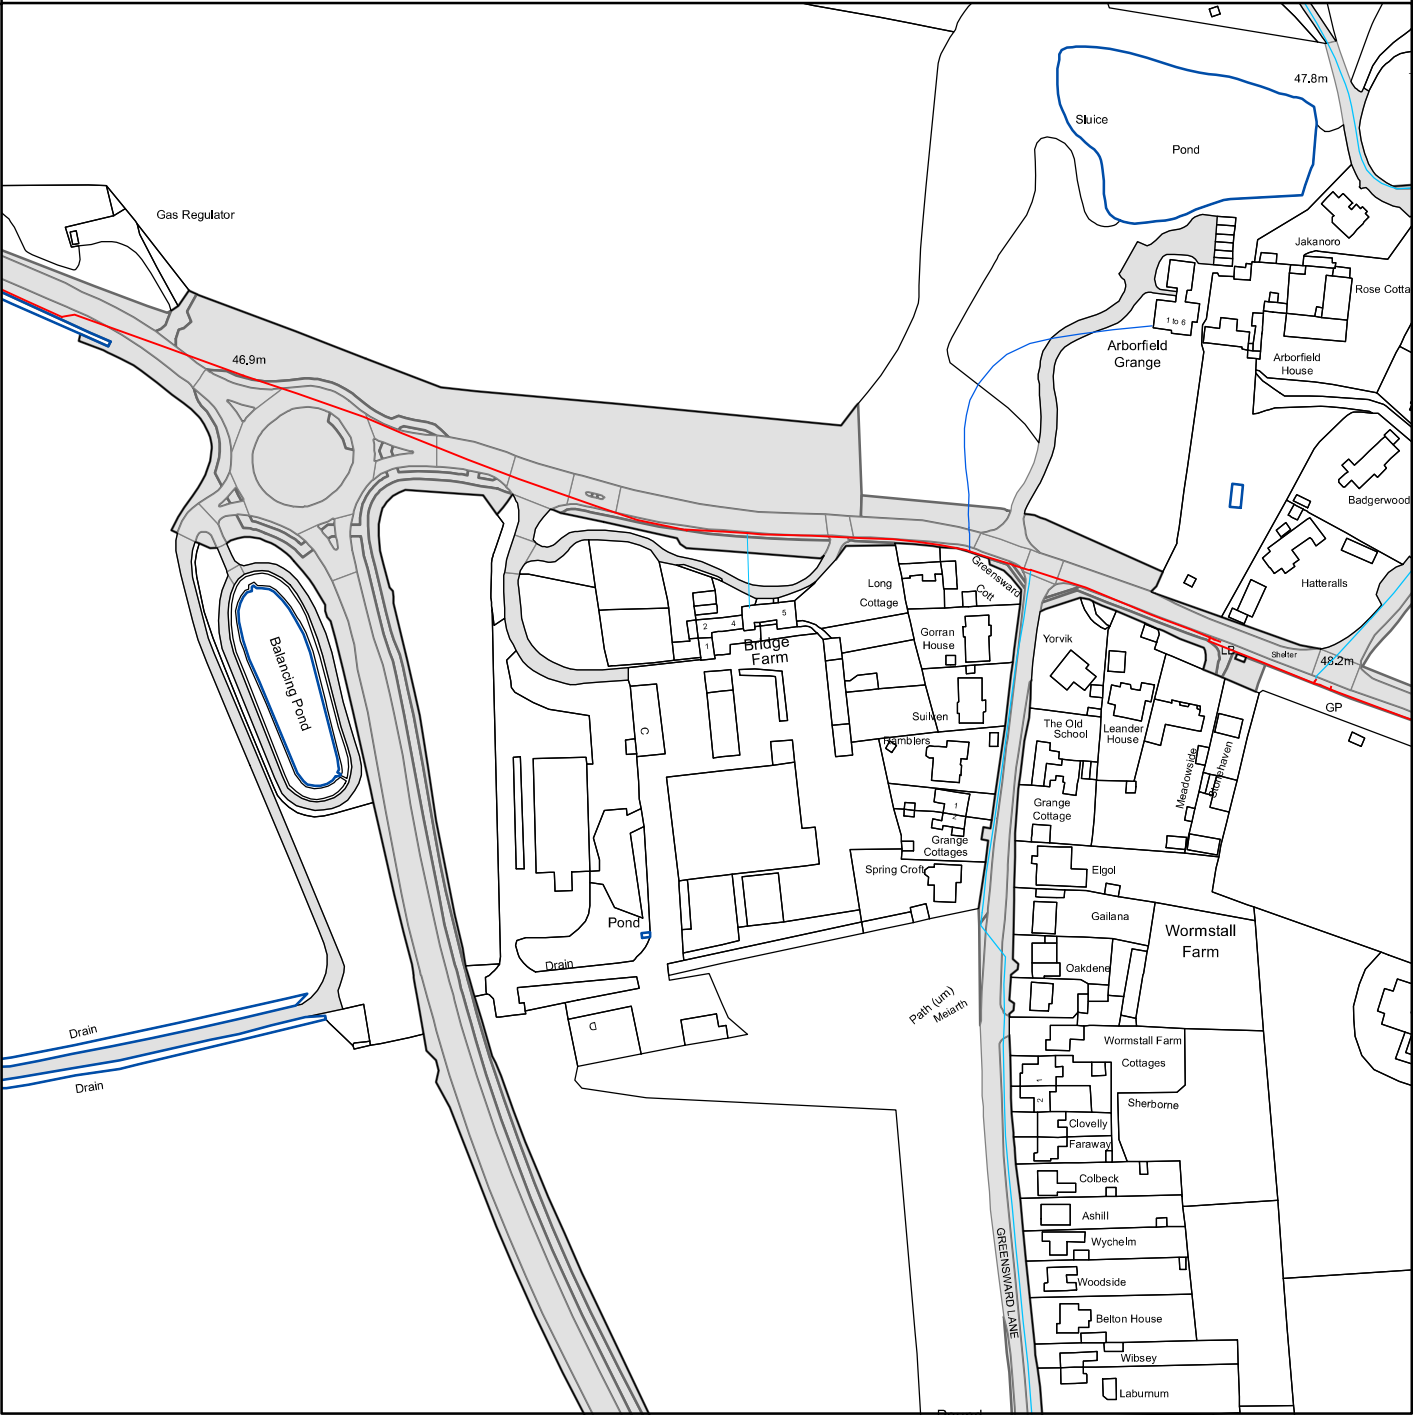
The position of the apparatus shown on this plan is given without obligation and warranty, and the accuracy cannot be guaranteed. Service pipes are not shown but their presence should be anticipated. No liability of any kind whatsoever is accepted by Thames Water for any error or omission. The actual position of mains and services must be verified before any works are undertaken. Crown copyright Reserved
