**BS 5837:2012 Tree Survey,  
Arboricultural Impact Assessment,  
Arboricultural Method Statement and  
Tree Protection Plan**

**At  
Suncot, School Road,  
Barkham RG41 4TR**

**December 2025**

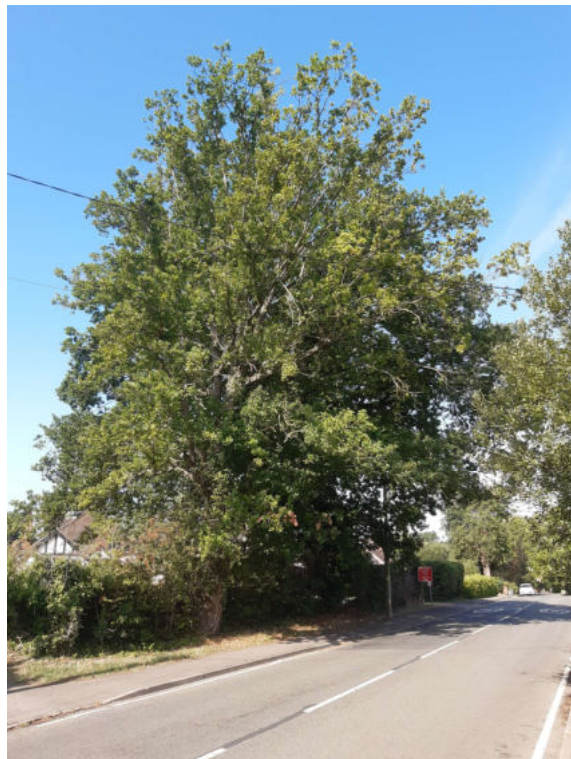
12. The front boundary is dominated by three mature Oak trees, two of which are located outside the site boundary. Consequently, they offer a significant contribution to the wider visual amenity.
13. T3 is showing slight signs of reduced vigour but nothing that warrants remedial action at this moment in time.
14. The main tree in the rear garden is a semi-mature Cedar. This tree is of good form but has a number of dead branches located on the southwest side of the canopy.
15. There are mature Cypress hedges along both boundaries of varying quality.

**Oaks on frontage with School Lane**

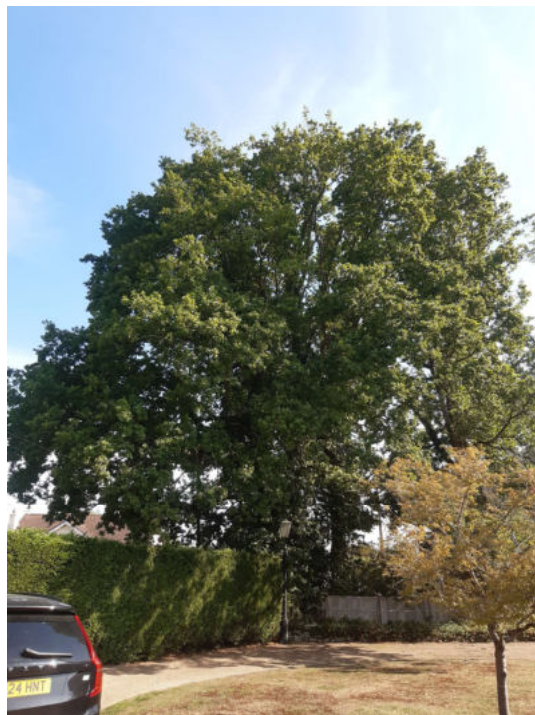
| Tree ID | Species | Height (m) | SD (mm) | Crown Spread (N) | Crown Spread (E) | Crown Spread (S) | Crown Spread (W) | Age Class | P.Cond | Structural Condition | Radius | RPA | Sq.Sides | ERC | Category Grading | Category Criteria | Works required in the interests of H&S |
|---|---|---|---|---|---|---|---|---|---|---|---|---|---|---|---|---|---|
| T1 | Oak | 19 | 1010 | 7 | 4 | 10.5 | 10 | Mature | Good | Fair. Canopy weighted to south. Heavily ivy clad. Minor deadwood | 12 | 462 | 21 | >40 yrs | B | 1 | No works required |

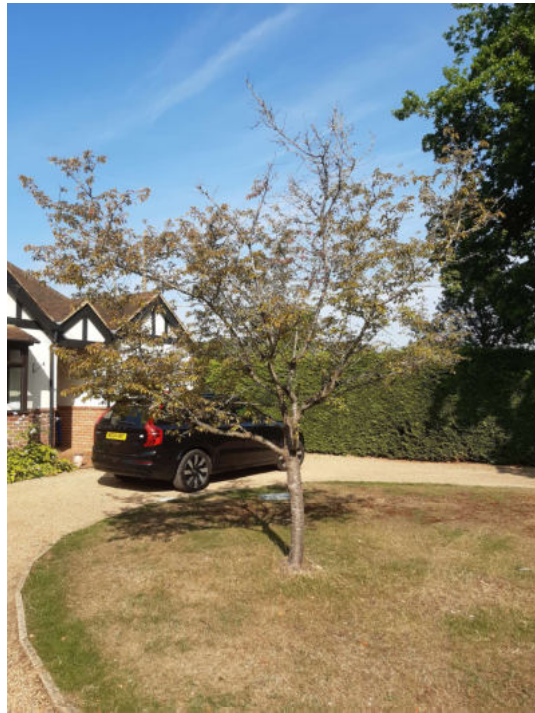
**T4 (to be removed)**

- T4 - Fell and grind

| Tree ID | Species | Height (m) | SD (mm) | Crown Spread (N) | Crown Spread (E) | Crown Spread (S) | Crown Spread (W) | Age Class | P.Cond | Structural Condition | Radius | RPA | Sq.Sides | ERC | Category Grading | Category Criteria | Works required in the interests of H&S |
|---|---|---|---|---|---|---|---|---|---|---|---|---|---|---|---|---|---|
| T4 | Prunus | 3 | 120 | 2 | 2 | 2.5 | 1.5 | Semi-mature | Fair | Fair. Sparse canopy. Minor deadwood. | 1 | 7 | 3 | 10 to 20 yrs | B | 1 | No works required |

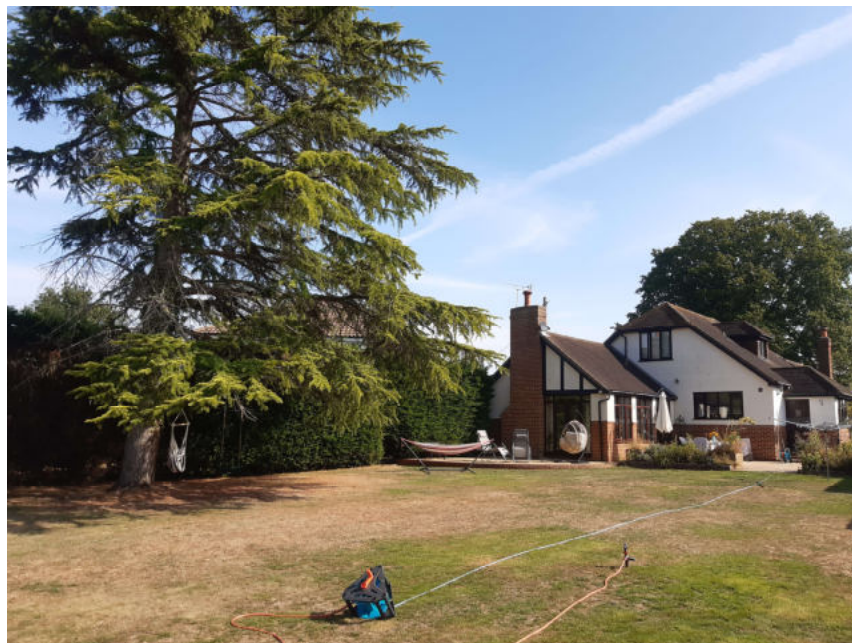
**T5 in relation to rear of property**

| Tree ID | Species | Height (m) | SD (mm) | Crown Spread (N) | Crown Spread (E) | Crown Spread (S) | Crown Spread (W) | Age Class | P.Cond | Structural Condition | Radius | RPA | Sq.Sides | ERC | Category Grading | Category Criteria | Works required in the interests of H&S |
|---|---|---|---|---|---|---|---|---|---|---|---|---|---|---|---|---|---|
| T5 | Deodar Cedar | 17.5 | 590 | 6.5 | 6.5 | 5 | 4.5 | Semi-mature | Fair | Fair. Canopy dieback to southwest, lower branches only. | 7 | 157 | 13 | 20 to 40 yrs | B | 1 | No works required |

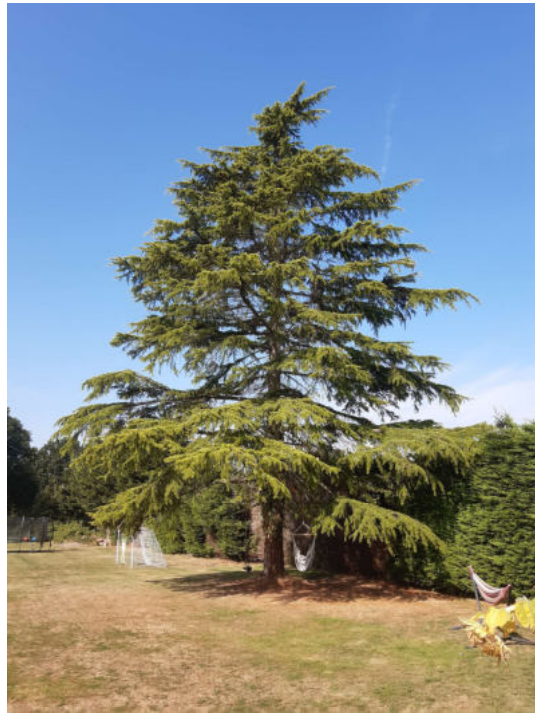
T5 - Cedar

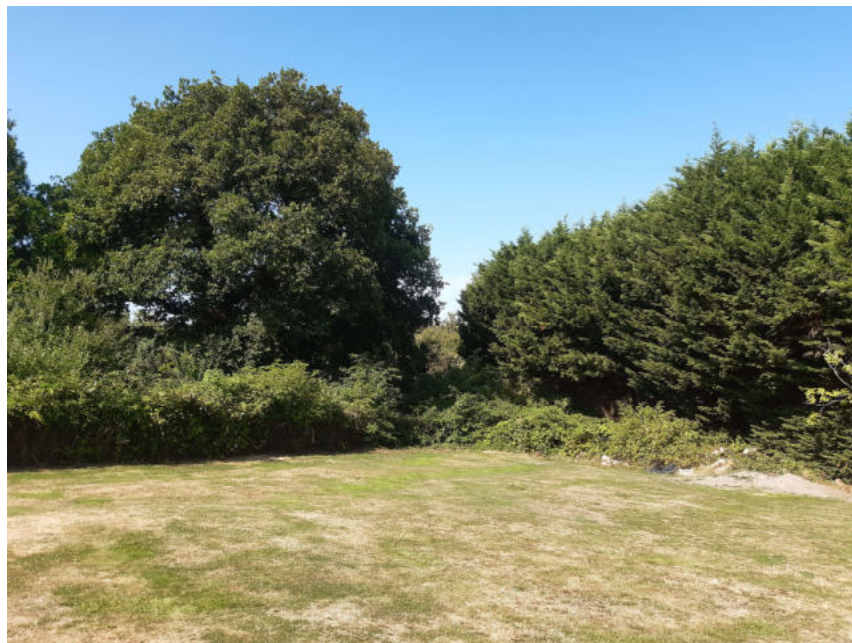
T6 in neighbouring property to south

| Tree ID | Species | Height (m) | SD (mm) | Crown Spread (N) | Crown Spread (E) | Crown Spread (S) | Crown Spread (W) | Age Class | P.Cond | Structural Condition | Radius | RPA | Sq.Sides | ERC | Category Grading | Category Criteria | Works required in the interests of H&S |
|---|---|---|---|---|---|---|---|---|---|---|---|---|---|---|---|---|---|
| T6 | Oak | 17 | 900 | 11 | 10 | 9 | 10 | Mature | Good | Good. Third party tree. No obvious external indications of weakness or decay | 11 | 366 | 19 | >40 yrs | A | 1 | No works required |

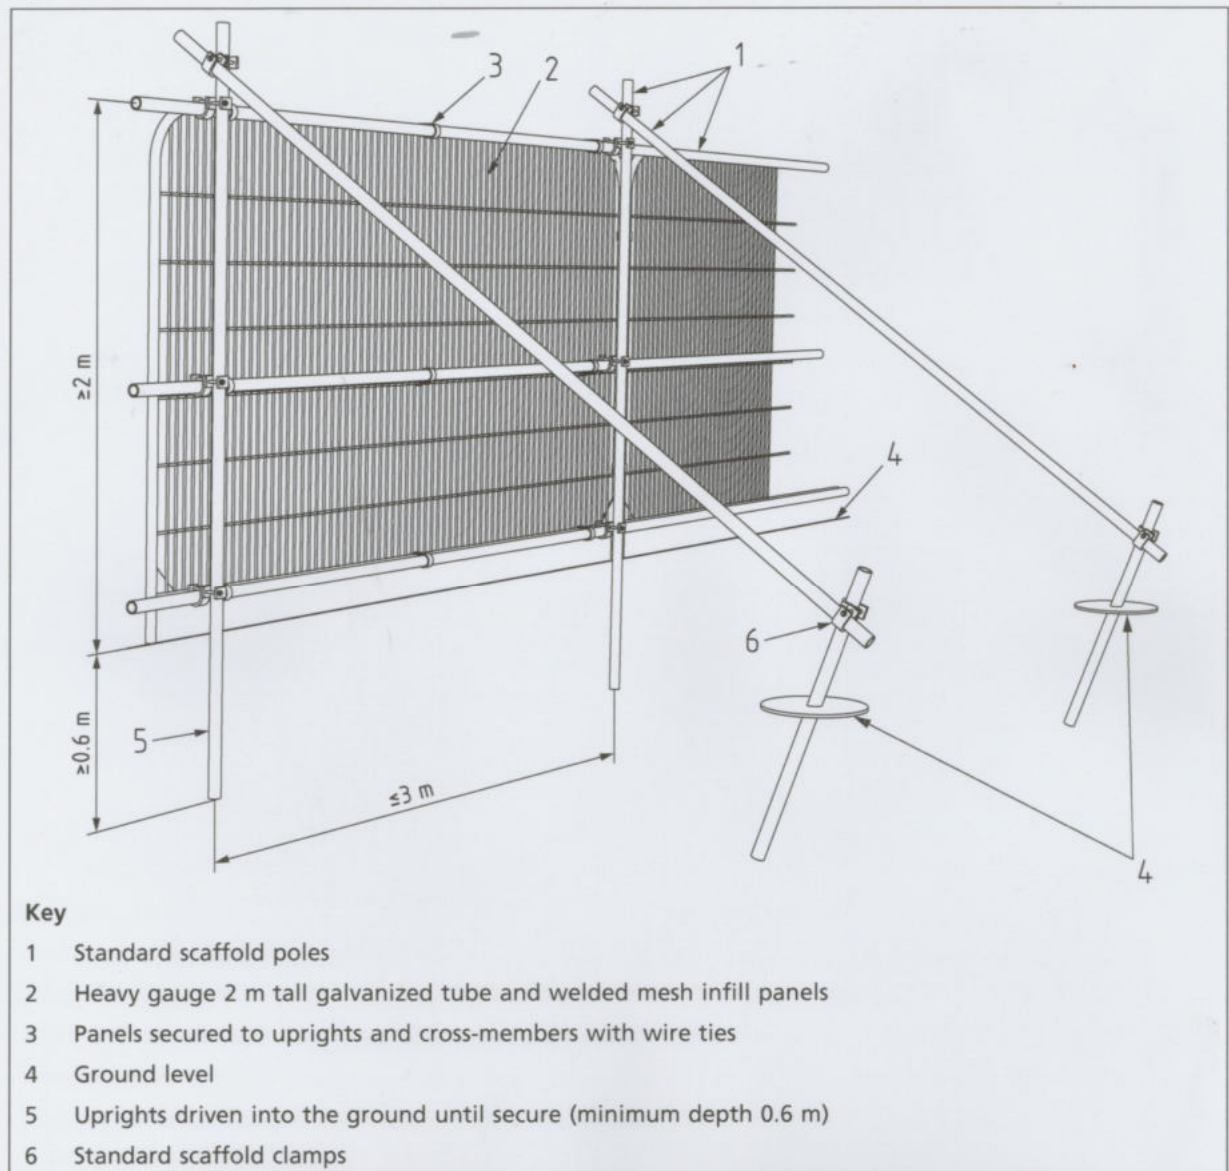
Figure 2 Default specification for protective barrier

45. The specification for the protective fencing (in blue on the TPP) will comply with Figure 2 in BS 5837:2012 and be mounted on a horizontal and vertical framework of scaffold poles made fast in the ground. Panels of weldmesh or 20mm exterior plywood shall be fixed to the framework with wire or scaffold clamps.
