Annex D: Ground Gas Protection

Main Contractor Name: MCS		Date: 03/01/2025		
Site Name: Headley Road East, Woodley, Reading.		Temp: 8 °C		
		Installer: UK Membranes.		
Postcode: RG5 4SJ.	Surveyor: Adam McDermott (TGPV)			
Building Reference/Unit No:	Units 1,2 & 3.			
Area Inspected:	Line out to communal areas. (See Marked Up Plan).			
Description of Works:	MEC Environmental carried out a thorough inspection of the Juta GP5 gas membrane that has been laid upon a well rolled fine aggregate substrate floor to the communal areas in units 1,2 3. All membrane laps have been hand welded together using a hot air gun and rolled using a neoprene roller with pressure applied. All detailing work to the steel Stanchions, pipe penetrations, perimeter steel cladding rail and precast concrete lift pit has been successfully completed using Juta GP SAM.			
Sub-Grade Preparation:	The subgrade consists of graded coarse aggregate down to dust that has been well rolled and compacted and is acceptable to lay the membrane on

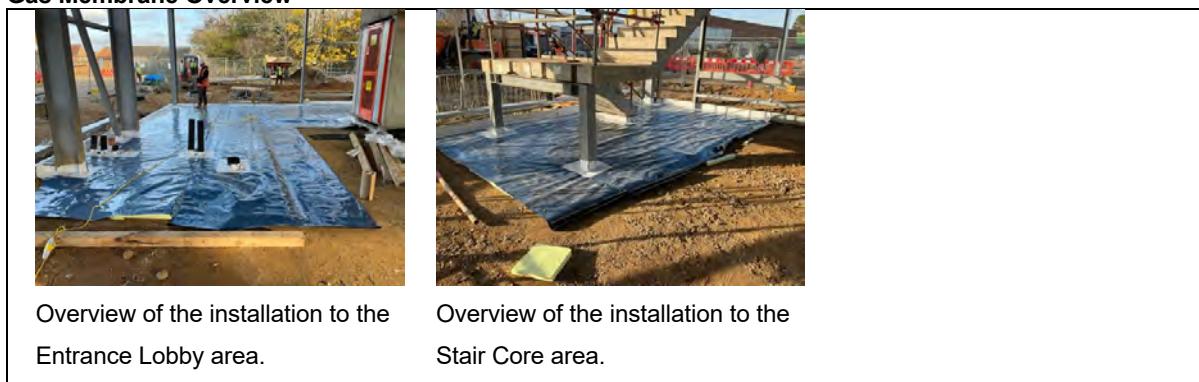
Gas Membrane Overview

Overview of the installation to the Entrance Lobby area.

Overview of the installation to the Stair Core area.

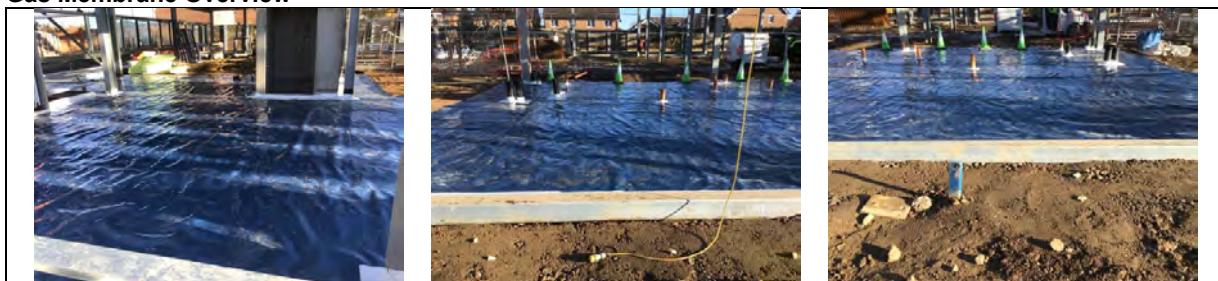
Gas Membrane Overview

A general overview of the installed Juta GP5 gas membrane to the communal area in unit 1.

A general overview of the installed Juta GP5 gas membrane to the communal area in unit 2.

A general overview of the installed Juta GP5 gas membrane to the communal area in unit 3.

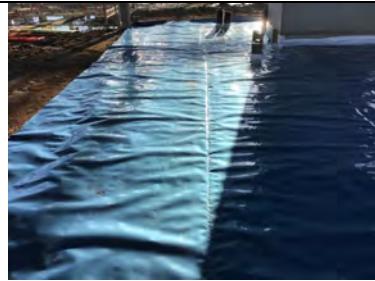
A typical hand welded membrane lap in unit 1.

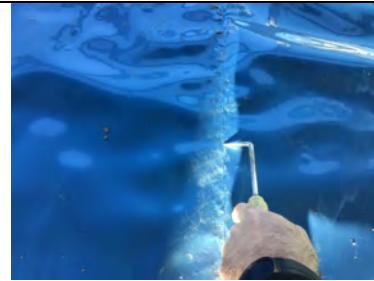
Probe testing a hand welded membrane lap in unit 1.

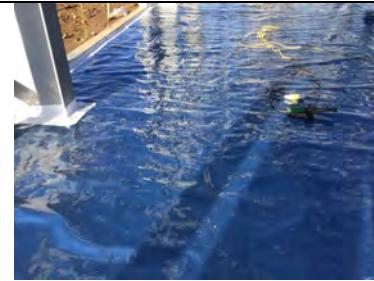
All membrane laps have been hand welded together using a hot air gun in units 2 & 3.

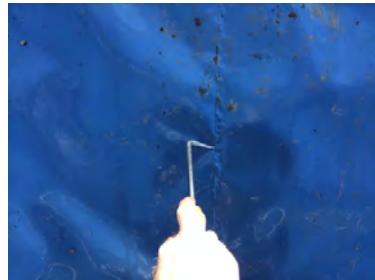
Probe testing a hand welded membrane lap in unit 3.

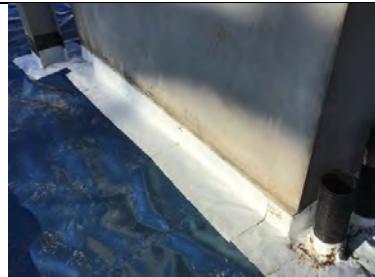
Retro fit detailing to the precast concrete lift pit wall in unit 1.

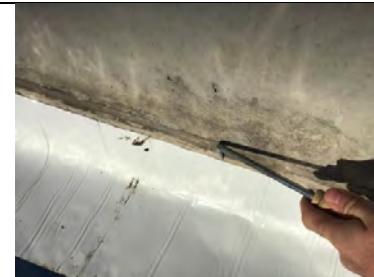
Probe testing the detailing work around the lift pit in unit 1.

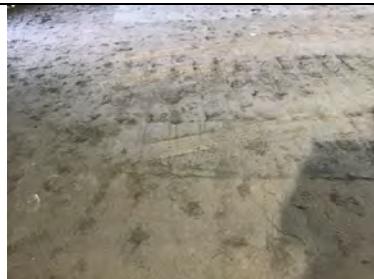
Evidence of a well rolled fine aggregate substrate that the membrane has been laid upon.

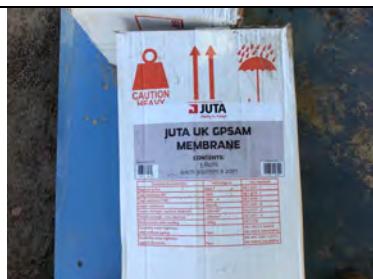
Evidence of the Juta GP SAM that has been used for the detailing work on this project.

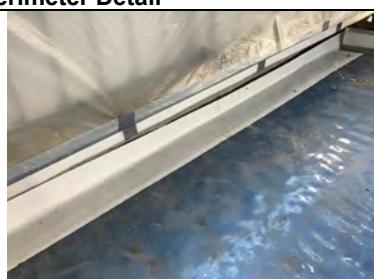
Retro fit detailing to the perimeter cladding rail.

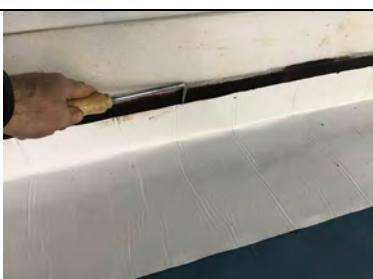
Probe testing all perimeter detailing.

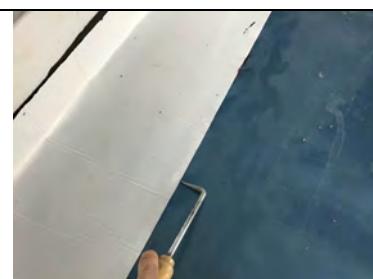
Probe testing the perimeter detailing.

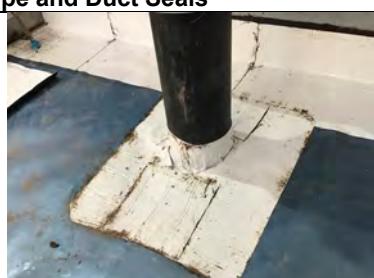
Typical pipe penetration detailing.

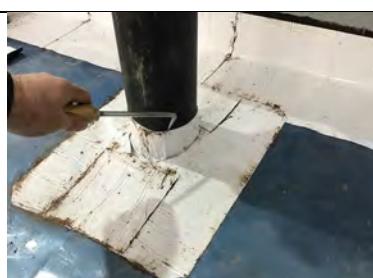
Probe testing a sealed pipe penetration.

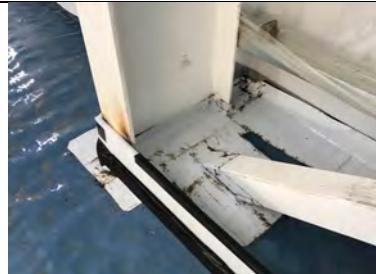
Typical steel stanchion detailing.

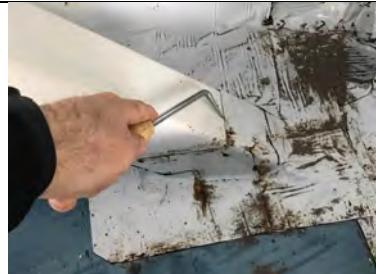
Probe testing a sealed steel stanchion.

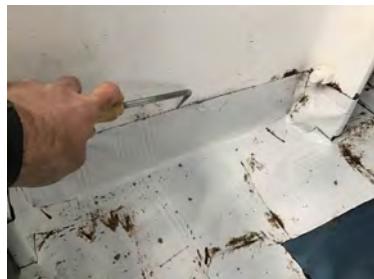
Probe testing the inner web of the steel stanchion.

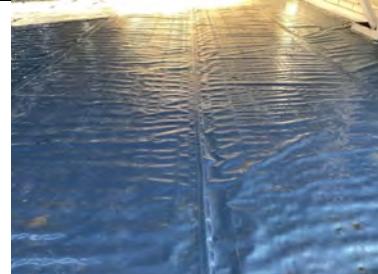
A typical auto welded membrane lap.

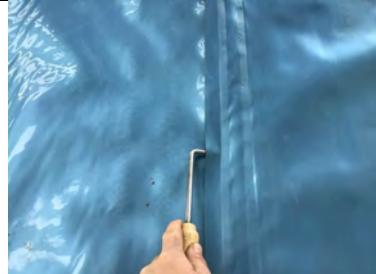
Probe testing a auto welded membrane lap.

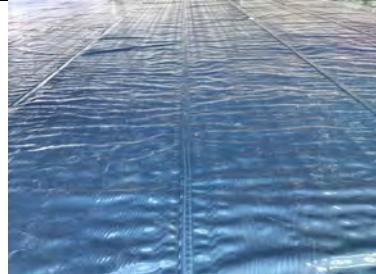
Overview of an auto welded membrane lap.

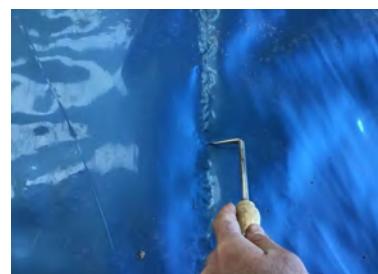
Probe testing a hand welded membrane lap.

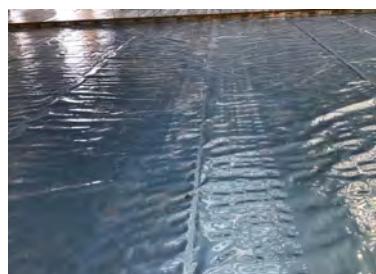
A typical hand welded membrane lap.

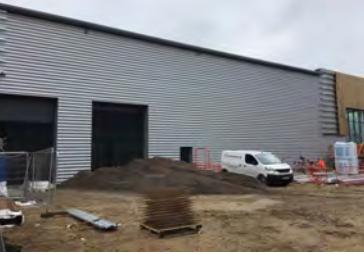
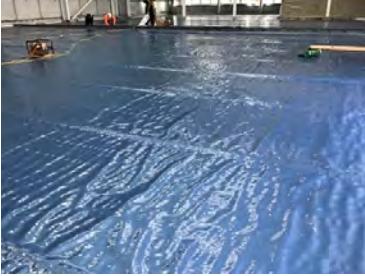
Gas Membrane Overview

<p>A general overview of unit 10.</p>	<p>An overview of the Juta GP5 gas membrane that has been installed across the full footprint of unit 10.</p>

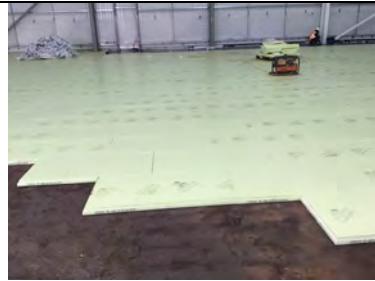
Subgrade Photos

Evidence of the insulation boards being laid prior to the installation of the loose laid gas membrane.

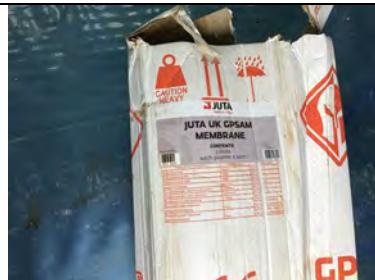
Evidence of the Juta GP SAM that has been used for the detailing work on this project.

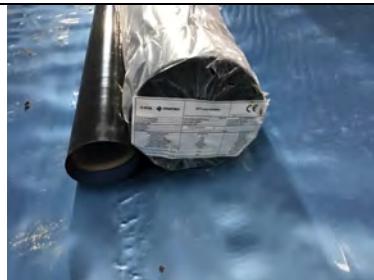
Evidence of the Juta GP5 gas membrane that has been installed as a full line out in unit 10.

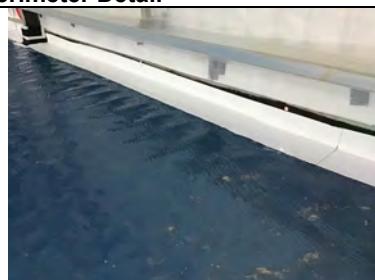
Perimeter Detail

Overview of the retro fit detailing to the perimeter cladding rail.

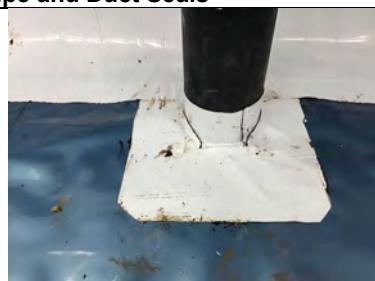
Pipe and Duct Seals

Typical pipe penetration detailing.

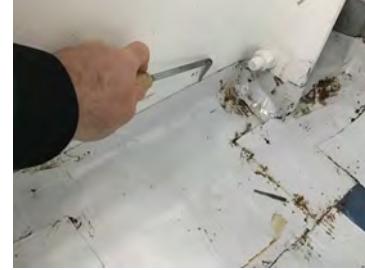
Stanchions and Columns Seals

<p>At the time of our inspection all steel stanchions had a steel plate and miothene in place around them, I was however able to inspect and probe test the inside of the web of the steel but not the face of the steel stanchion so therefore our inspection to these areas was restricted.</p> <p>During our inspection holes were found in the membrane around the armoured joint pins due to follow on trades these areas were repaired upon our inspection by UK Membranes using Juta GP SAM.</p>	<p>No Action Required all Defects rectified at time of inspection</p>
---	---

A restricted inspection took place upon todays visit due to the steel plate & mithene that had already been welded to the steel stanchions.	A restricted inspection took place upon todays visit due to the steel plate & mithene that had already been welded to the steel stanchions.	Probe testing the inner web of the steel stanchion.

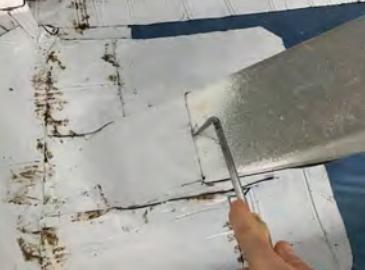
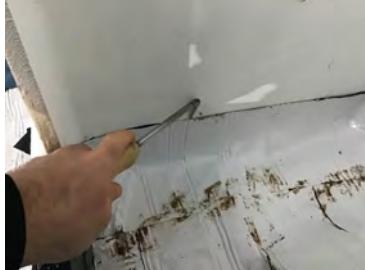
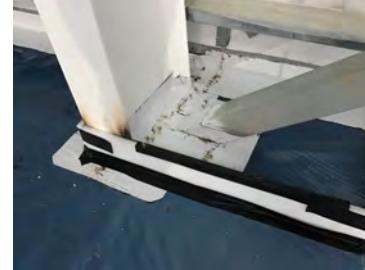
Probe testing a sealed steel stanchion.	Probe testing the inner web of the steel stanchion.	A restricted inspection took place upon todays visit due to the steel plate & mithene that had already been welded to the steel stanchions.

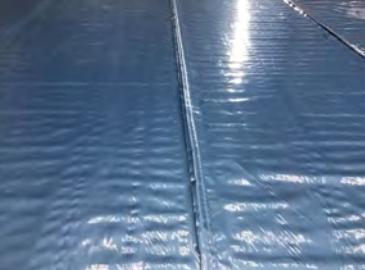
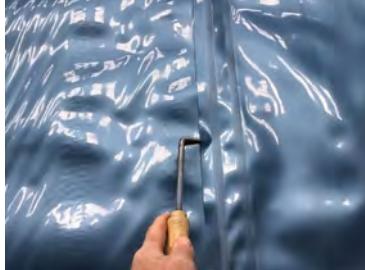
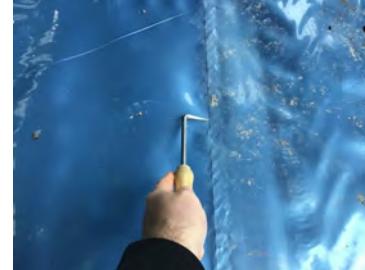
Testing of Joints

A typical auto welded membrane lap.	Probe testing a auto welded membrane lap.	Probe testing a typical hand welded membrane lap.

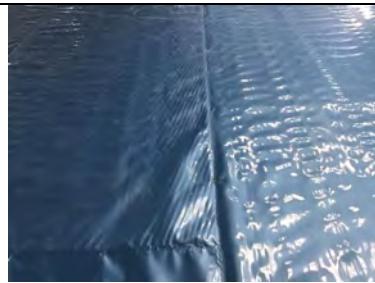
Overview of a typical hand welded membrane lap.

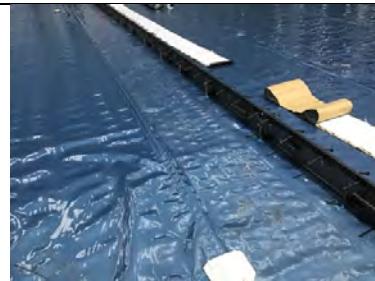
Double sided tape has been used to sealed the armoured joint metal pins.

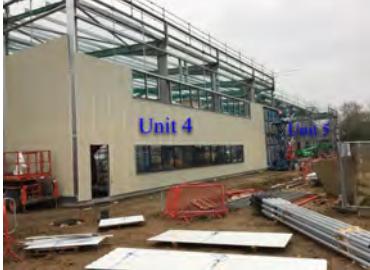
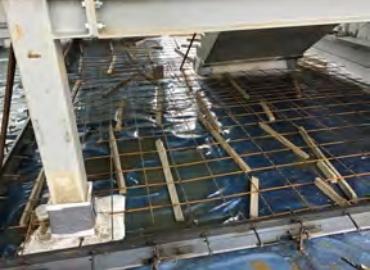
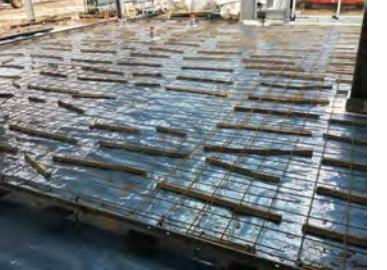
Gas Membrane Overview

A general overview of units 4 & 5.	An overview of the Juta GP5 gas membrane installed to the stair core area in unit 4.	Overview of the Juta GP5 gas membrane that has been installed to the communal area in unit 4.

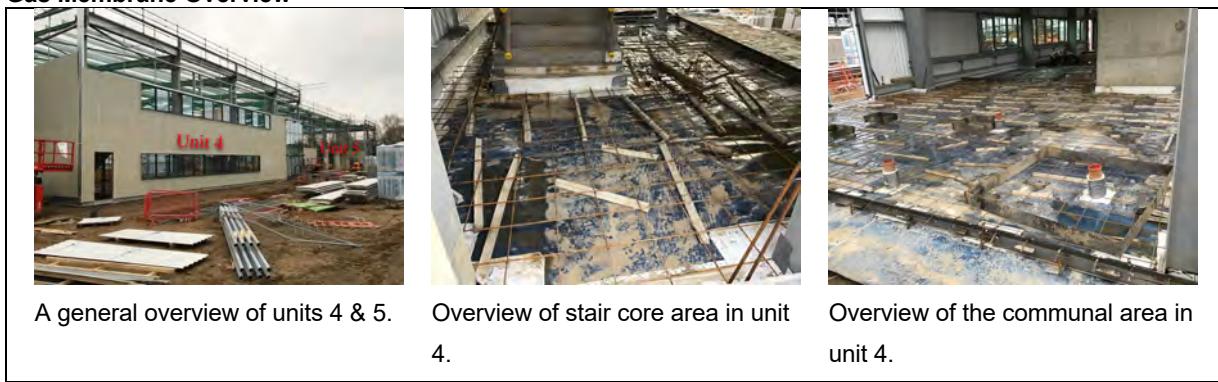
Gas Membrane Overview

A general overview of units 4 & 5.

Overview of stair core area in unit 4.

Overview of the communal area in unit 4.

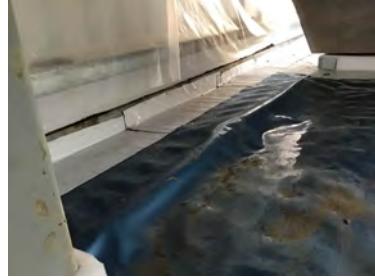
Retro fit detailing in units 7 & 8.

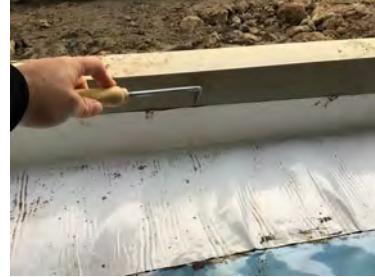
Probe testing all perimeter retro fit detailing within units 7 & 8.

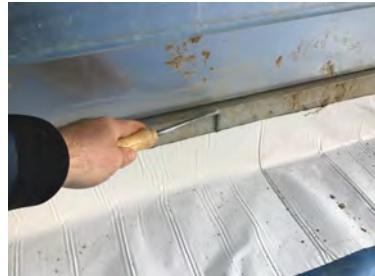
Probe testing all perimeter detailing within units 7 & 8.

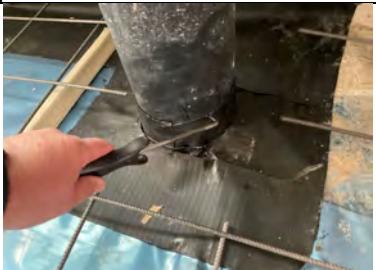
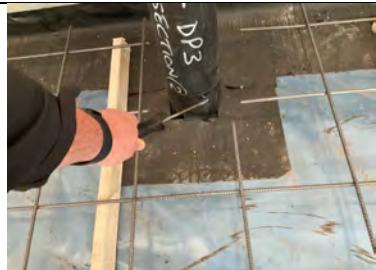
Probe testing to pipe penetration details.	Probe testing to pipe penetration details.

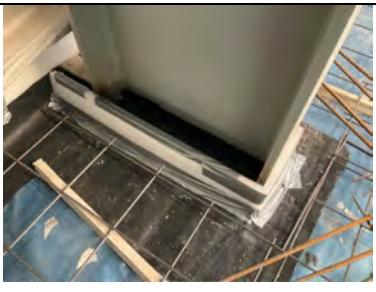
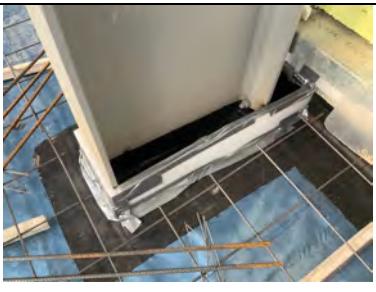
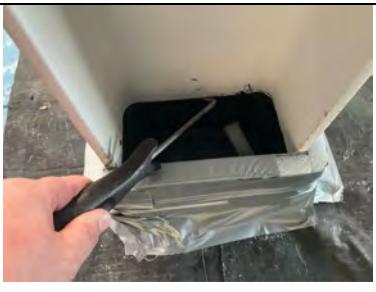
Steel stanchion detailed using Juta GP1 SAM but restricted inspection.	Steel stanchion detailed using Juta GP1 SAM but restricted inspection.	Probe testing to partially restricted steel stanchion.

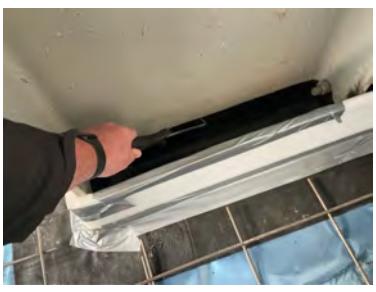
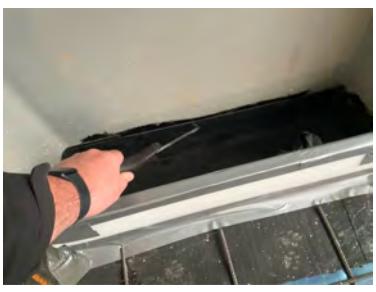
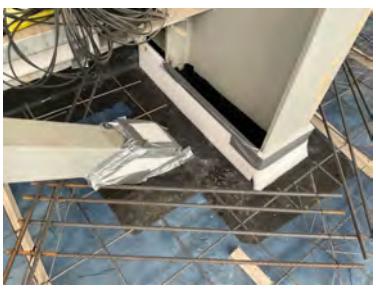
Probe testing to partially restricted steel stanchion.	Probe testing to partially restricted steel stanchion.	Steel stanchion detailed using Juta GP1 SAM but restricted inspection.

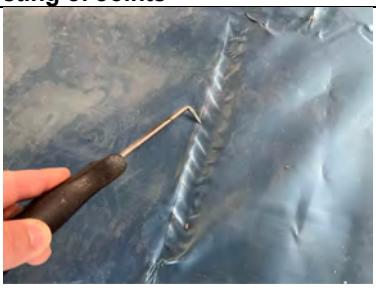
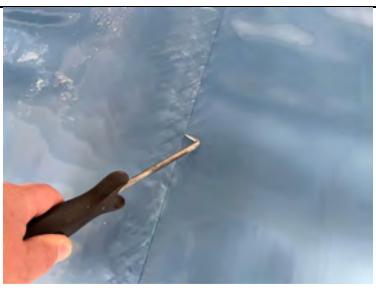
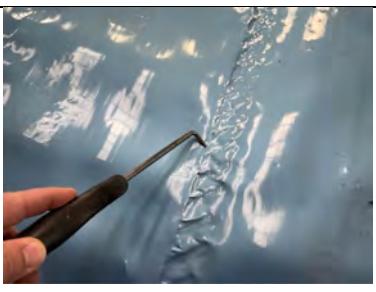
Probe testing along hand welded membrane lap joints.	Probe testing along hand welded membrane lap joints.	Probe testing along hand welded membrane lap joints.

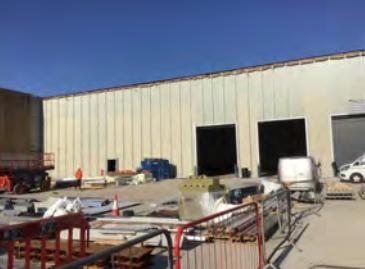
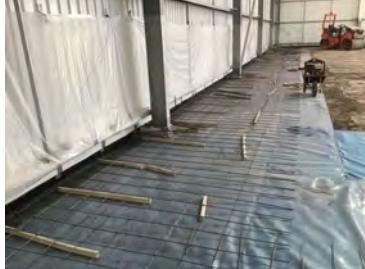
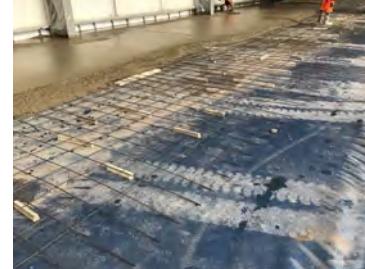
Gas Membrane Overview

A general overview of unit 6.	Overview of the Juta GP5 gas membrane installation as the pour progresses.	Overview of the Juta GP5 gas membrane installed on a just in time basis as the pour progresses.

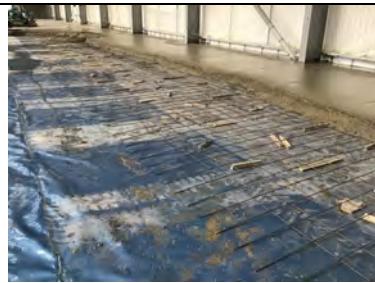
Overview of the Juta GP5 gas membrane installed on a just in time basis as the pour progresses.

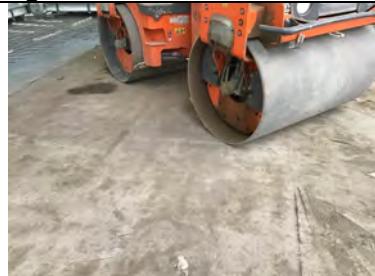
The substrate had been continuously rolled during the installation of the gas membrane as the pour progresses.

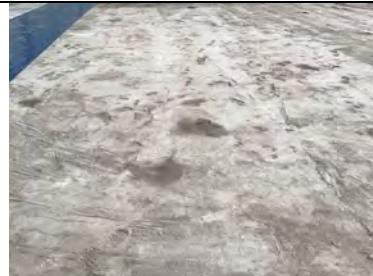
Evidence of a well rolled substrate.

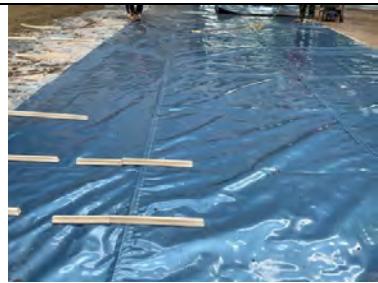
Overview of the installation of Juta GP5 Gas Barrier as the pour progressed.

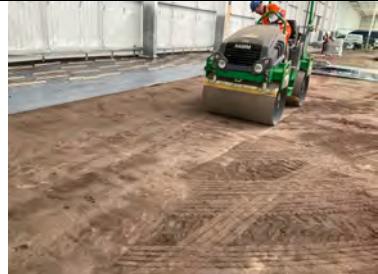
Substrate being continuously rolled prior to gas membrane installation.

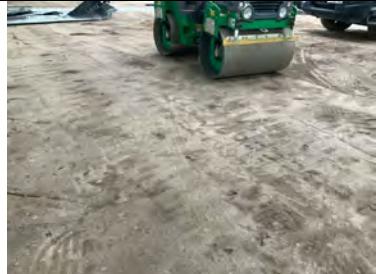
Substrate rolled in prep for gas membrane installation.

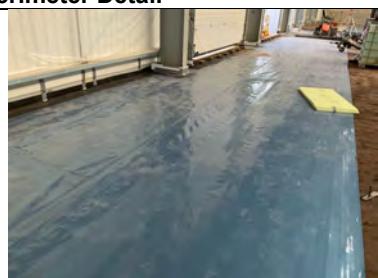
Overview of the perimeter edge

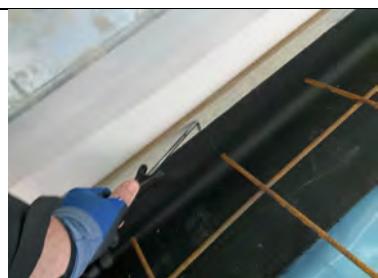
Probe testing to perimeter edge termination.

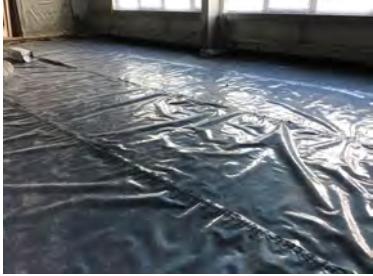
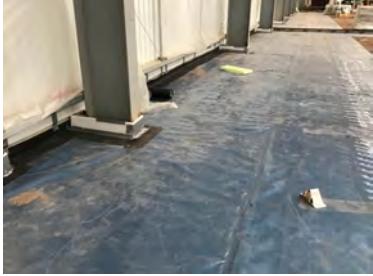
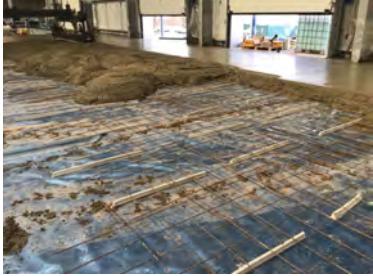
Gas Membrane Overview

Overview of the Installed Juta GP5 gas membrane to the undercroft area in unit 2. (marked in yellow on the site plan).	Overview of the Juta GP5 gas membrane installed to the perimeter edge in unit 2 (marked in yellow on the site plan).	Overview of the pour progressing.

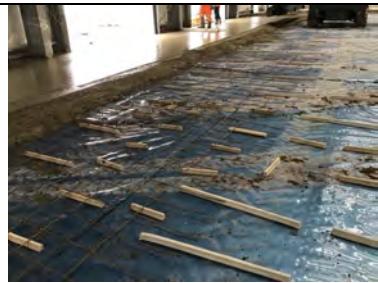
Overview of the Juta GP5 gas membrane installation as the pour progresses.

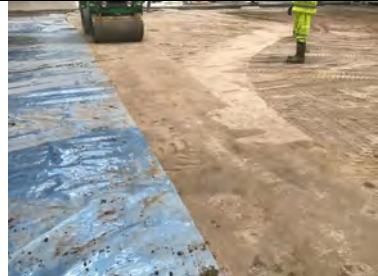
Evidence of the substrate being rolled prior to the installation of the Juta GP5 gas membrane as the pour progresses.

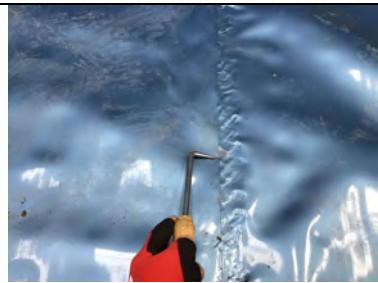
Probe testing all hand welded
membrane laps.

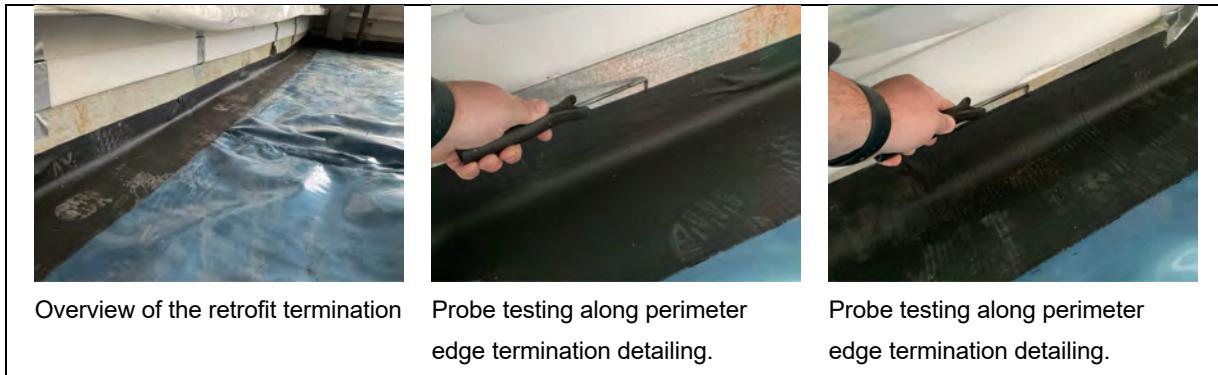
Perimeter Detail

detailing along perimeter edge
cladding rail using Juta GP1 SAM.

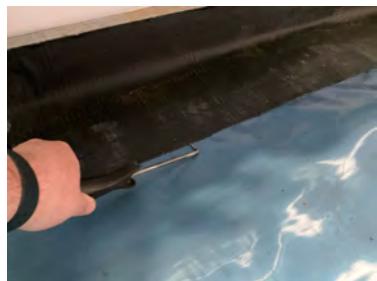
Probe testing along perimeter
edge termination detailing.

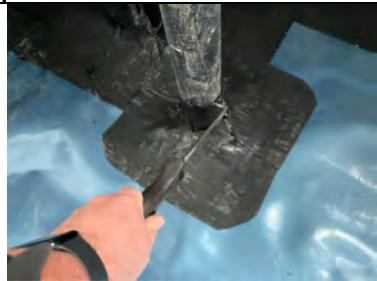
Probe testing to pipe penetration
detail.

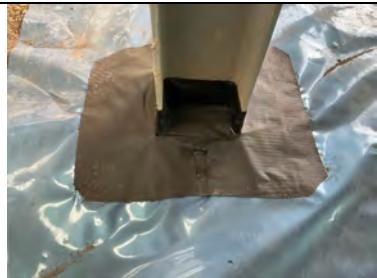
Steel stanchion detailed using
Juta GP1 SAM.

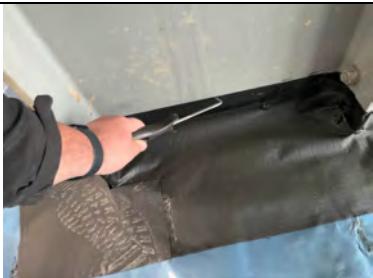
Probe testing to steel stanchion
details.

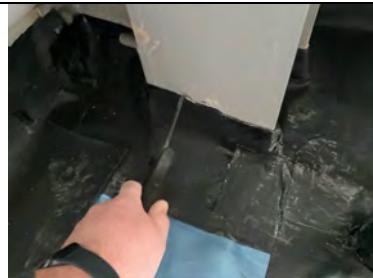
Probe testing to steel stanchion
details.

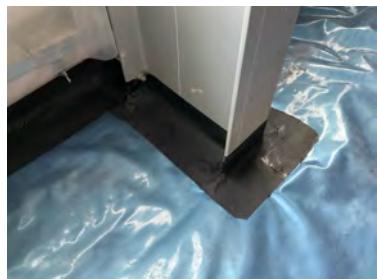
Steel stanchion detailed using
Juta GP1 SAM.

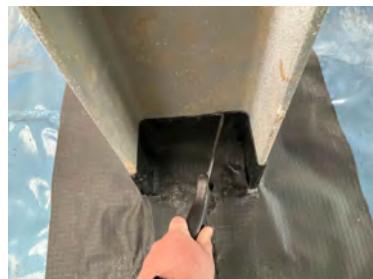
Probe testing to steel stanchion
details.

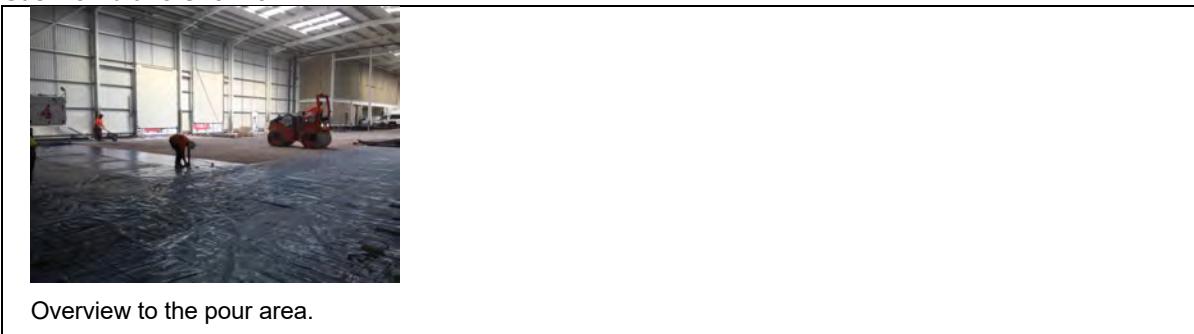
Overview to the pour area.

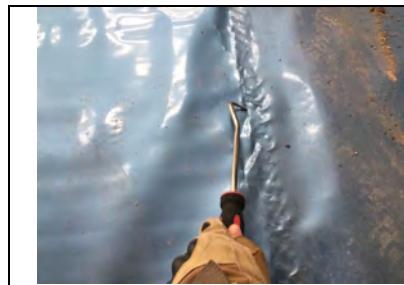
Testing to the hand welded lap joint.

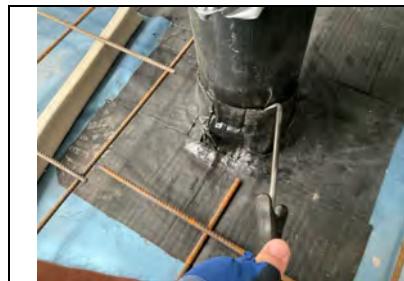
Probe testing to pipe penetration details.

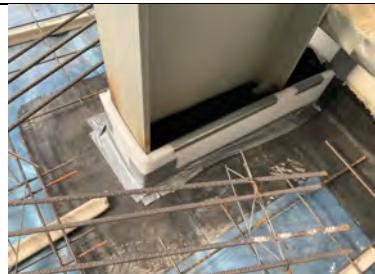
Restricted inspection to steel stanchions due to miothene strips surrounding.

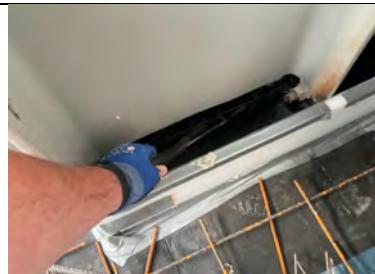
Probe testing to steel stanchion details.

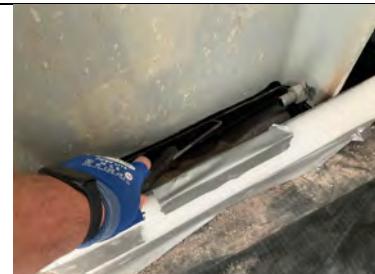
Probe testing to steel stanchion details.

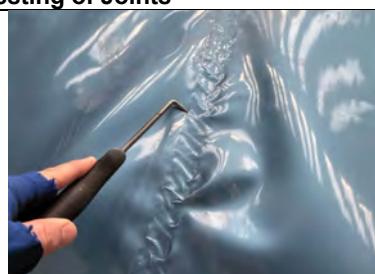
Probe testing along hand welded membrane lap joints.

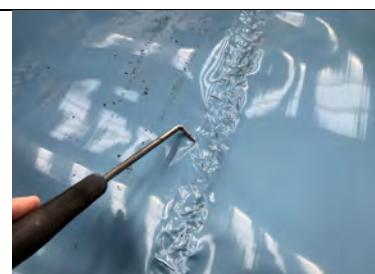
Probe testing along hand welded membrane lap joints.

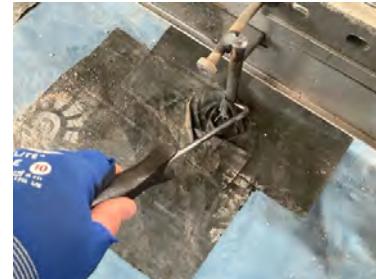
Probe testing to detailed
armoured joint pin.

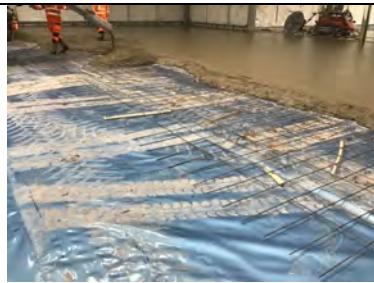
Overview of the Juta GP5 gas membrane installation as the pour progresses.

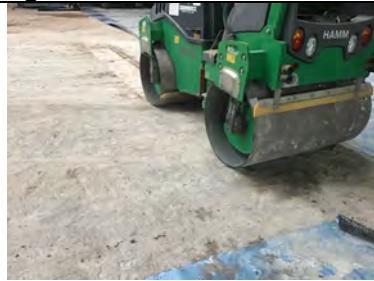
Evidence of the substrate being rolled prior to the installation of the Juta GP5 gas membrane as the pour progresses.

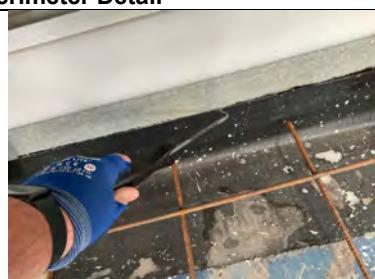
Probe testing along the perimeter edge cladding rail termination detailing

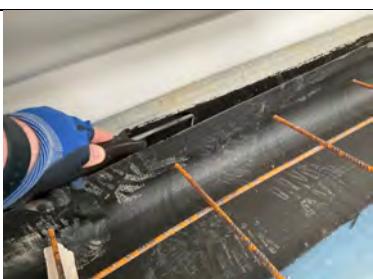
Probe testing along the perimeter edge cladding rail termination detailing

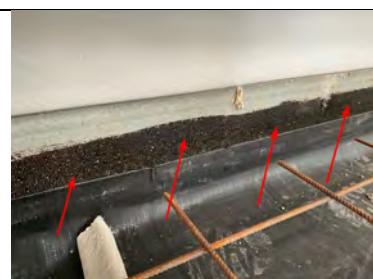
Evidence of the perimeter edge cladding rail being primed prior to termination detailing.

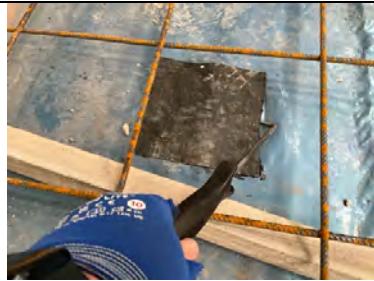
Probe testing installers own CQA patch repairs.

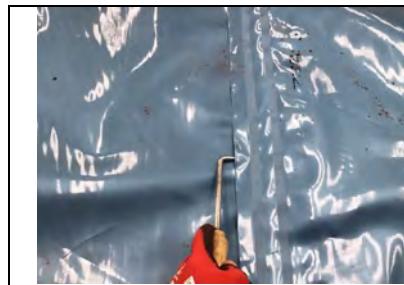
Probe testing all auto welded membrane laps.

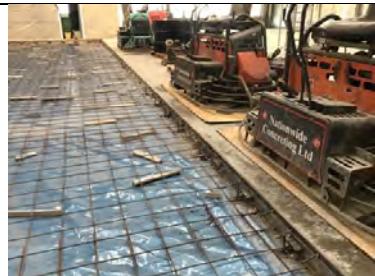
All armoured joint pin holes have been sealed using Juta GP1 SAM.

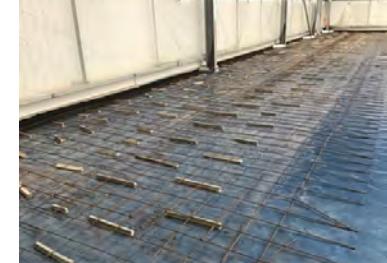
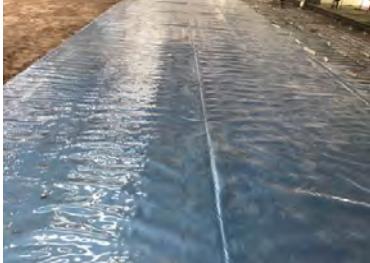
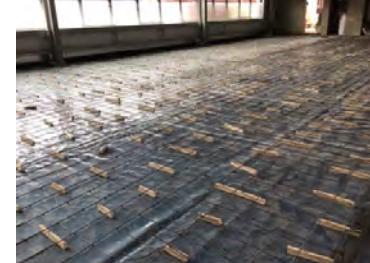
Gas Membrane Overview

Overview of the Juta GP5 gas membrane installation prior to the pour progressing.	Overview of the Juta GP5 gas membrane installation prior as the pour is progressing.	Overview of the Juta GP5 gas membrane installation to the undercroft area in unit 7.

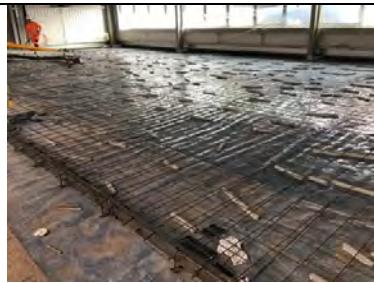
Overview of the Juta GP5 gas membrane installation to the undercroft in unit 8.

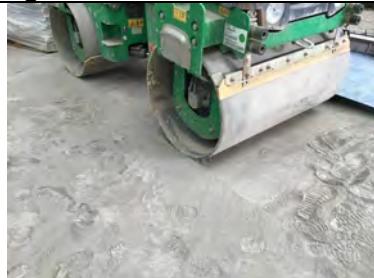
Subgrade Photos

Evidence of the substrate being rolled prior to the installation of the Juta GP5 gas membrane as the pour progresses.

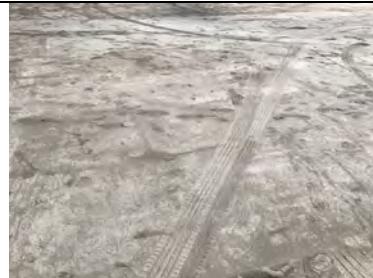
Overview of the rolled substrate.

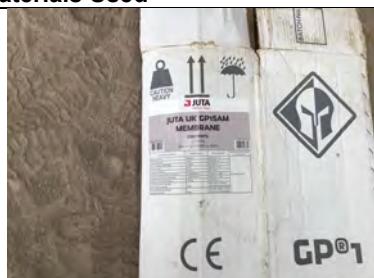
Materials Used

Evidence of the Juta GP1 SAM that has been used for the detailing work on this project.

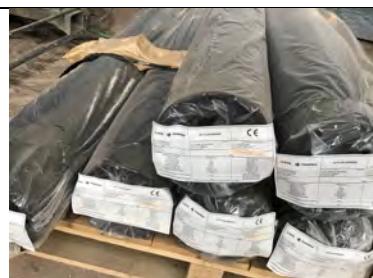
Evidence of the Juta GP5 gas membrane that has been used on this project.

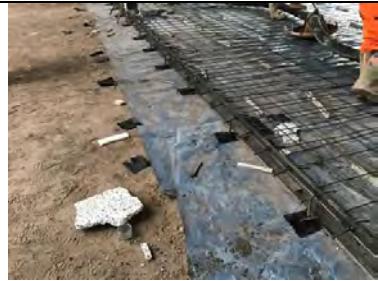
Additional Photos

Armoured joint pin hole detailing.

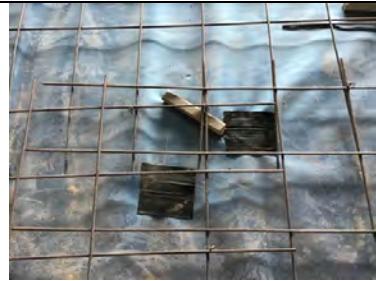
UK Membranes carried out the own CQA repairs as the pour progressed.

UK Membranes carried out their own CQA repairs as the the pour progressed.	No Action Required all Defects rectified at time of inspection
--	--
