## **Planning Application Structural Report**

Bird Place  
Henley Bridge  
Henley-on-Thames  
Berkshire  
RG9 2LN

03 April 2025

25-2795

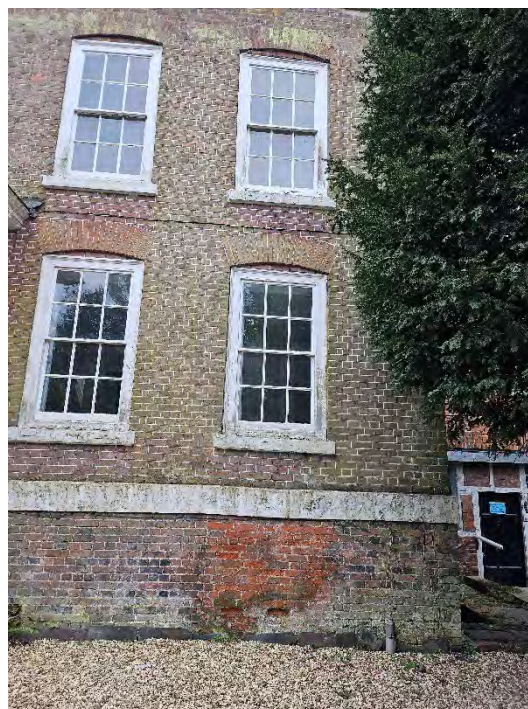
**P24 Front – adjacent yew**

The mitigation measures will probably be dependent upon the removal of the yew tree which is likely to have been influential in the movement caused at the front.

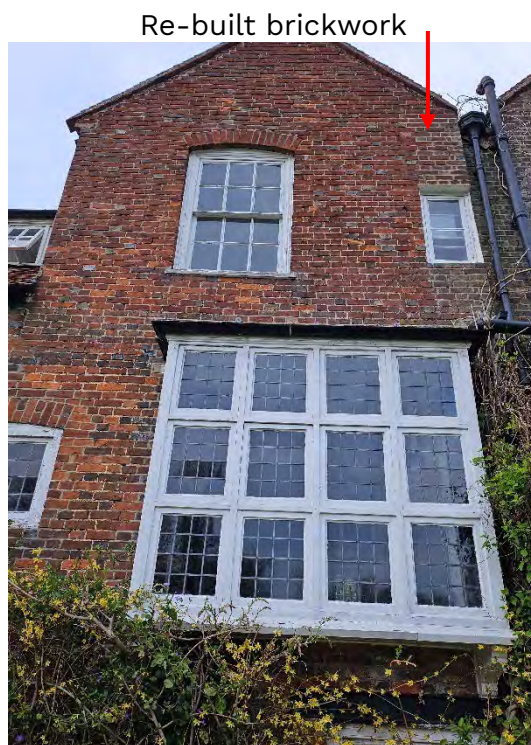
The rear bow window is supported on framing at ground floor level which is supported on two brick piers. This is clearly an addition to the building and it appears there has been some settlement down of the piers and also potential corrosion of the steel strapping within the bow window.

**P44 Bay window – rear (See also P45)**

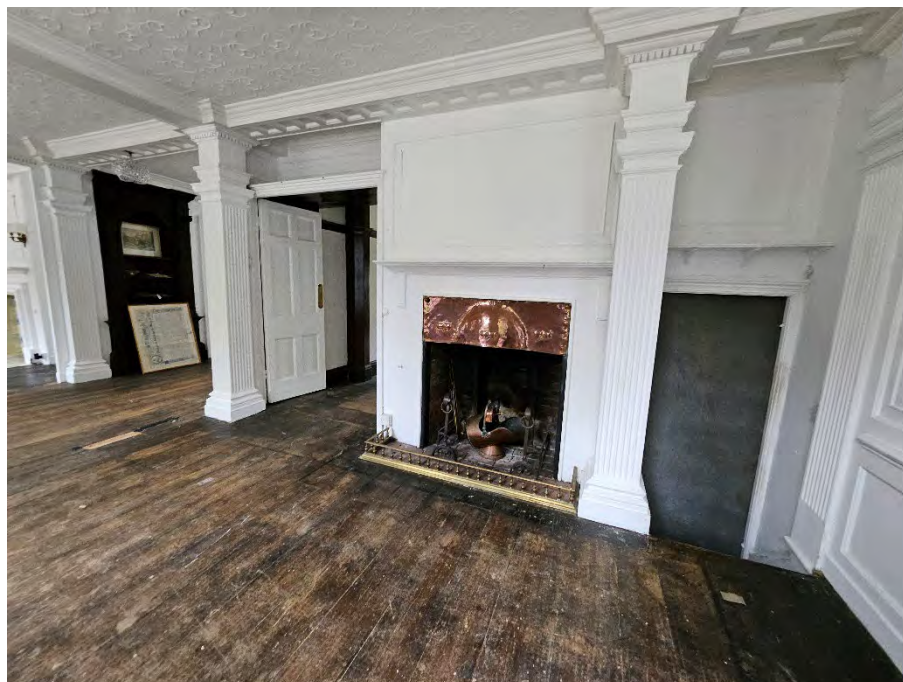
**P60 Encased framing to beams**

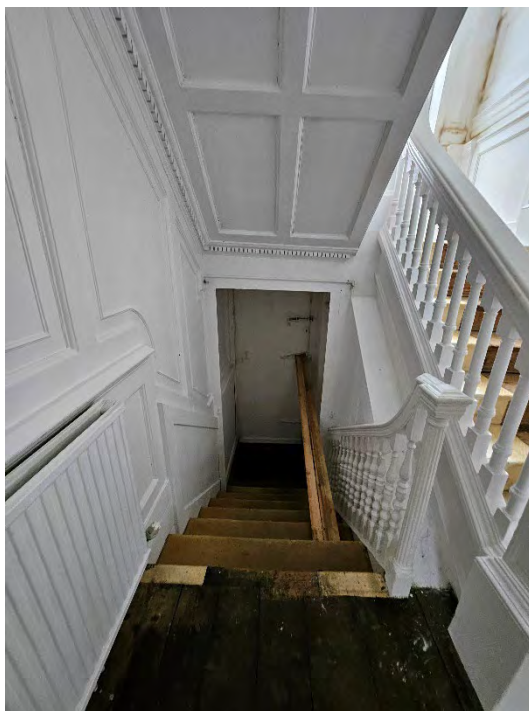
**P65 Stairs to rear over basement**

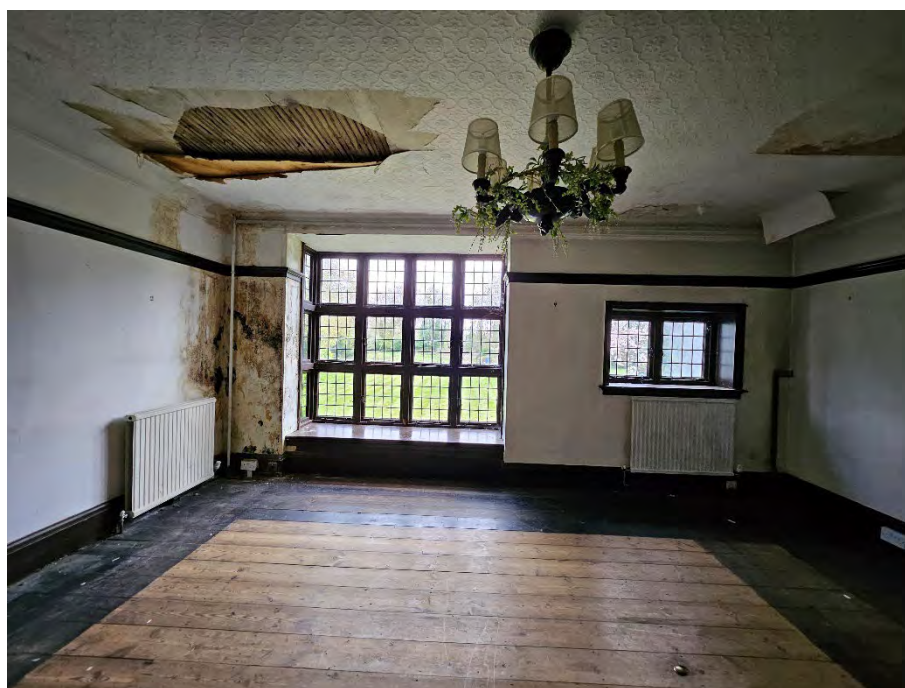
**P70 Rear right-hand ground floor**

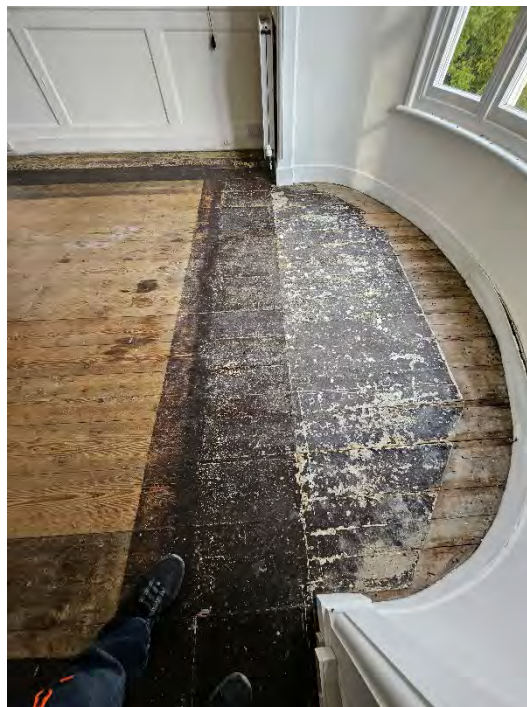
**P76 Displacement to floor**
